# RENESAS TECHNICAL UPDATE

Product Category	System LSI		Document No.	TN-RIN-A015A/E	Rev.	1.00
Title	Ethernet MAC reception issue in case TCPIP accelerator enabled		Information Category	Technical Notification		
Applicable Product	Please refer to [1. Applicable Product] described below.	Lot No.	Reference Document	R-IN32M3 Series User's Manual: Peripheral Modules R-IN32M3-EC, R-IN32M3-CL Rev9.00 (R18UZ0007EJ0900)		
		All lot

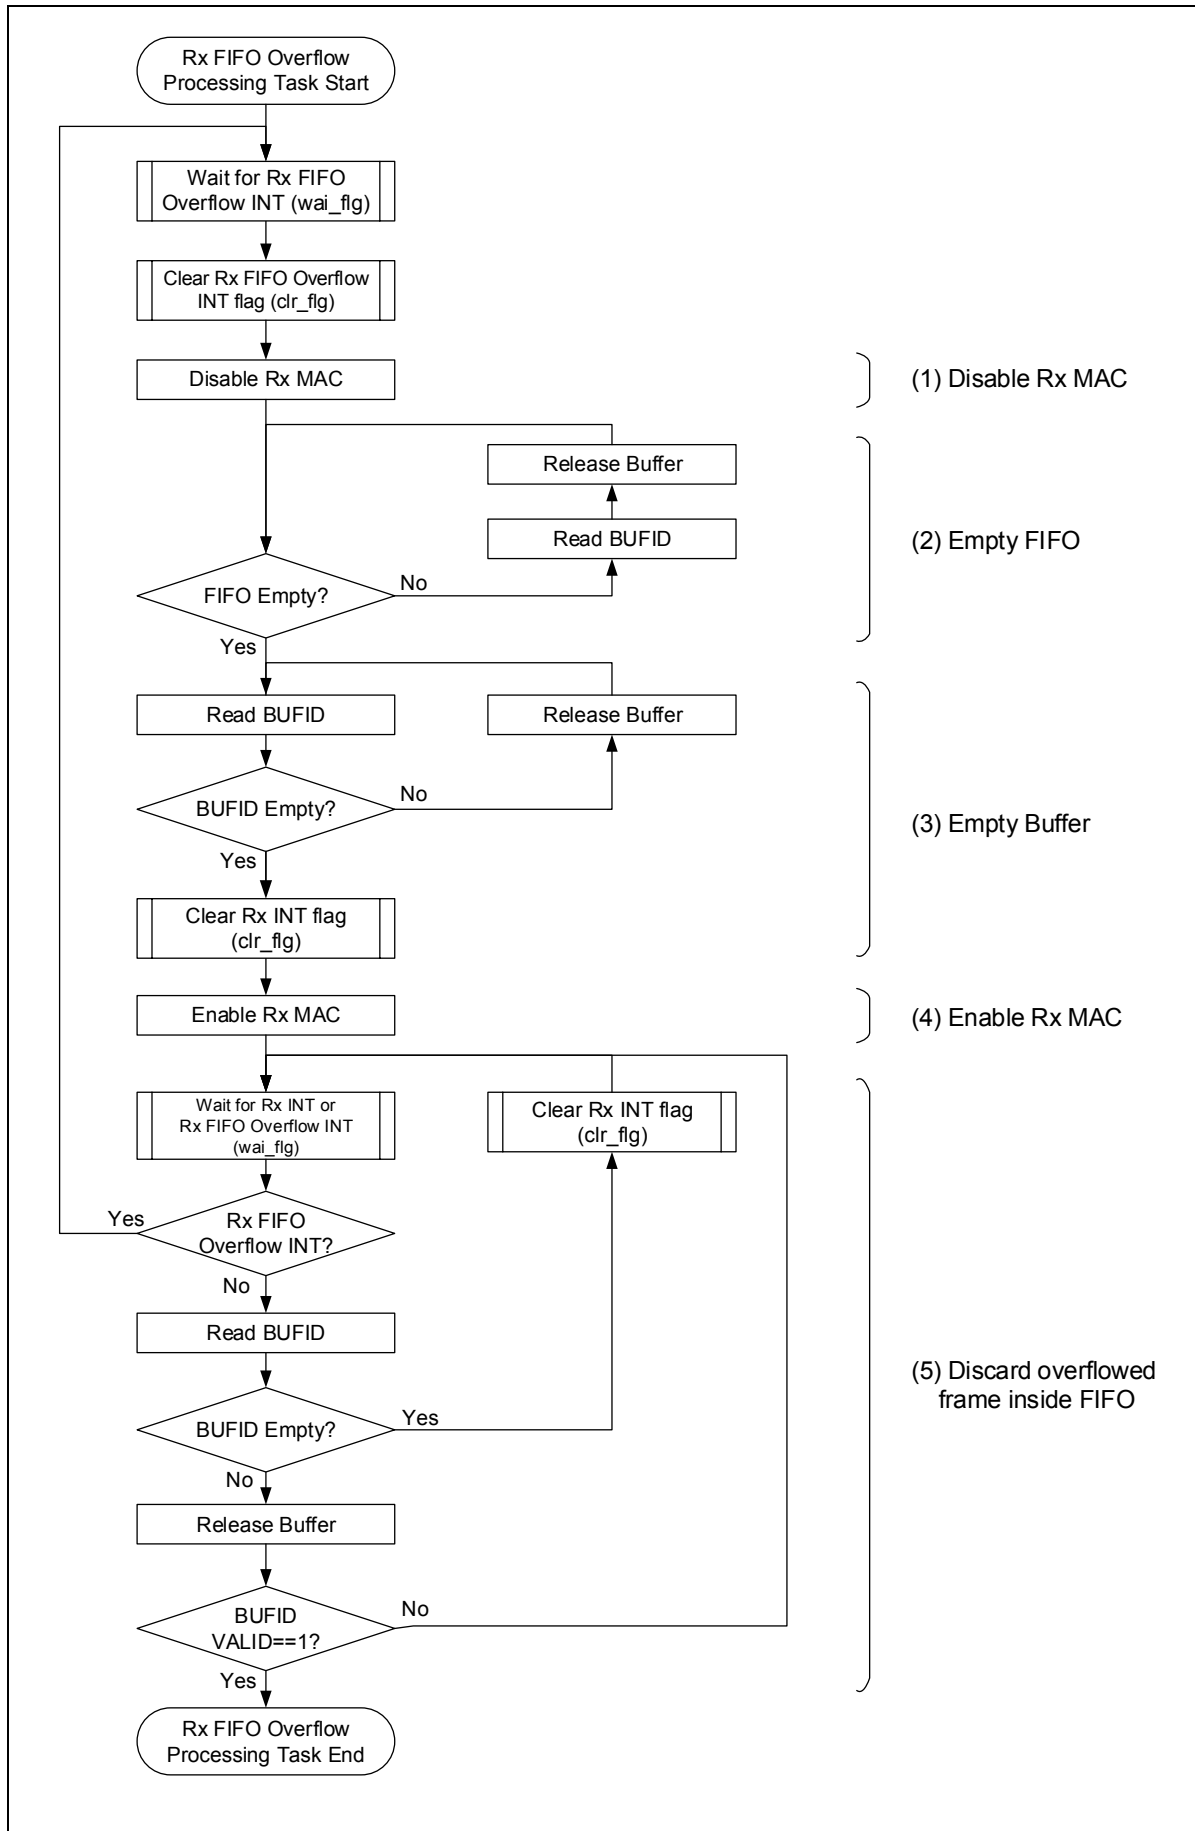
Fig1: Flowchart of RX FIFO overflow processing task (In case of using HW-RTOS)

- It is possible that error information which is related to the previous error frame is included in frame information of normal reception frame.
- It is possible that abnormal frame which caused Rx FIFO overflow is regarded as normal frame because of illegal value is included in frame information

In case Rx FIFO overflow is occurred when Rx TCPIP accelerator is enabled.

- (A) Disable Rx TCPIP accelerator without padding insertion to MAC header. Specifically, clear bit0 of GMAC\_ACC register.
- (B) When Rx FIFO is overflowed, discard all frames left in Rx FIFO and Buffer RAM. Specifically, apply the following procedure;
  - (1) Disable Rx MAC.
  - (2) Discard all frames inside Rx FIFO.
  - (3) Discard all frames inside Buffer RAM.
  - (4) Enable Rx MAC.
  - (5) Discard at least one frame with BUFID VALID bit = 1. This is because FIFO empty state can be read even if the frame which caused FIFO overflow remains in the FIFO. Receive normal frame once and discard remained abnormal frame with it.

- ✓ Create overflow processing task with higher priority than one of reception processing task
- ✓ Start overflow task by HWISR combined with FIFO overflow interrupt
- ✓ Discard the abnormal frame remained in the FIFO by HWISR combined with reception interrupt

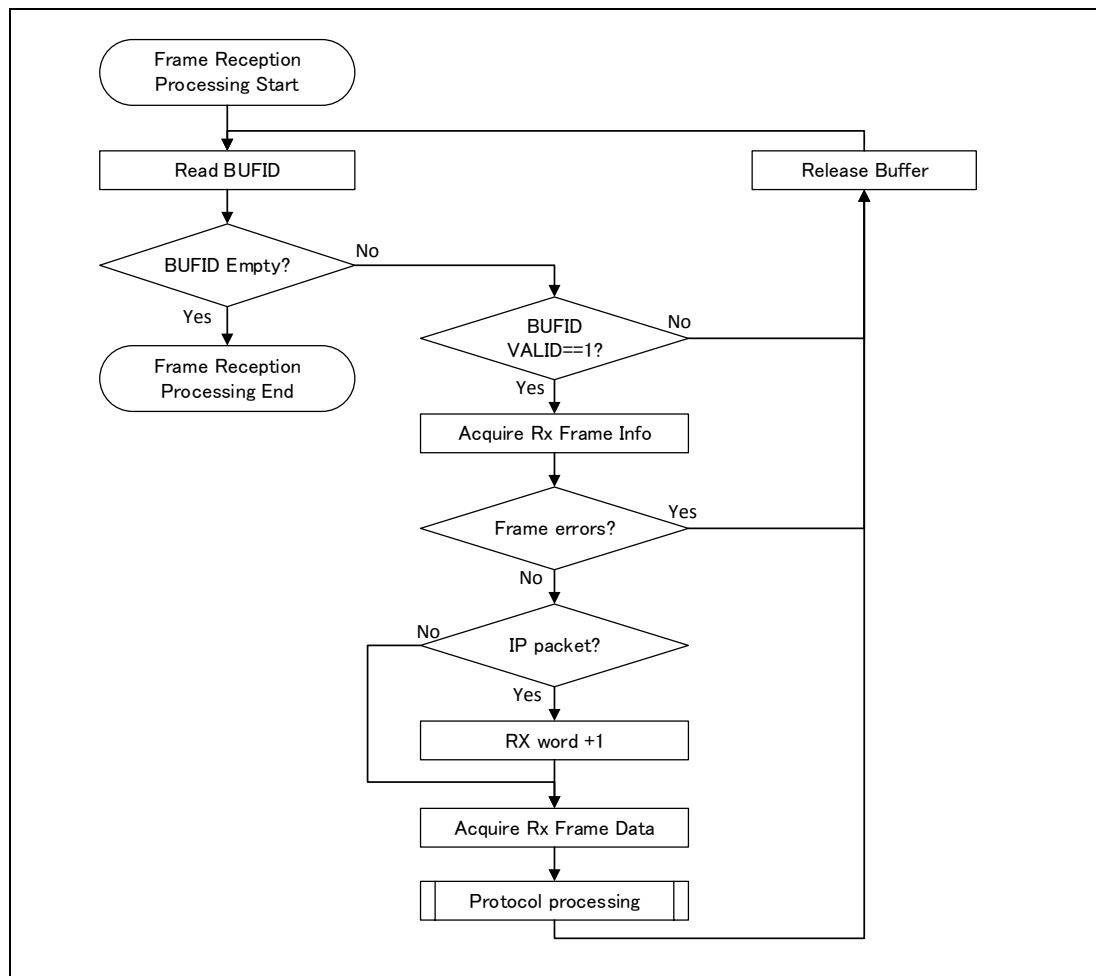
Fig 5: Flowchart of Reception processing

It is possible that reception word size (RX\_WORD[12:0]) in the frame information increases by 1 word (4 bytes) or decreases by 1 word compared with correct size. In case of decrease by 1 word, it is possible that RX\_WORD indicates the size which causes lack of IP packet. IP packet itself is NOT lacked.

- (A) RX TCPIP accelerator enabled
- (B) Reception frame meets all the following conditions;
  - (1) Frame size including FCS is more than 64 bytes.
  - (2) TCP/IP or UDP/IP packet is included.
  - (3) Padding (Trailer) is included between IP packet and FCS.

- (A) Disable Rx TCPIP accelerator. Specifically, clear bit0 or set bit2 of GMAC\_ACC register.
- (B) In order to avoid lack of the IP packet, increase reception word size by 1 and transfer the size to protocol stack. In the protocol stack, payload data should be extracted based on size of Total Length field in IP header and the rest data should be discarded. Fig 5 is the flowchart of this workaround.
