1 Purpose of Document

This document summarizes the changes between the previous ASI4U silicon revision C and the current silicon revision E. These include requested UART design changes. The purpose of the redesign was to correct reported timing errors by the UART in the following modes: Master, Monitor, and Repeater. A problem with slave communication in special network constellations was also fixed.

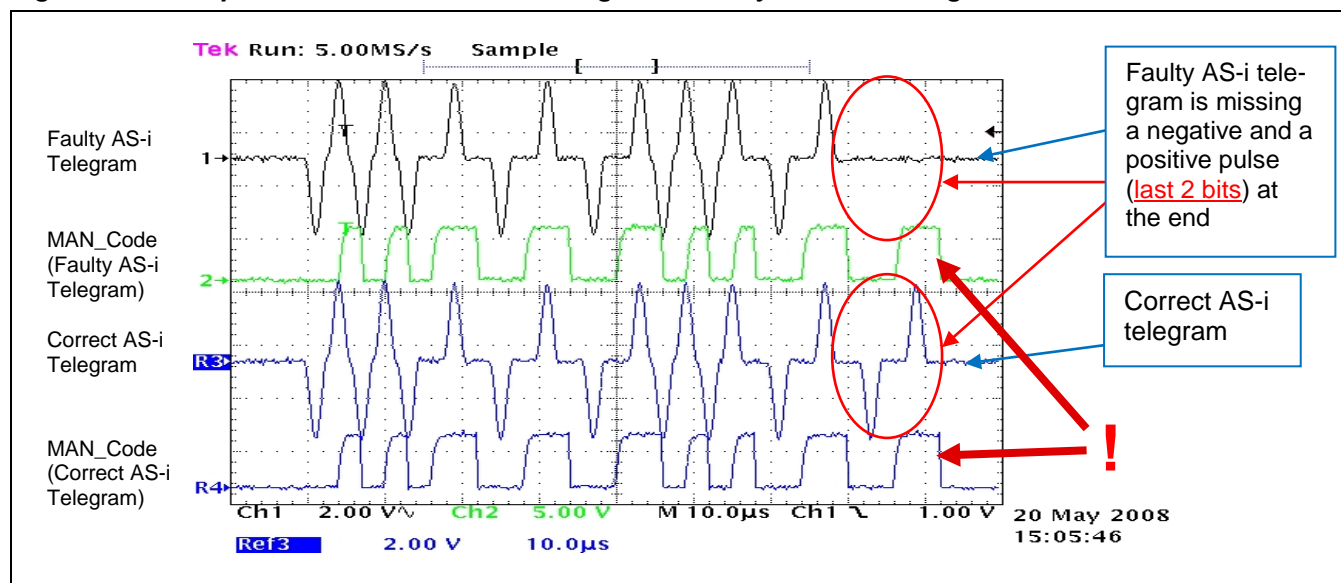
Figure 2.1 Comparison of Valid MAN-Code Signal to Faulty MAN-Code Signal

If the ASI4U revision C operates in Master Mode, Monitor Mode or Repeater Mode, the error signaling for an *End_Bit_Error* does not work correctly. In some special cases, the generated MAN-Code of a signal with an *End_Bit_Error* looks similar to the MAN-Code of a signal without any errors as demonstrated in Figure 2.1.

This malfunction of the ASI4U revision C results in an MAN-coded output signal that does not allow distinction between correct AS-I pulse sequences and pulse sequences that are shortened (missing one negative and one positive pulse). It occurs only under the following conditions:

- The parity of the signal is even.
- The last bit of the corrupt telegram is equal to binary 1.
- The *Stop_Bit* and the *Parity_Bit* or the *Start_Bit* and the *Control_Bit* are missing.
- If the *Start_Bit* and the *Control_Bit* are missing, the first pulse must have a negative polarity.

1. The last pulse of the MAN-coded LED1 output signal is now always kept in ACTIVE state for 9μs if an ASI telegram with an *Endbit_error* is received.

The polarity of the ACTIVE State depends on the signal setting at the DI ports in Master Mode, Monitor Mode, and Repeater Mode. If DI2 and DI3 are driven by equal input signals, the MAN output signal at LED1 is configured ACTIVE LOW. If DI2 and DI3 are driven by unequal input signals, LED1 becomes inverted and is configured ACTIVE HIGH.

Since a 9μs-wide MAN pulse is an out-of-specification event for the AS-I MAN signal, it will allow the connected microcontroller to recognize the error in the AS-I pulse signal on the AS-I line.

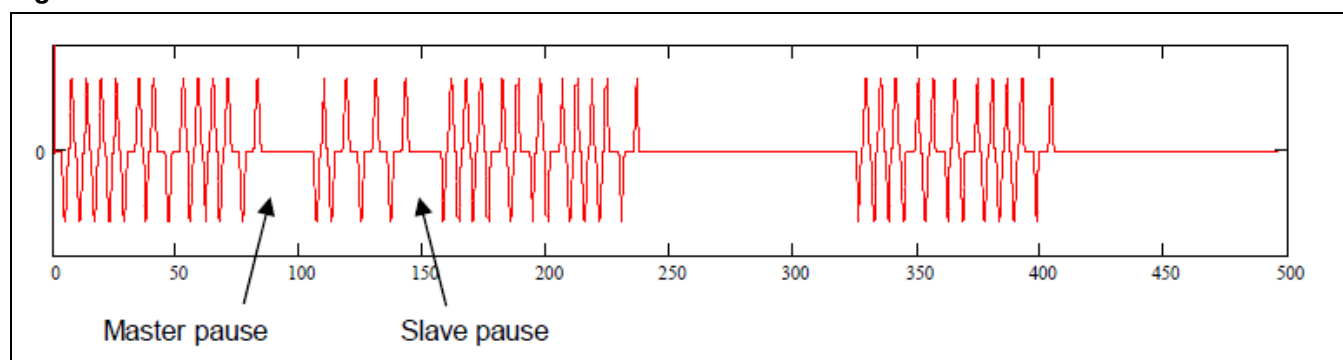
Figure 3.1 Test for ASI4U Revision C Error in Master Pause Detection

If the previous ASI4U revision C is operated in Slave Mode, the UART Master Pause detection does not always function correctly when the UART must listen to slave responses from a different slave. Depending on the actual AS-I line pulse timing, a slave response from a different slave is sometimes not recognized correctly, which results in a UART communication error. This prevents the Slave from understanding the next Master telegram correctly. If the Master telegram addresses the Slave itself, the error leads to a missing slave response and the Slave replies on a second repetition of the Master Call to its own address in asynchronous mode.

This behavior was mostly observed in mixed networks that used modules with the ASI4U, SAP5, and SAP4.1.

Figure 3.1 shows a telegram test case to reproduce the error. The AS-I signals shown in Figure 3.1 were generated by a signal generator that allowed sweeping the Master Pause and Slave Pause duration over the allowed specification limit. The first Master Call contains a different slave address than the tested slave. The second and third master calls address the tested slave. The tested slave replied with the erroneous behavior for certain Master pause and Slave pause scenarios only. The majority of the test cases were passed without error.

A new principle of AS-i telegram pause detection was implemented in ASI4U silicon revision E that is more precise and able to cover all valid timing scenarios for Master and Slave pauses. The new principle is now independent of the internal timing constraints of the UART state machine.
