RENESAS TECHNICAL UPDATE

Product Category	System LSI		Document No.	TN-RIN-A016A/E	Rev.	1.00
Title	Ethernet MAC reception issue in case TCPIP accelerator enabled		Information Category	Technical Notification		
Applicable Product	Please refer to [1. Applicable Product] described below.	Lot No.	Reference Document	R-IN32M4-CL2 User's Manual: Peripheral Modules R9J03G019GBG Rev1.00 (R18UZ0034EJ0100)		
		All lot

This document describes information about issues of Ethernet MAC in case TCPIP accelerator is used. Please use the Ethernet MAC considering those issues.

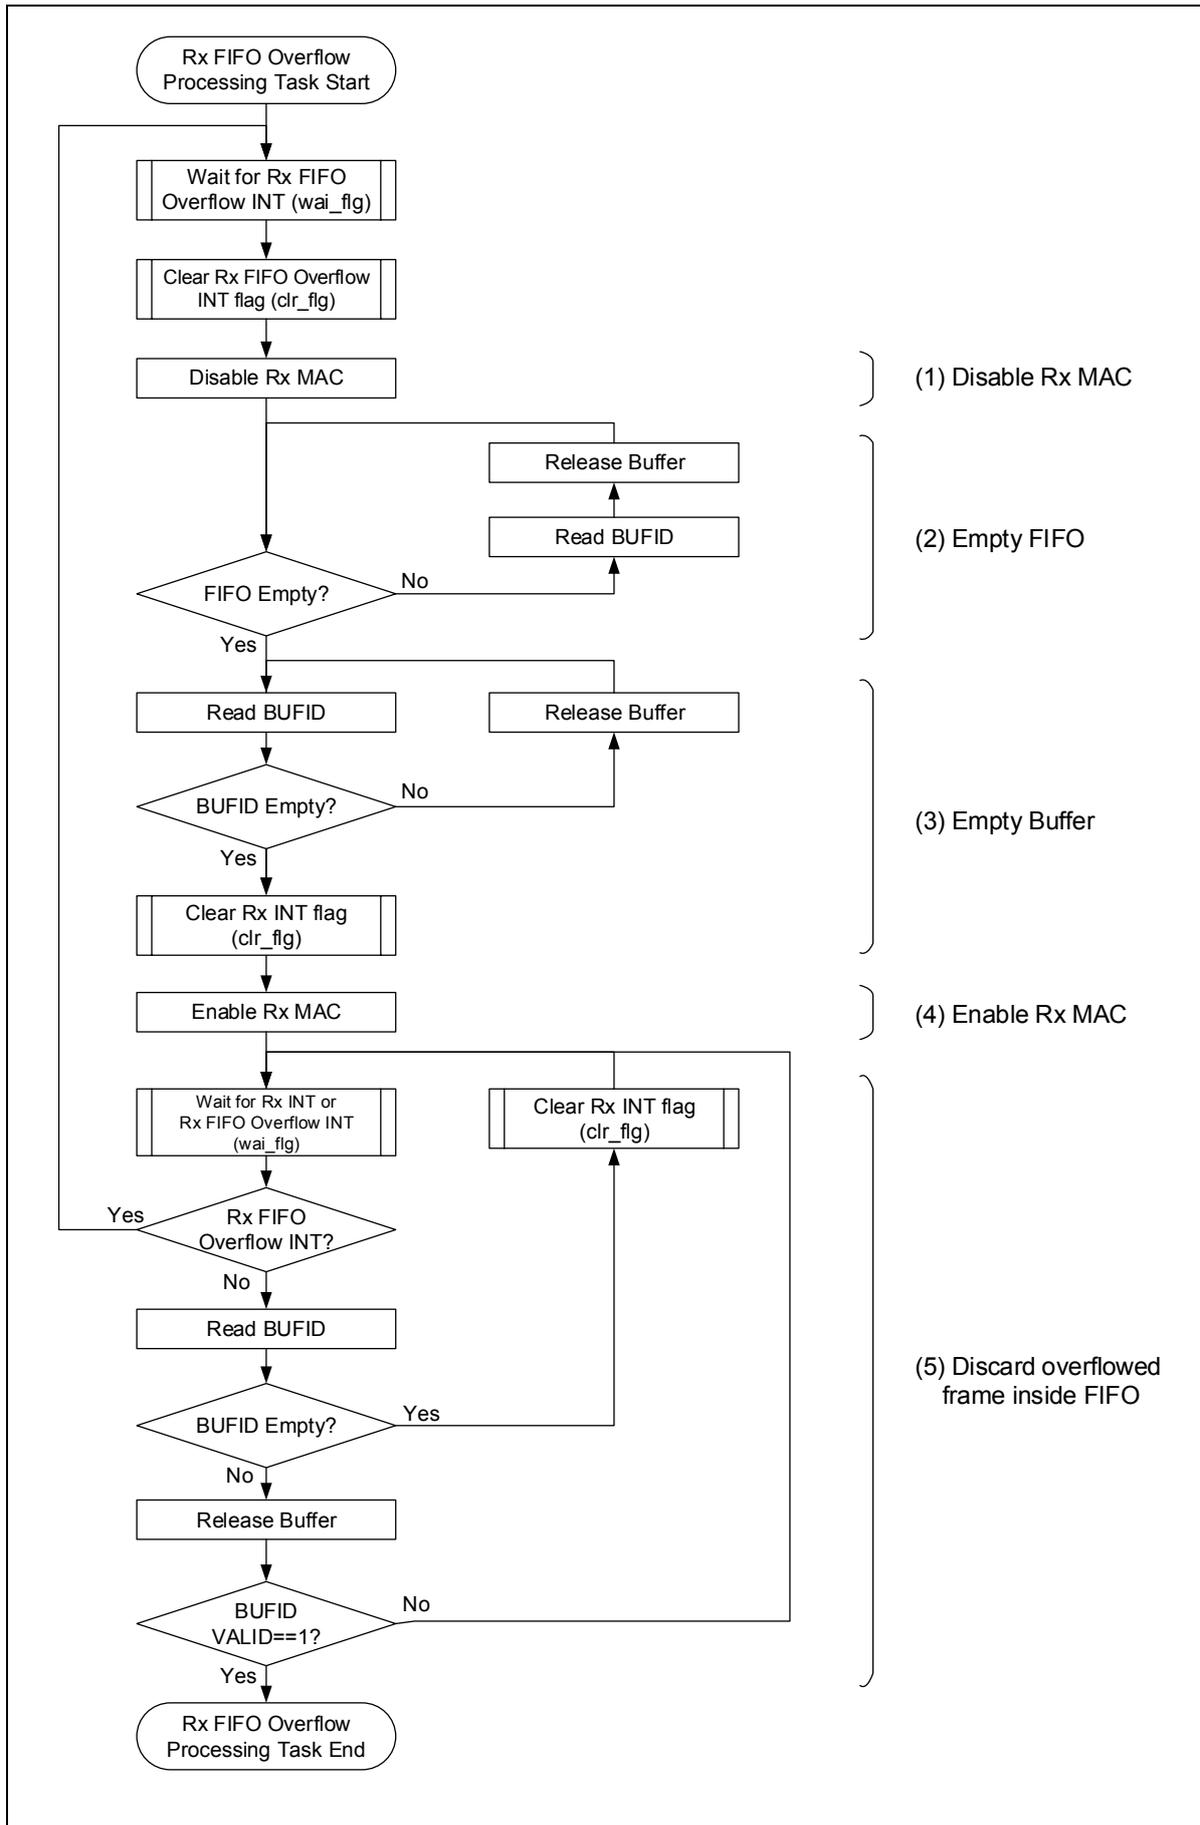
Fig1: Flowchart of RX FIFO overflow processing task (In case of using HW-RTOS)

- It is possible that error information which is related to the previous error frame is included in frame information of normal reception frame.
- It is possible that abnormal frame which caused Rx FIFO overflow is regarded as normal frame because of illegal value is included in frame information

In case Rx FIFO overflow is occurred when Rx TCPIP accelerator is enabled.

- (A) Disable Rx TCPIP accelerator without padding insertion to MAC header. Specifically, clear bit0 of GMAC_ACC register.
- (B) When Rx FIFO is overflowed, discard all frames left in Rx FIFO and Buffer RAM. Specifically, apply the following procedure;
 - (1) Disable Rx MAC.
 - (2) Discard all frames inside Rx FIFO.
 - (3) Discard all frames inside Buffer RAM.
 - (4) Enable Rx MAC.
 - (5) Discard at least one frame with BUFID VALID bit = 1. This is because FIFO empty state can be read even if the frame which caused FIFO overflow remains in the FIFO. Receive normal frame once and discard remained abnormal frame with it.

- ✓ Create overflow processing task with higher priority than one of reception processing task
- ✓ Start overflow task by HWISR combined with FIFO overflow interrupt
- ✓ Discard the abnormal frame remained in the FIFO by HWISR combined with reception interrupt

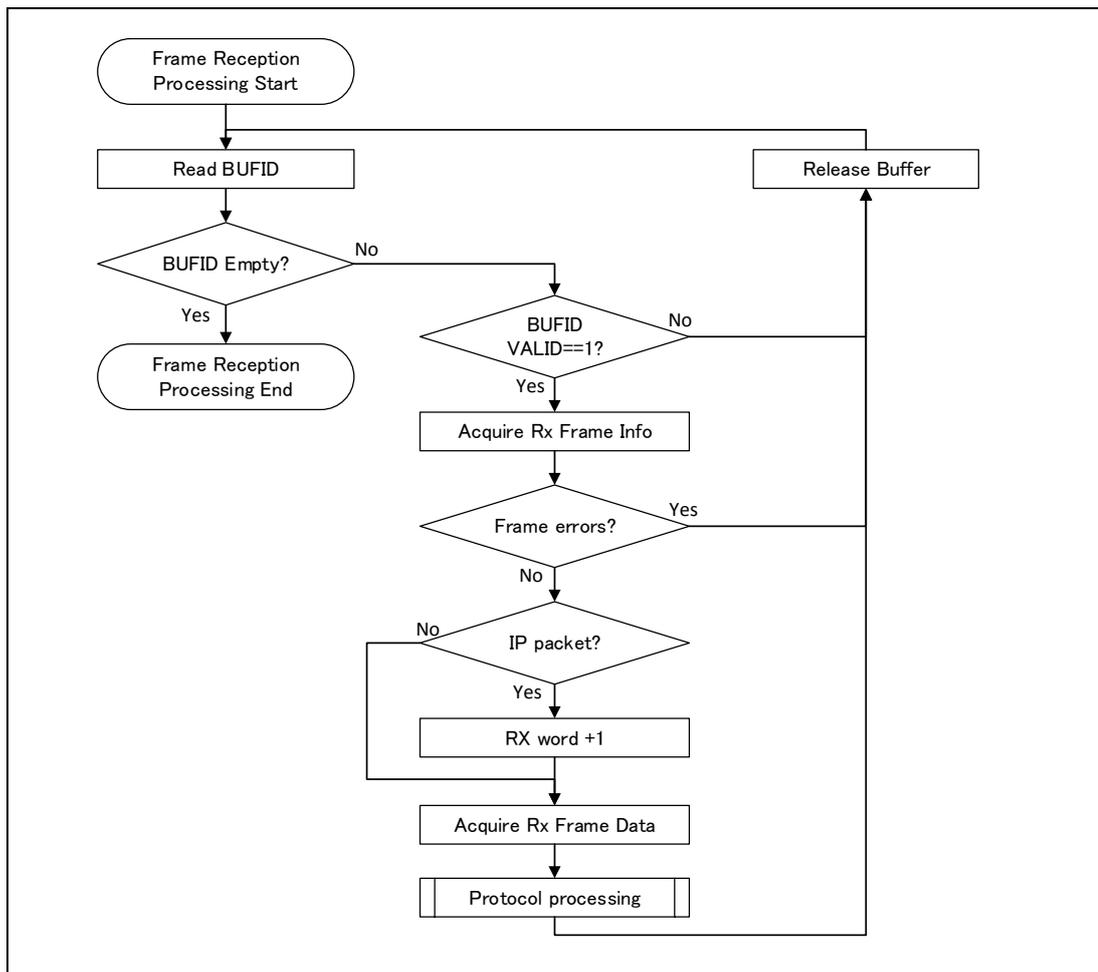
Fig 5: Flowchart of Reception processing

It is possible that reception word size (RX_WORD[12:0]) in the frame information increases by 1 word (4 bytes) or decreases by 1 word compared with correct size. In case of decrease by 1 word, it is possible that RX_WORD indicates the size which causes lack of IP packet. IP packet itself is NOT lacked.

- (A) RX TCPIP accelerator enabled
- (B) Reception frame meets all the following conditions;
 - (1) Frame size including FCS is more than 64 bytes.
 - (2) TCP/IP or UDP/IP packet is included.
 - (3) Padding (Trailer) is included between IP packet and FCS.

- (A) Disable Rx TCPIP accelerator. Specifically, clear bit0 or set bit2 of GMAC_ACC register.
- (B) In order to avoid lack of the IP packet, increase reception word size by 1 and transfer the size to protocol stack. In the protocol stack, payload data should be extracted based on size of Total Length field in IP header and the rest data should be discarded. Fig 5 is the flowchart of this workaround.
