Microcomputer Technical Information

| | | Document No. | | -CD-04-0077 | 1/2 |
| IE-78K0K1-ET In-Circuit Emulator for 78K0/KB1, KC1, KD1, KE1, KF1, KB1+, KC1+, KD1+, KE1+, KF1+ Usage Restrictions | | Date issued | September 28, 2004 Development Tool Group Multipurpose Microcomputer Systems Division 3rd Systems Operations Unit NEC Electronics Corporation | | |

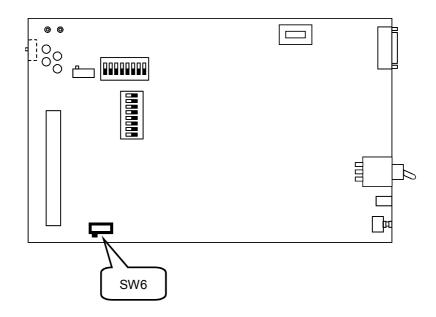
Package Drawing of Emulation board (S-780148 Board)

No. 2 SW6

Use SW6 in the default setting (3-side). (SW6 is a switch used for maintenance.)
