RENESAS TECHNICAL NEWS

No.M16C-112-0309

M30245MC/8-XXXGP

Cautions on Serial I/O

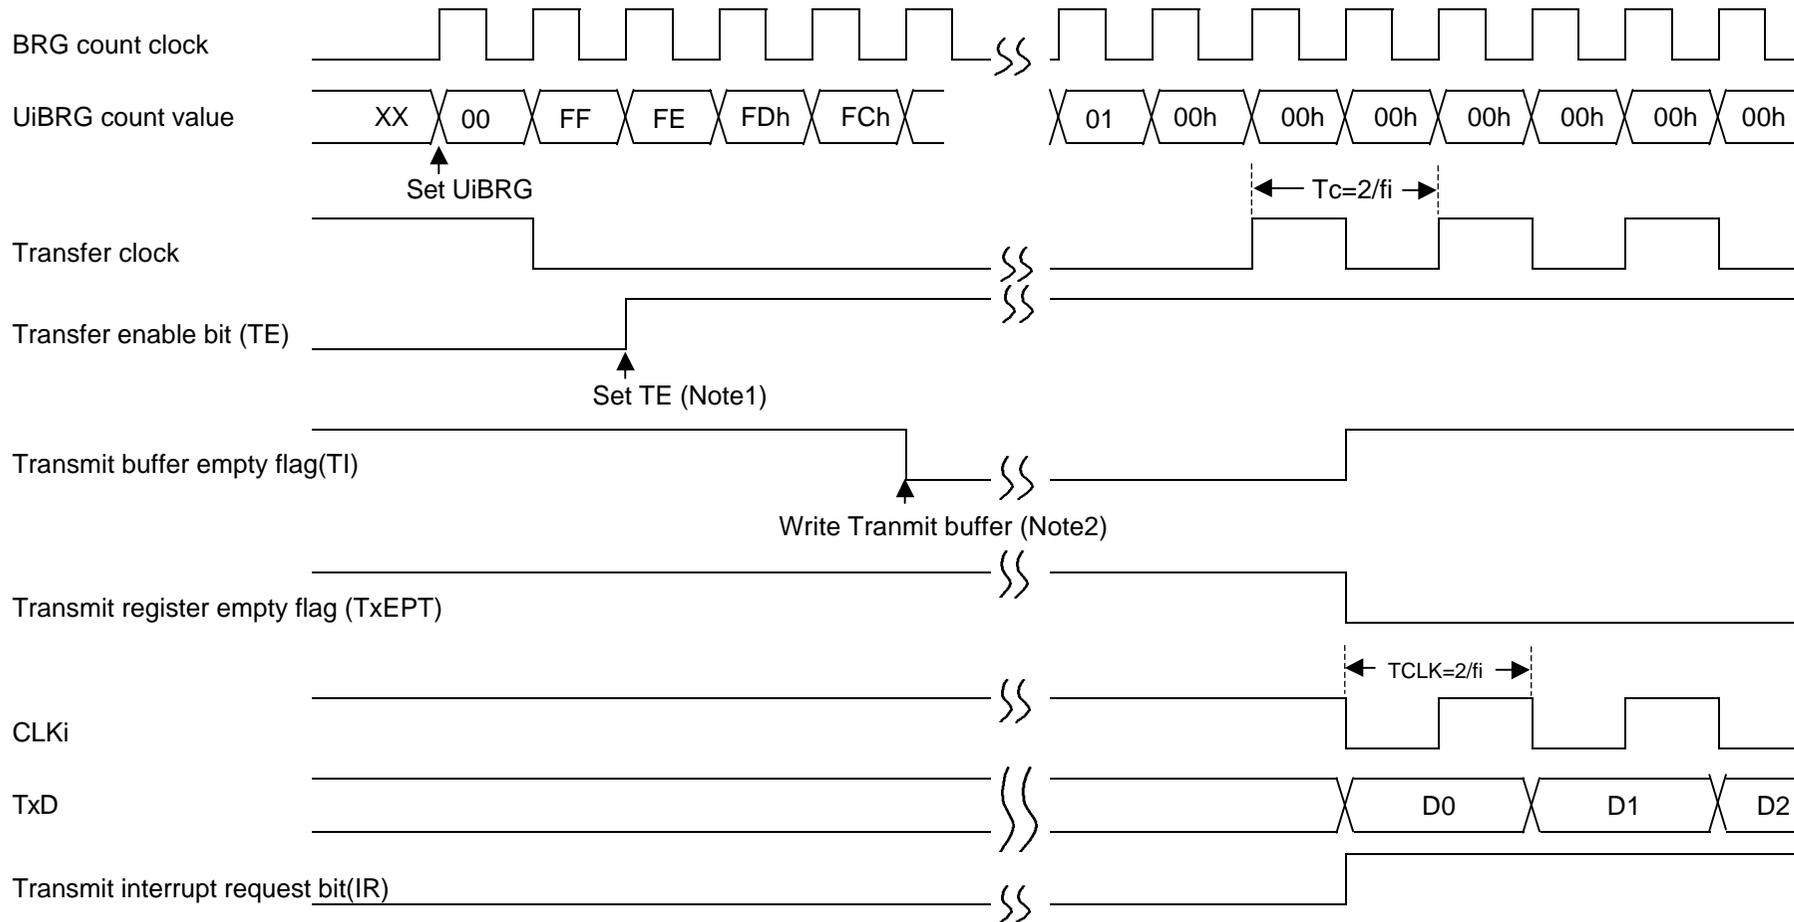
Operation when UiBRG is set to '00h'

Under the condition below, there is a possibility that the cycle when the first data transfer is available is delayed for 256 cycles (maximum) of BRG count source.

Due to the delay of the cycle when the first data transfer is available, Transmit register empty flag (TXEPT) is delayed as well. Please consider the delay when judging TXEPT to know the status of the transfer.

BRGi divides the count source by n+1 (n: value set to UiBRG). The divide-by-two signal of the underflow signal is UARTi Transfer clock or UARTi Receive clock. In case that UiBRG is set to '00h', there is a possibility that the first underflow of BRG is delayed for 256 cycles. Therefore, data transfer is not available until the first underflow is generated. Underflows except the first time are generated during the expected cycle (no division). The timing diagram in the next page shows an example of the behavior.

- (1) In order to eliminate the influence of the delay of the cycle when the first data transfer is available, please set Transmit enable bit (TE) and/or Receive bit (RE) 256 cycles (of BRG count source) after setting UiBRG. Since underflows except the first time are generated during the expected cycle, the delay of the first underflow of BRG does not affect the cycle when data transfer is available.
- (2) If case (1) above is impossible, please set UiBRG to any value except '00h'. The delay of the first underflow of BRG will not occur.

M30245MC/8-XXXGP will be revised. The new revision of the chip will be available for ROM ordering in Nov. 2003. If case (1) or (2) above is implemented, two revisions of the chip behaves in the same way.
