# RENESAS TECHNICAL UPDATE

Product Category	MPU&MCU		Document No.	TN-SH7-A684A/E	Rev	1.00
Title	Note on Use of SH7780 SIOF Master Mode 2		Information Category	Technical Notification		
Applicable Product	SH7780 Group	Lot No.	Reference Document	SH7780 Hardware Manual Rev.1.00 Dec.13.2005 (REJ09B0158-0100)		
		All lots

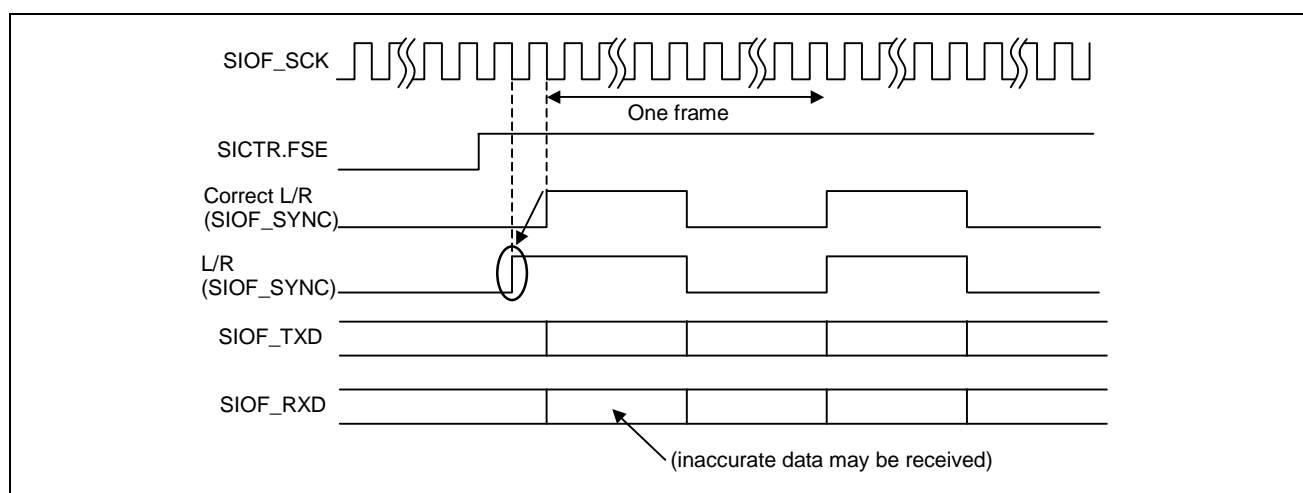
Figure 1. SIOF\_SYNC Output Timing in Master Mode 2 (Transfer Started)

When using master mode 2 of the SIOF, if a transfer is started as set SICTR.FSE to 1 after reset, the first L/R signal (SIOF\_SYNC) is always asserted early for one clock (see figure 1). And if a transfer is suspended as clear SICTR.FSE to 0 and resumes as set SICTR.FSE to 1 again, the first L/R signal may be asserted one clock late (see figure 2). In any case, an inaccurate data may be received at the first slot of received frame.

1. When the L/R signal asserted early for one clock.

There is no suitable workaround about the SIOF of the SH7780. If this operation is the problem in your system, take the countermeasure on your system for example ignore the first data.

If any countermeasure cannot be used on your system, use the SSI instead of the SIOF. However, the SSI cannot perform the full-duplex transfer by multiple slots. Furthermore, the SIOF cannot be used when use the SSI because of the SH7780 pin configuration.
