MESC TECHNICAL NEWS

No. M16C-58-0007

Notes on Control Transfer of M30240 Group One Time PROM version

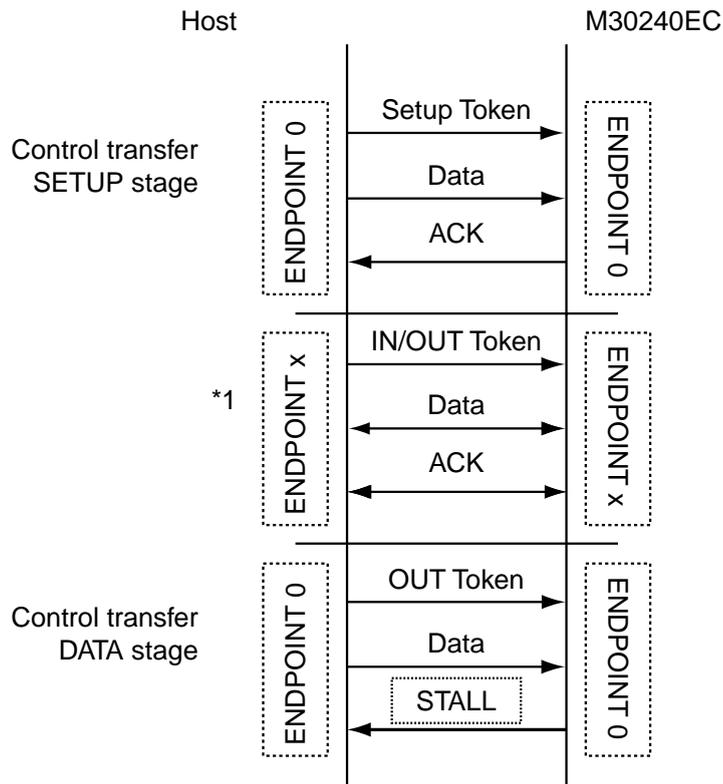
Case 1: At Control Write transfer DATA stage, M30240EC sends STALL for the handshake.

These four cases can be prevented by avoiding occurrence of any transfer of Endpoint x during SETUP stage and DATA stage of control transfer.

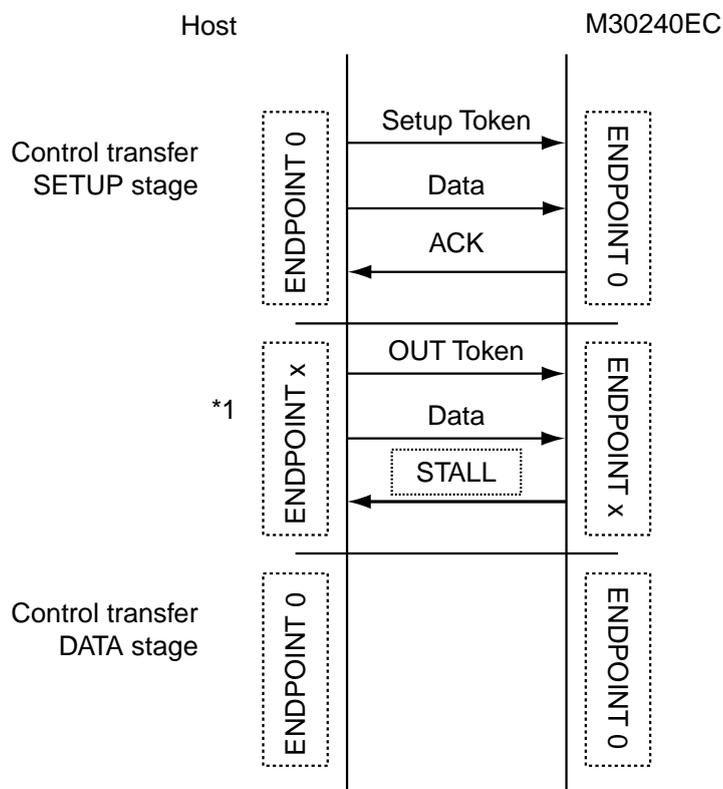
Case 2: During transfer of ENDPOINT x (*1), M30240EC sends STALL for the handshake.

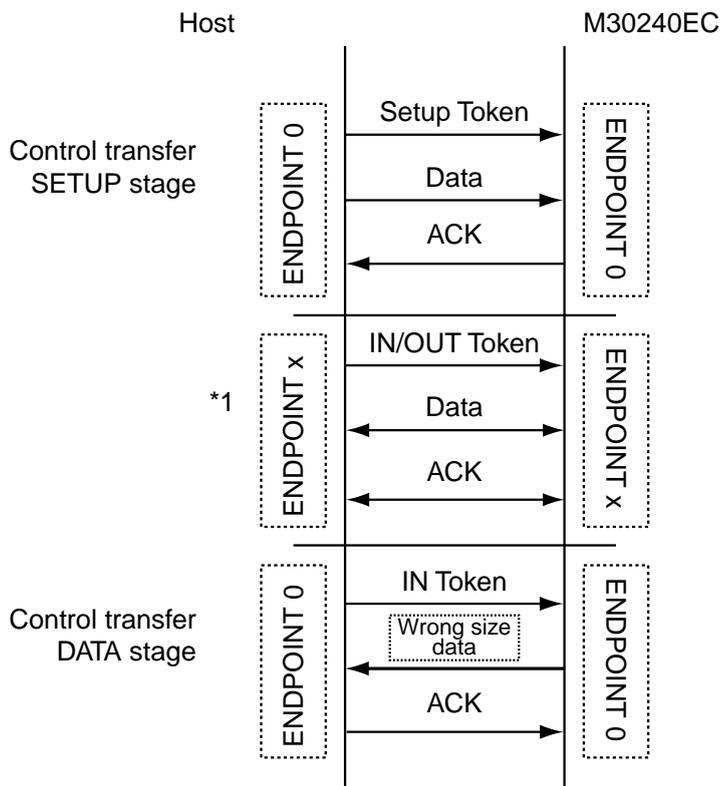
Case 3 occurs if the following two conditions are added to the above.

- (a) The actual packet size the host sends/receives to/from other endpoints is not equal to its endpoint's MAXP.
- (b) The difference of MAXP and the actual packet size is less than EP0 MAXP.

Case 3: At Control Read transfer DATA stage, M30240EC sends wrong size data.

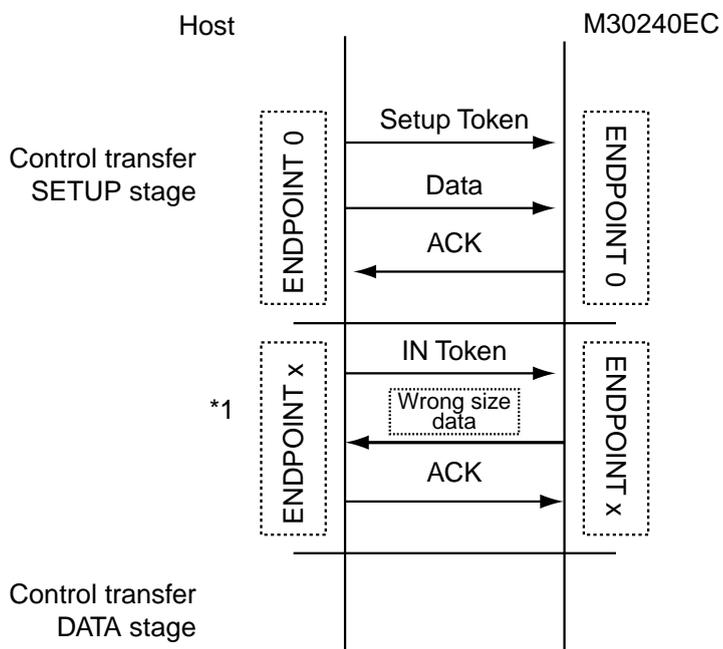
Case 4: During transfer of ENDPOINT x (*1), M30240EC sends wrong size data.
