Microcontroller Technical Information

Document No.	ZBG	-CD-10-0007	1/2	
QB-78K0RIX3 (Old Name: QB-78K0RKX3L)	Date issued	Janu	ary 25, 2010		
In-Circuit Emulator for	Issued by	Development Tool Solution Group			
78K0R/KC3-L, KD3-L, KE3-L, IB3, IC3, ID3, IE3		Multipurpose Microcomputer Systems			
		Microcomputer Operations Unit			
Usage Restrictions		NEC Electronics Corporation			
Related documents	Notification		Usage restriction		
QB-78K0RIX3 User's Manual: U19228EJ1V0UM00	classification		Upgrade		
QB-78K0RIX3 (Old Name: QB-78K0RKX3L)			Document modification		
In-Circuit Emulator for 78K0R/KC3-L, KD3-L, KE3-L, IB3, IC3, ID3, IE3 Upgrade: ZBG-CD-10-0008			Other notification

Operating Precautions for QB-78K0RIX3

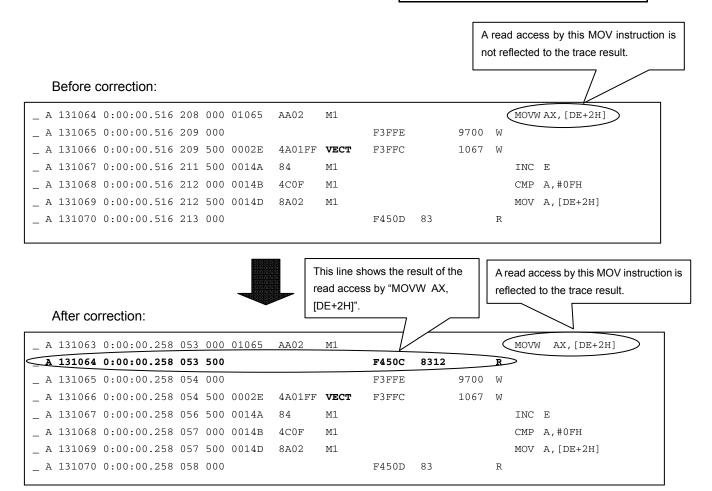
No. 6 Restriction on trace data when an interrupt occurs (1)

If a read access or write access is performed immediately before occurrence of an interrupt, this access might not be reflected to the trace result.

An example of trace data before and after the correction of this restriction is shown below.

This issue has been corrected in QB-78K0RIX3 with control code D.

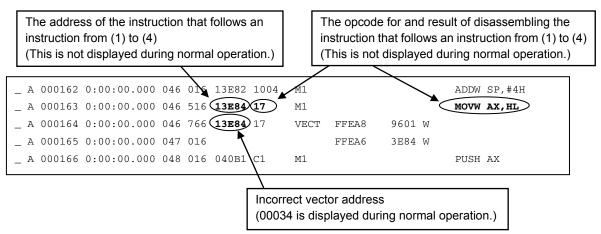
Before correction:

No. 9 Restriction on trace data when an interrupt occurs (2)

If interrupt servicing is executed under a specific condition, the trace result might be incorrect.

If execution jumps to an interrupt vector immediately after executing one of the above instructions, the instruction that follows the above instructions is not supposed to be executed or displayed in the trace result. However, due to this problem, the following items are displayed in the trace result:

- The instruction that follows the above instructions
- The incorrect vector address

An example of trace data before and after correcting this restriction is shown below.

This issue will be corrected in the next revision.
