Microcomputer Technical Information

QB-V850ESFX2 In-Circuit Emulator for V850ES/FE2, V850ES/FF2, V850ES/FG2, V850ES/FJ2, μ PD703229Y, μ PD70F3229Y Usage Restrictions		Document No.	ZBG-CD-05-0093	1/3
		Date issued	October 25, 2005	
		Issued by	Development Tool Group Multipurpose Microcomputer Systems Division 4th Systems Operations Unit NEC Electronics Corporation	
Related documents	QB-V850ESFX2 User's Manual: ZUD-CD-05-0129	Notification classification	<input checked="" type="checkbox"/> Usage restriction <input type="checkbox"/> Upgrade <input type="checkbox"/> Document modification <input type="checkbox"/> Other notification

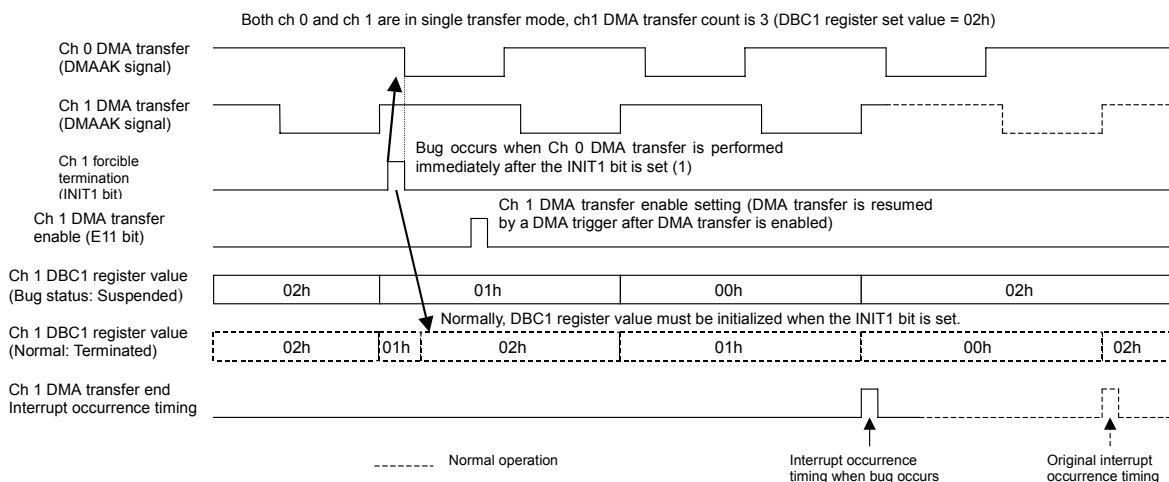
No. 6 Bug related to DMA transfer forcible termination (n = 0 to 3)

When terminating a DMA transfer by setting the INITn bit of the DCHCn register, the transfer may not be terminated, but just suspended, even though the INITn bit is set (1). As a result, when the DMA transfer of a channel that should have been terminated is resumed, the DMA transfer will terminate after an unexpected number of transfers are completed and a DMA transfer completion interrupt may occur. This bug occurs if a DMA transfer is executed immediately after a forcible termination is set (by setting the INITn bit) (see the figure below).

This bug does not depend on the number of transfer channels, transfer type (2-cycle or flyby), transfer target (between memory and memory, memory and I/O; including internal resources), transfer mode (single, single-step, or block), or trigger (external request, interrupt from internal

peripheral I/O, or software), and can occur with any combination of the above elements that can be set under the specifications. In addition, another channel may affect the occurrence of this bug.

The following registers are buffer registers with a 2-stage FIFO configuration of master and slave. If these registers are overwritten during a DMA transfer or in the DMA-suspended status, the value is written to the master register, and reflected in the slave register when the DMA transfer of the overwritten channel is terminated.

The “initialization” in the above figure means that the contents of the master register are reflected in the slave register.

This bug can be avoided by implementing either of the following procedures using the software.

(1) Stop all the transfers from DMA channels temporarily

- <1> Disable interrupts (DI state).
- <2> Read the DMA restart register (DRST) and transfer the ENn bit of each channel to a general-purpose register (value A).
- <3> Write 00H to the DMA restart register (DRST) twice^{Note}.
By executing twice^{Note}, the DMA transfer is definitely stopped before proceeding to <4>.
- <4> Set (1) the INITn bit of the DCHCn register of the channel that should be terminated forcibly.
- <5> Perform the following operations for value A read in <2>. (Value B)
 - (a) Clear (0) the bit of the channel that should be terminated forcibly
 - (b) If the TCn and ENn bits of the channel that is not terminated forcibly are 1 (AND makes 1), clear (0) the bit of the channel.
- <6> Write value B in <5> to the DRST register.
- <7> Enable interrupts (EI state).

- (2) Repeat setting the INITn bit until the forcible DMA transfer termination is correctly performed (n = 0 to 3)

- <1> Copy the initial transfer count of the channel that should be terminated forcibly to a general-purpose register.
- <2> Set (1) the INITn bit of the DCHCn register of the channel that should be terminated forcibly.
- <3> Read the value of the DMA transfer count register (DBCn) of the channel that should be terminated forcibly and compare the value with the one copied in <1>. If the values do not match, repeat <2> and <3>.

This bug has been corrected in control code B or later.

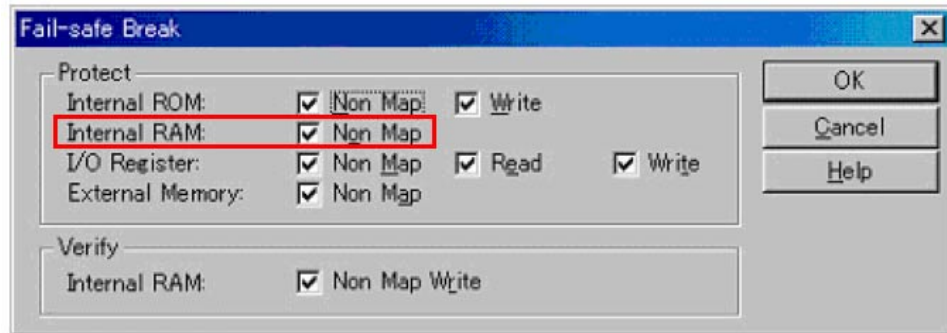
A non-map break occurs if all of the following conditions are satisfied, even if the program itself is correct.

- Cancel the fail-safe break setting for the internal RAM in the debugger.

- When using ID850QB

Click the [Detail] button in the Fail-safe Break field in the Configuration window and clear the check in the check box for "Internal RAM".
