Microcomputer Technical Information

QB-V850ESKX1H In-Circuit Emulator for V850ES/KE1, V850ES/KF1, V850ES/KG1, V850ES/KJ1, V850ES/KE1+, V850ES/KF1+, V850ES/KG1+, V850ES/KJ1+ Usage Restrictions		Document No.	ZBG-CD-05-0080	1/3
		Date issued	September 28, 2005	
		Issued by	Development Tool Group Multipurpose Microcomputer Systems Division 4th Systems Operations Unit NEC Electronics Corporation	
Related documents	QB-V850ESKX1H User's Manual: U17214EJ2V0 QB-V850ESKX1H (Control Code: A, B, C) Operating Precautions: ZUD-CD-05-0063	Notification classification	√	Usage restriction
				Upgrade
				Document modification
				Other notification

QB-V850ESKX1H In-Circuit Emulator for V850ES/KE1, V850ES/KF1, V850ES/KG1, V850ES/KJ1,
V850ES/KE1+, V850ES/KF1+, V850ES/KG1+, V850ES/KJ1+ Usage Restrictions

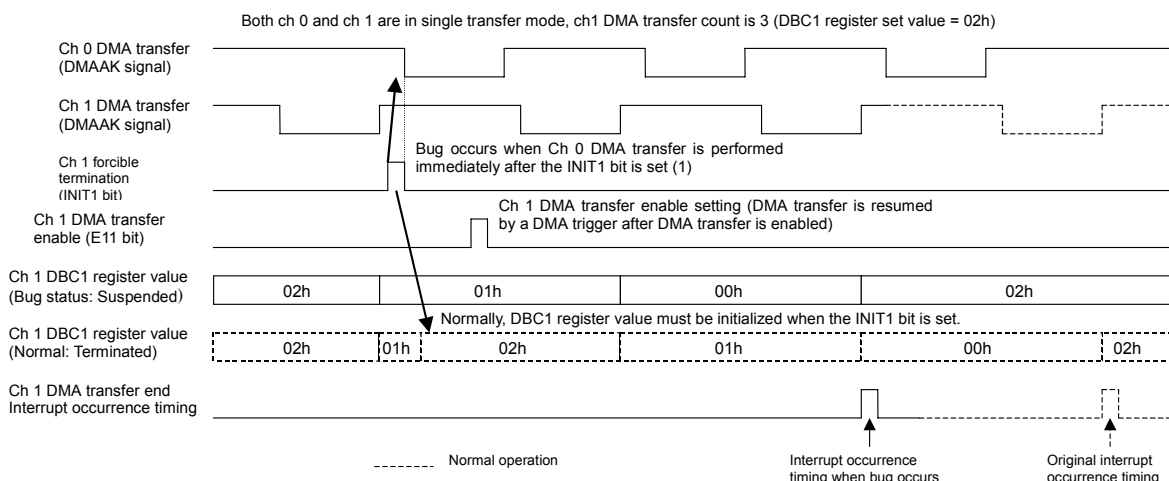
No. 4 Bug related to DMA transfer forcible termination

When terminating a DMA transfer by setting the INITn bit of the DCHCn register, the transfer may not be terminated, but just suspended, even though the INITn bit is set (1). As a result, when the DMA transfer of a channel that should have been terminated is resumed, the DMA transfer will terminate after an unexpected number of transfers are completed and a DMA transfer completion interrupt may occur (n = 0 to 3). This bug occurs if a DMA transfer is executed immediately after a forcible termination is set (by setting the INITn bit) (see the figure below).

This bug does not depend on the number of transfer channels, transfer type (2-cycle or flyby), transfer target (between memory and memory, memory and I/O; including internal resources), transfer mode (single, single-step, or block), or trigger (external request, interrupt from internal peripheral I/O, or software), and can occur with any combination of the above elements that can be set under the specifications. In addition, another channel may affect the occurrence of this bug.

The following registers are buffer registers with a 2-stage FIFO configuration of master and slave. If these registers are overwritten during a DMA transfer or in the DMA-suspended status, the value is written to the master register, and reflected in the slave register when the DMA transfer of the overwritten channel is terminated.

The "initialization" in the above figure means that the contents of the master register are reflected in the slave register.

This bug can be avoided by implementing any of the following procedures using the software.

This bug has been corrected in control code B or later.

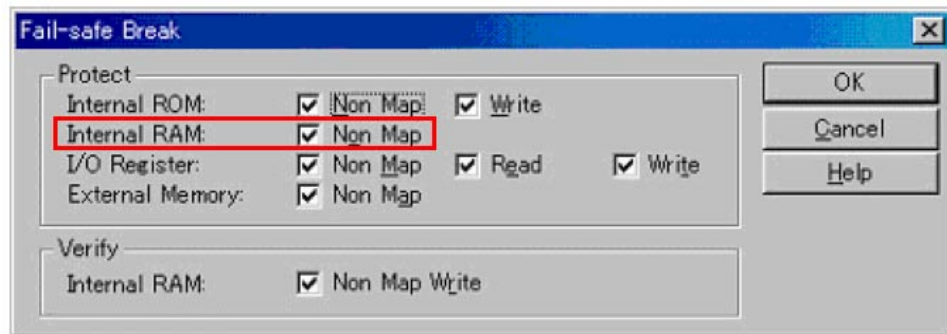
No. 10 Illegal break occurs during program execution in internal RAM

An illegal break may occur when a peripheral I/O register is accessed during program execution in the internal RAM.

Cancel the fail-safe break setting for the internal RAM in the debugger.

Click the [Detail] button in the Fail-safe Break field in the Configuration window and clear the check box for "Internal RAM".

Please regard this item as a permanent restriction.

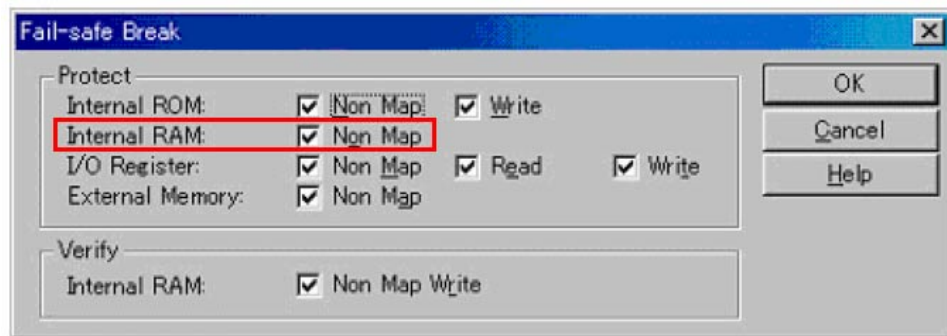
No. 15 Illegal break occurs during program execution in internal RAM (2)

A non-map break occurs if all of the following conditions are satisfied, even if the program itself is correct.

- A program is executed in the internal RAM area.
- Data access for the internal RAM area is performed twice in succession.
- An execution branches to the internal ROM area using a JR or JARL instruction immediately after the above successive data access, or one NOP instruction after the above successive data access.

- Cancel the fail-safe break setting for the internal RAM in the debugger.
 - When using ID850QB

Click the [Detail] button in the Fail-safe Break field in the Configuration window and clear the check in the check box for "Internal RAM".

- Insert two or more NOP instructions between the successive data access for the internal RAM area and an instruction to branch to the internal ROM area.
