RENESAS TECHNICAL UPDATE

Product Category	MPU&MCU	Document No.	TN-MC*-A014A/E	Rev.	1.00
Title	Restrictions on dead time of the motor management timer (MMT) in the SH7065 Series and H8S/2612 Group	Information Category	Technical Notification		
Applicable Product	SH7065 Series and H8S/2612 Group	Lot No.	Reference Document	SH7065 Hardware Manual (ADE-602-166C Rev. 4.0) SH2612 Group Hardware Manual (REJ09B0211-0500 Rev. 5.00)	
		All lots

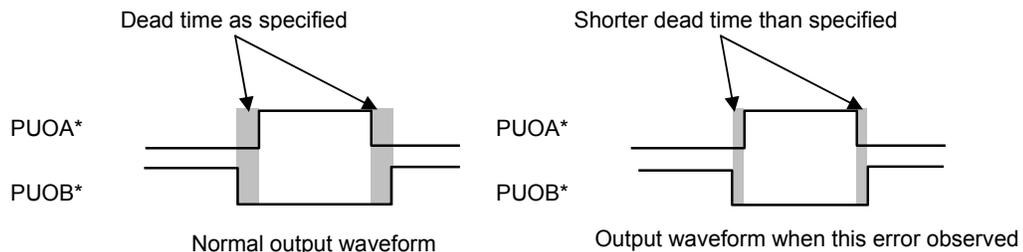
A PWM waveform output may have a shorter dead time (non-overlap time) than the time specified by the timer dead time register (MMT_TDDR) or may have no dead time (a dead time of 0).

Note: * The same error is observed for the PVOA and PVOB pins or the PWOA and PWOB pins.

This error occurs when the counter is restarted (setting the CST bit in TCNR to 1) after the counter is stopped by clearing the CST bit in TCNR to 0 while the MMT repeats count up and count down.

The CST bit should not be cleared to 0 when the counter is restarted by setting the CST bit to 1. If the CST bit needs to be cleared, the CST bit should not be set to 1 after clearing.

1. Specify the PWM output pin as a general input port by the pin function controller (PFC) for the SH7065 Series and the MMT pin control register (MMTPC) for the H8S/2612 Group.
2. Write H'0000 to free-operation addresses of all buffer registers (TBRU, TBRV, and TBRW).
3. After the specified dead time has elapsed, write H'00 to TCNR to clear the CST bit to 0.
4. Set the CST bit to 1 to restart the counter.
