RENESAS TECHNICAL UPDATE

Product Category	MPU/MCU		Document No.	TN-R8C-A042A/E	Rev.	1.00
Title	Serial Interface (UART2) Special Mode1 (I2C Mode) Conditions		Information Category	Technical Notification		
Applicable Product	Described below	Lot No.	Reference Document

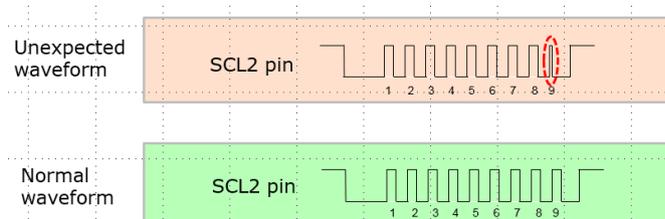
When using serial interface (UART2) Special Mode 1 (I2C mode) as master in the following condition, the 9th clock pulse of SCL2 output possibly be shorter than the normal width.

- Internal/External clock select bit (CKDIR) of UART2 Transmit /Receive mode Register (U2MR) as "0" (Internal clock).
- Clock synchronization bit (CSC) of UART2 Special Mode Register 2 (U2SMR2) as "1" (Approved).
- U2BRG count source select bit (CLK1/0) of UART2 Transmit /Receive Control Register 0 (U2C0) as 00:f1/01:f8 select

In order to prevent such phenomenon, if that clock synchronization is not needed, Clock synchronization bit (CSC) shall be set to "0".

Also, there is a case that selecting 10:f32 at CLK 1/0 bit able to prevent, please contact Renesas sales.
