# RENESAS TECHNICAL UPDATE

Product Category	MPU&MCU		Document No.	TN-SH7-A676A/E	Rev.	1.00
Title	SH7764 on-chip SSI (DMAC portion) trouble and additional notes of hardware manual (Rev1.0)		Information Category	Technical Notification		
Applicable Product	R5S77640P300BG R5S77640D300BG R5S77640N300BG R5S77641P300BG R5S77641D300BG R5S77641N300BG	Lot No.	Reference Document	SH7764 Group Hardware Manual (REJ09B0360-0100)		
		All lots

Please be informed of SH7764 on-chip SSI (DMAC portion) trouble and additional notes of hardware manual (Rev1.0).

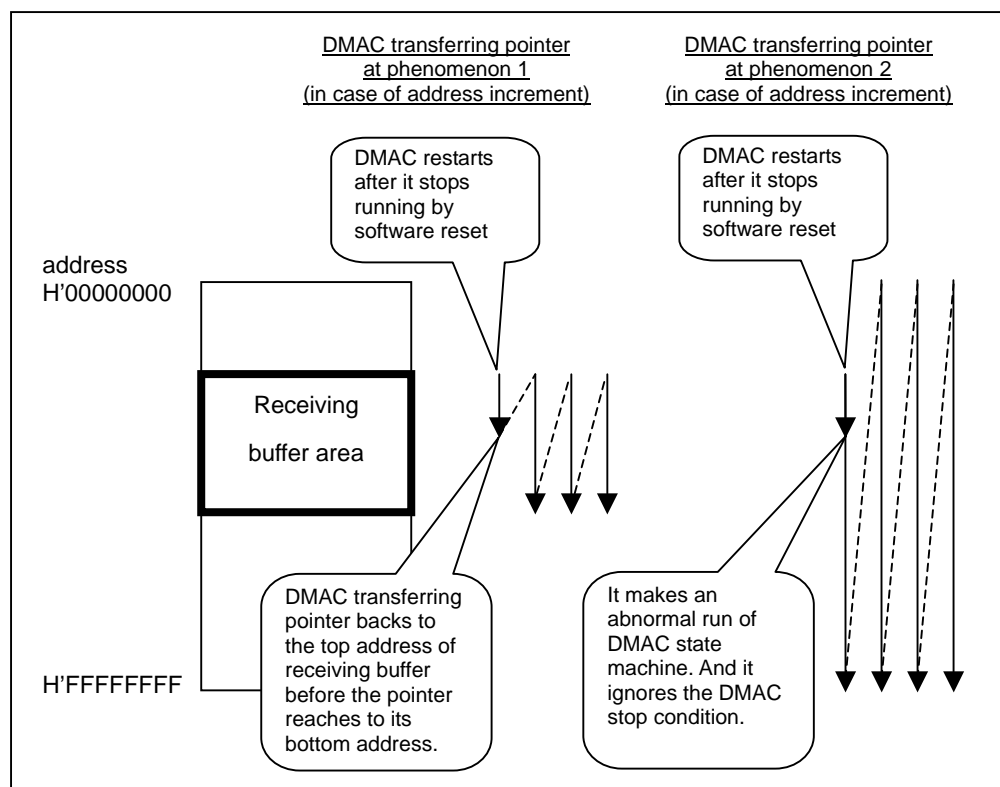
Figure.1 DMAC trouble phenomenon

DMAC transferring pointer backs to the top address of receiving buffer (which is allocated on RAM) before the pointer reaches its bottom address. Please refer figure.1. As the result, the read address of the received data which software calculates by SSIBLCNT and SSIBLNCNT counters will be different from the transferring address of the received data by DMAC.

DMAC transferring pointer is incremented/decremented to outside of receiving buffer range. As the result, DMAC transfers data to outside of receiving buffer. Please refer figure.1. If you copy the program to RAM, DMAC transfer reaches to the area and it might make a system hung-up.

It is possible to make the countermeasure as followings operation, if you select 1-burst (8-byte) or 2-burst (16-byte) at WDMBSZ bit in SSIDMMR. Selecting 4-burst (32-byte) at this bit is prohibited.

- Clear RPTMD bit in SSIDMCOR
- Clear DMEN bit in SSIDMCOR
- Wait DMEND interruption or polling DMEND flag in SSIDMINTSR
- Clear DMEN bit in SSICR
- Clear EN bit in SSICR
- Set DMRST bit in SSIDMCOR
- Set RXRST bit in SSIDMCOR
- Clear RXRST bit in SSIDMCOR
- Restart SSI and SSIDMAC
