RENESAS TECHNICAL NEWS

No.ASSP-08-0309

M66291 Dreq Signal Assertion Limitation

USB ASSP M66291GP/M66291HP

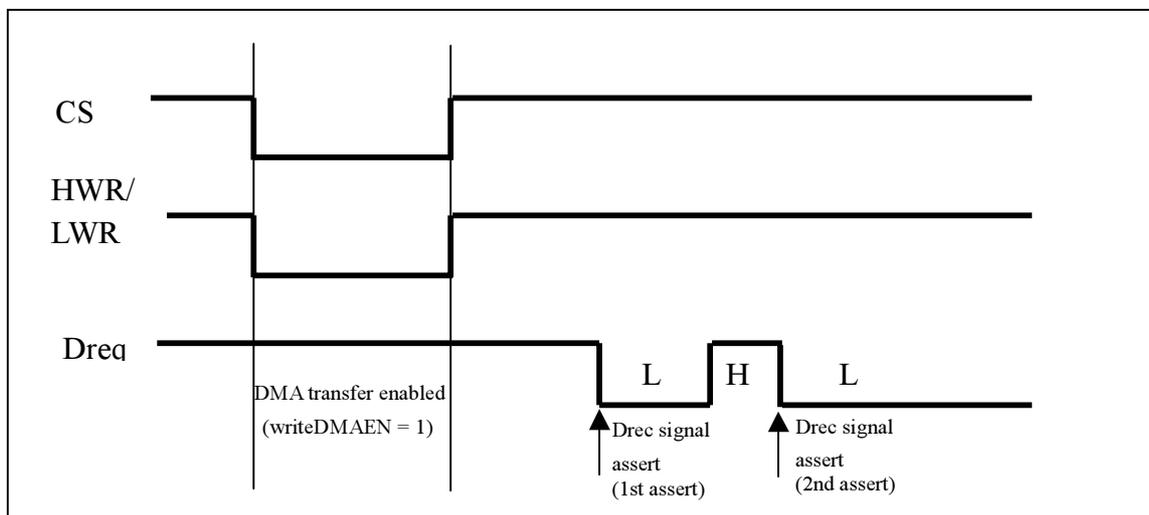
Figure 1. Incorrect Signal at Dreq Signal Assert

In systems that send DMA transfers to the IN-direction endpoint using D0_FIFO or D1_FIFO (Dn_FIFO hereon) by the DMA controller, when DMA transfer is enabled (write DMAEN = "1"), the Dreq signal may be asserted twice consecutively (see Diagram 1).

[Supplement] If the system is set so that the DMA transfer is triggered by the M66291 Dreq signal, this phenomenon may cause the DMA controller to malfunction, and data will not be written successfully to the Dn_FIFO.

This phenomenon (Dreq signal assertion occurring twice consecutively) occurs if all of the following conditions are present when the DMA transfer enable process is written to the Dn_FIFO (write DMAEN = "1").

- (1) The CPU writes to Dn_FIFO in word units (16-bit data bus).
- (2) When the designated endpoint (DMA_EP) before the write is set to the IN direction and the FIFO buffer status is Ready (Dreq = "0").
- (3) When the designated endpoint (DMA_EP) during the write is either IN-direction or OUT-direction.

- (1) Simultaneous Setup Method for DMA transfer enable and endpoint designation
To enable DMA transfer (write DMAEN = "1"), perform the following processes in the order indicated.
 - a. The CPU writes to the Dn_FIFO Select Register in word units when DMA transfer is disabled (write DMAEN = "0") and the endpoint is cleared (DMA_EP = "0000")
 - b. The CPU writes to the Dn_FIFO Select Register in word units when DMA transfer is enabled (write DMAEN = "1") and the endpoint is set (DMA_EP = corresponding EP)

- (2) CPU Byte-Unit Write Method

When enabling DMA transfer (write DMAEN = "1"), perform a write in byte-units to the upper 8 bits of the Dn_FIFO Select Register.

- * Do not write to the lower 8 bits of the Dn_FIFO.
- * The designated endpoint (DMA_EP = corresponding EP) must be set before writing to the upper 8 bits.
