# PowerSpan II™ Device Errata and Design Notes

80A1010\_ER001\_13

November 4, 2009

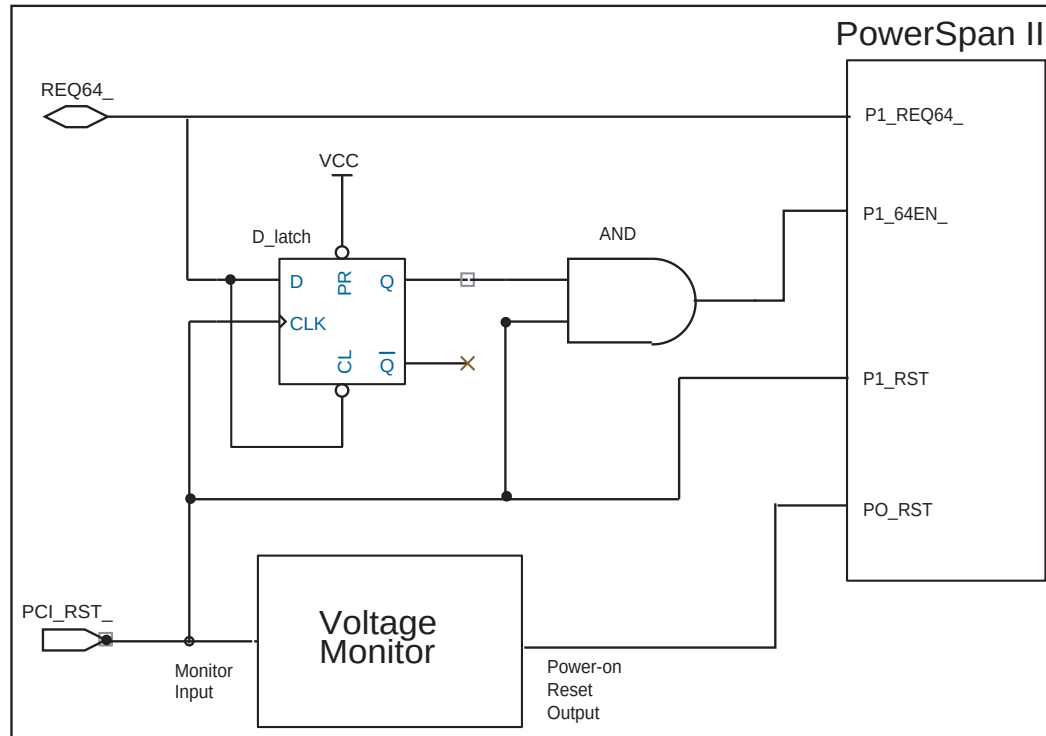
**Figure 1: Logic Required to Delay Deasserting PO\_RST\_ to PowerSpan II**

A customer used PowerSpan II in a PCI adapter card application. In this particular application, PO\_RST\_ was generated by a local voltage monitor device, while P1\_CLK was provided by the system controller board through the backplane. Under certain power-up events, P1\_CLK only became stable after the local PO\_RST\_ was deasserted because of different power ramping between the adapter card (containing PowerSpan II) and the system controller card. As a result of the application violating the clock and reset timing restrictions, the PowerSpan II PCI interface does not claim any transactions after reset.

By generating PO\_RST\_ off of PCI\_RST\_, there is a chance that the PowerSpan II will be unable to latch the state of the REQ64\_ signal on deassertion of PCI\_RST\_. Therefore, an external D-Latch is used to capture the state of REQ64\_ to determine the width of the bus (see [Figure 1](#)). The purpose of the asynchronous clear on D-latch is to prevent potential bus contention on the REQ64\_ signal which is driven by PowerSpan II on the deassertion of P1\_RST\_ in a 32-bit system. The P1\_64EN\_ signal, which is originally used for CompactPCI Hot Swap applications, is used here to tell the PowerSpan II if this is a 32 or 64-bit application. The AND gate is AND-ing the output of D-latch with PCI\_RST\_ to ensure the P1\_64EN\_ is low when the D-latch power-up with uncertain output.

The proposed work-around to this situation is to delay deasserting PO\_RST\_ to PowerSpan II until the host deasserts the PCI\_RST\_ signal. Since the PCI\_CLK is an output from the system controller along with PCI\_RST\_, the negation of PCI\_RST\_ implies the PCI\_CLK is stable. The local voltage monitor uses PCI\_RST\_ to make sure that the PCI\_CLK is stable before the deassertion of PO\_RST\_. A possible implementation of this circuit is shown in [Figure 1](#).

Figure 1 shows the logic required to delay deasserting PO\_RST\_ to PowerSpan II until the host deasserts the PCI\_RST\_ signal.

If the external glue logic shown in Figure 1 is implemented by a CPLD, make sure the CPLD output and Flip-flop state are not affected by any reset.

This work-around only applies to designs where PowerSpan II is in a PCI adapter card and is configured for a non-Hot Swap environment. Normally in this scenario, the PCI bus width is indicated by P1\_REQ64\_ signal (P1\_64EN\_ is pulled high). For designs where PowerSpan II is in a PCI host card or it is configured for a Hot Swap environment, the circuit shown in Figure 1 must not be used.
