Errata

SLG46127

CE-GP-024

This document contains the known errata for SLG46127 and the recommended workarounds.

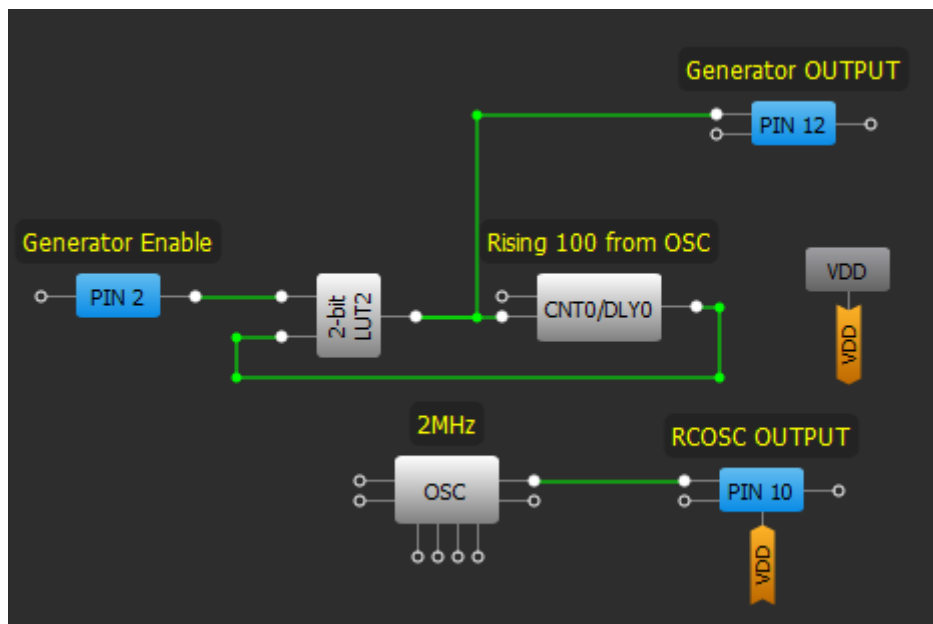
An example of such issue is in the following configuration:

The RC OSC has a longer settling time when configured as 2 MHz with Auto Power On in the designs that have very short RC OSC disable time.

The configuration shown above generates a periodical signal with a frequency defined by the Delay cell and started by a HIGH signal on PIN2. The issue becomes apparent in a longer settling time when the scheme generates short pulses (Delay is configured as a rising edge delay only). See waveform below.

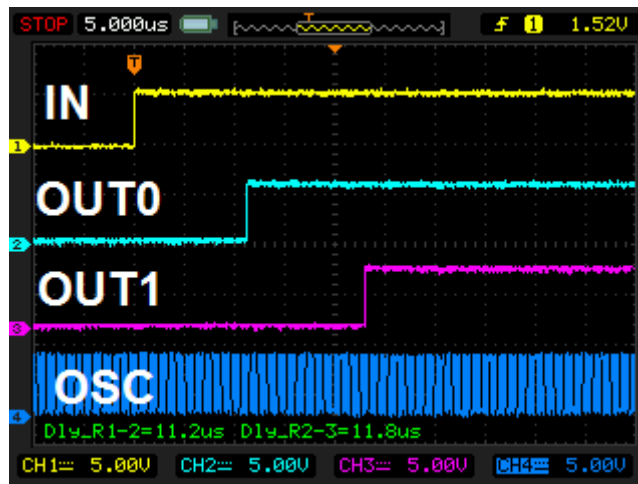
If there are some inner blocks which use RC OSC at the moment or RC OSC is forced power on when such error appears, RC OSC will be operational and delay value will be proper.

- use the “Force power on” RC OSC power control option to make the RC OSC operate at all times.

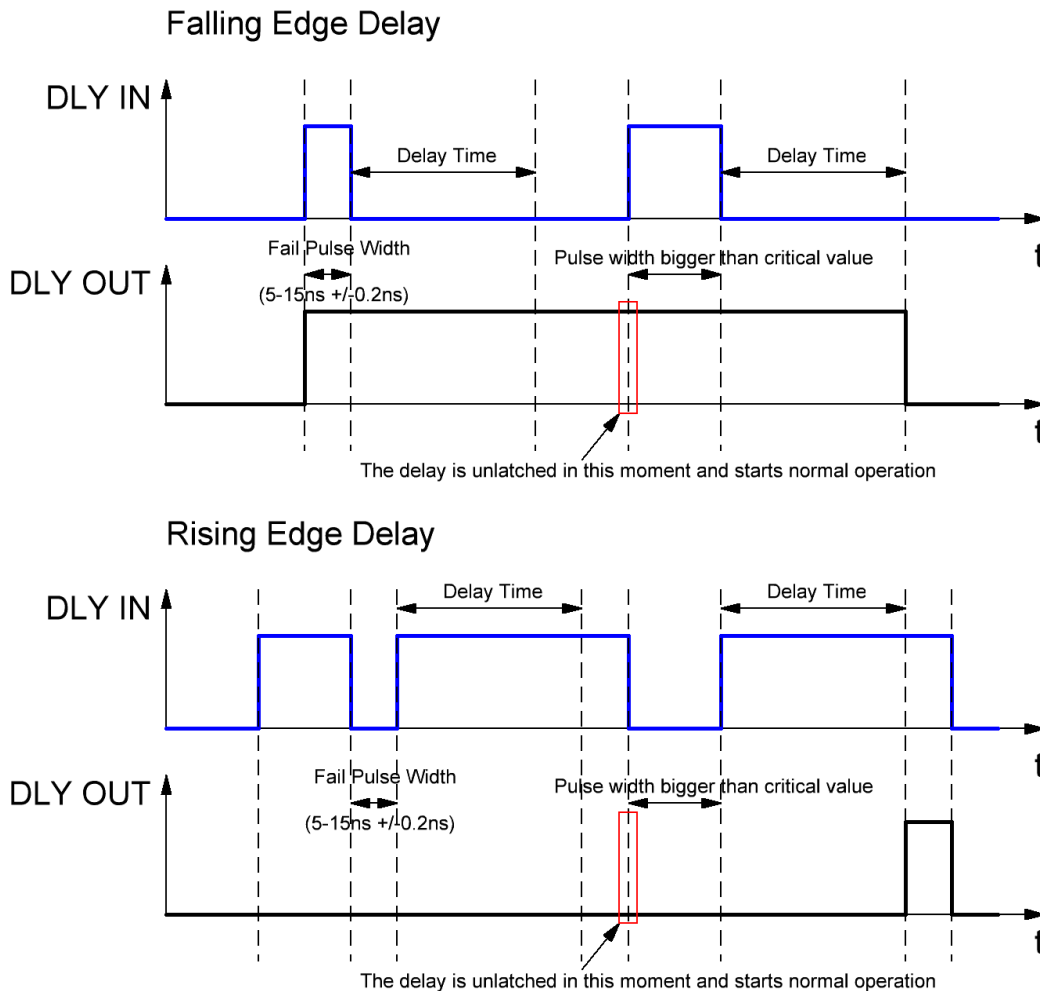
The delay output could be latched despite the input change when a short pulse is input. For example, if the delay cell is configured as a falling edge delay, the short pulse (see NOTE) appears on its input the delay cell output will switch from LOW to HIGH but may not switch from HIGH to LOW even after the delay time has passed.

NOTE: The pulse width varies from chip to chip and with different V_{DD} voltage. It is in range of 5-15ns and in the window $\pm 0.2ns$, so it should be very precise for issue happen.

Use P DLY/FILTER block configured as a both edge delay or FILTER.

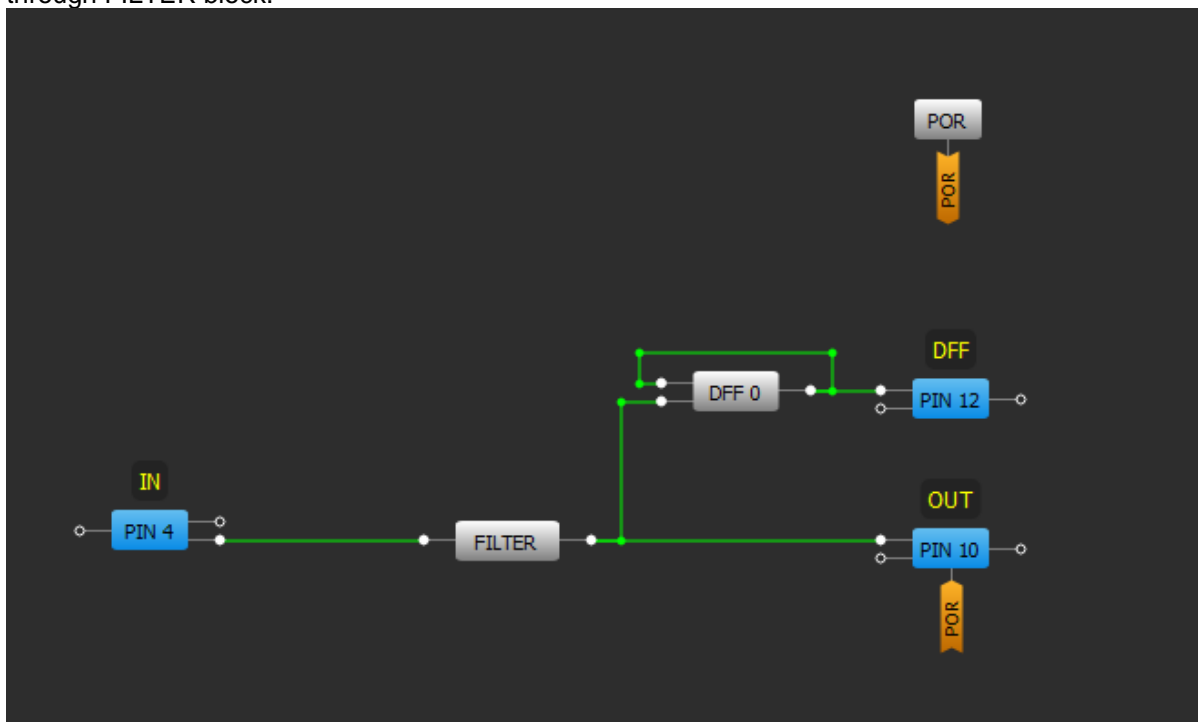
If clock type high frequency input comes in, the FILTER cell may not filter out it. There are several factors like input frequency, duty cycle and LOW duration in such signal that may lead to its passing through FILTER block.

Channel 1 (yellow/top line) – PIN#4 (IN)
 Channel 2 (light blue/2nd line) – PIN#10 (OUT)
 Channel 3 (magenta /3rd line) – PIN#12 (DFF)

Currently there is no workaround for this issue. Filter block is good at filtering short spontaneous glitches. It is intended to be used in series connection before the delay cell to avoid its latching (see issue #5).

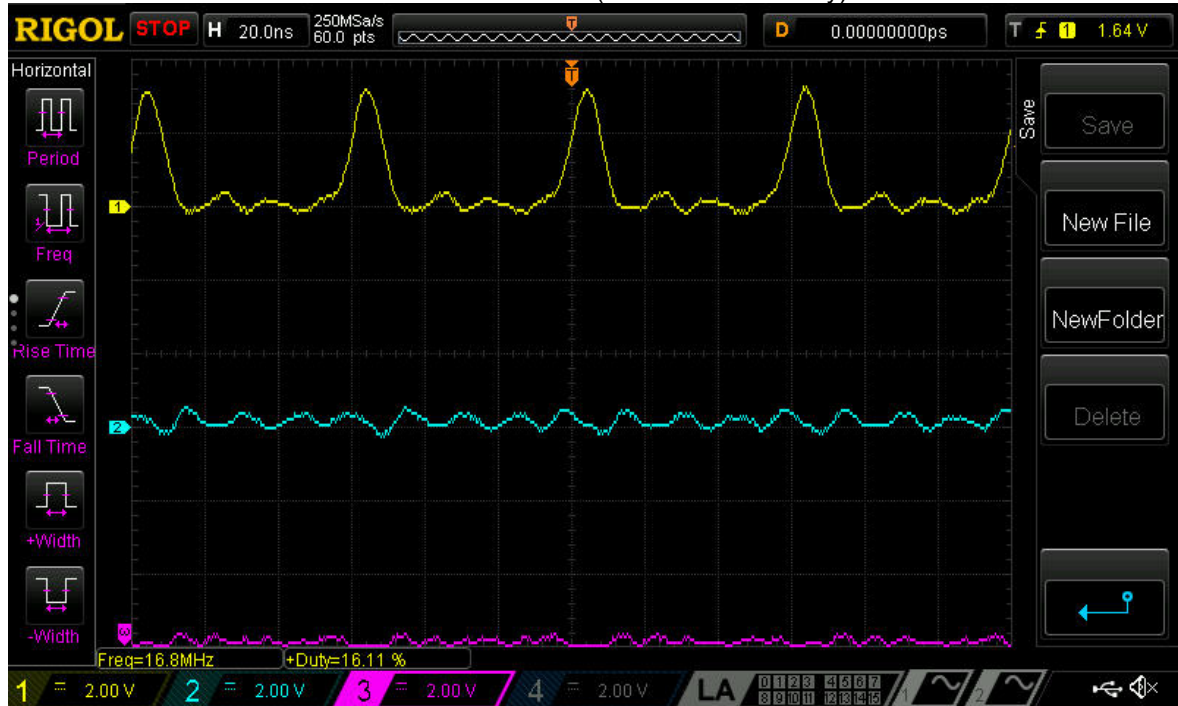
1. Period is 60ns. Pulse width is 10ns DC=16.7% (Correct functionality)

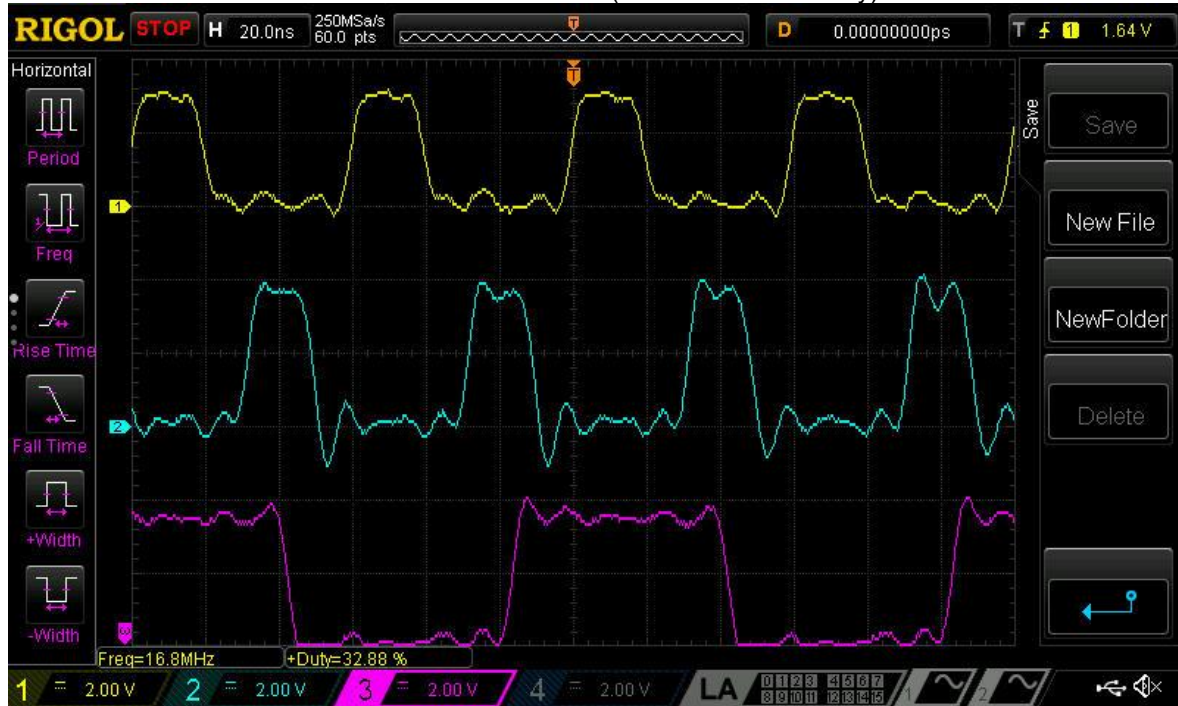
2. Period is 60ns. Pulse width is 20ns DC = 33.3% (Incorrect functionality)

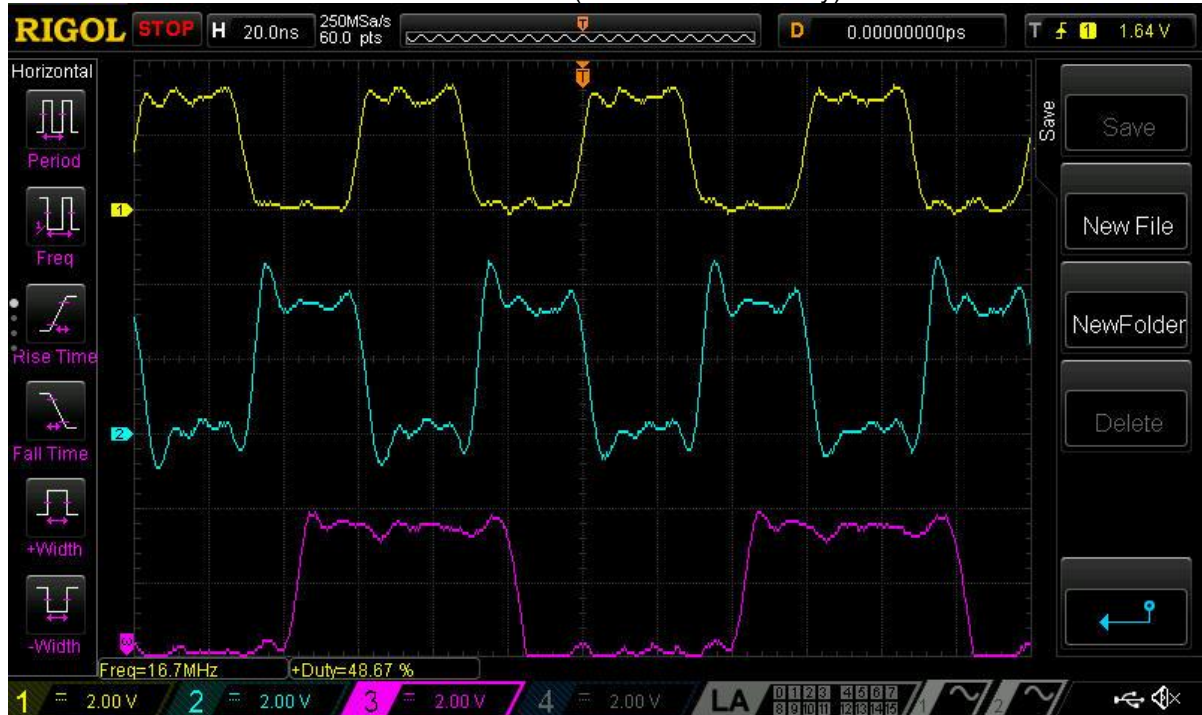
3. Period is 60ns. Pulse width is 30ns DC=50% (Incorrect functionality)

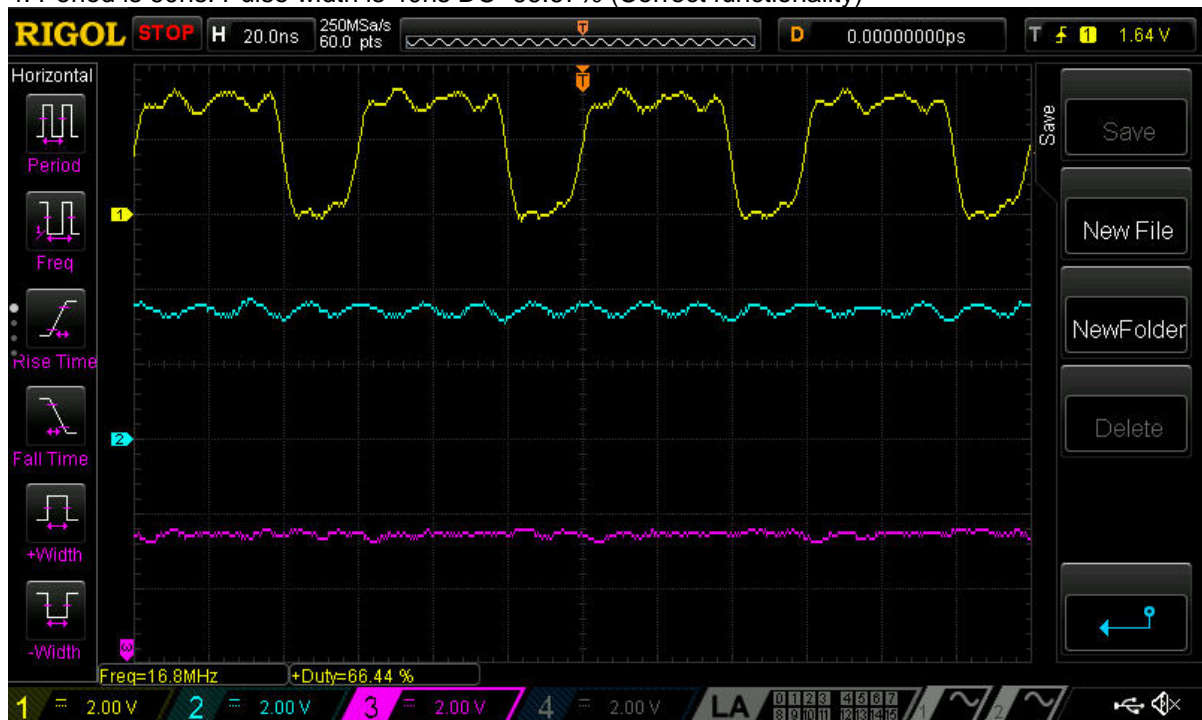
4. Period is 60ns. Pulse width is 40ns DC=66.67% (Correct functionality)

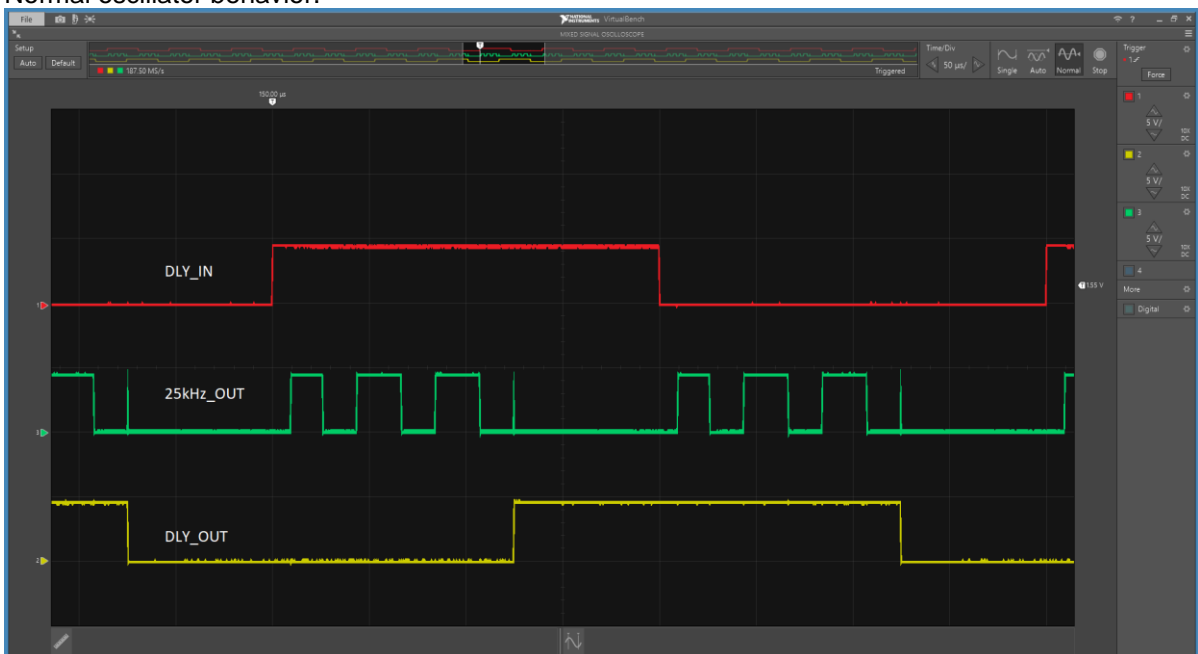
Normal oscillator behavior.

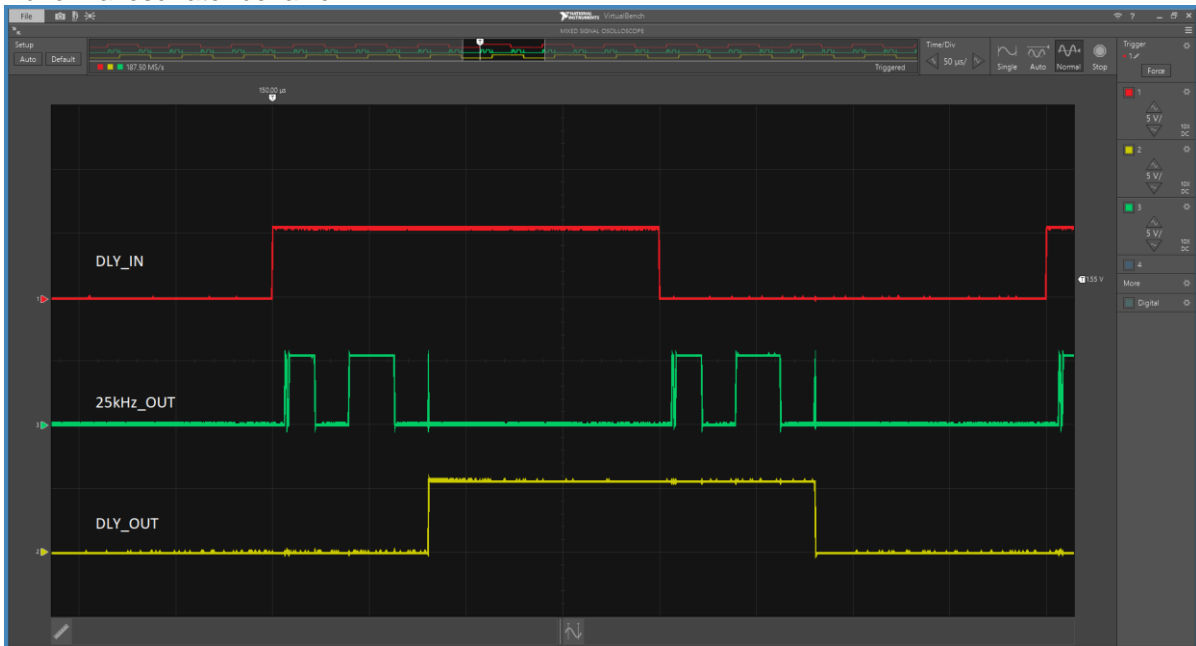
The first period of the RC OSC can be very short when OSC configured as 25 kHz with Auto Power On in the designs. This can be occurred when V_{DD} is above 4.0 V. Critical for CNT/DLY with a low counter data (less than 10) or if it is necessary to use the frequency of the OSC to clock external elements.

Abnormal oscillator behavior.

- Avoid V_{DD} higher than 4 V
- Force ON OSC
