## Errata Sheet

### SLG46140

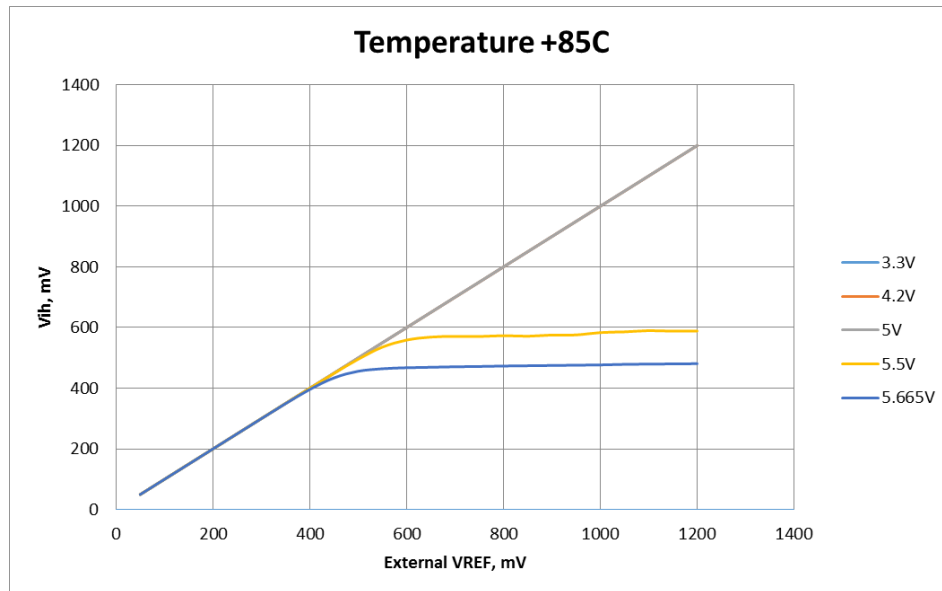
#### ISSUE 1: ACMP Output is Inaccurate when using External Vref at High VDD and Temperature Functional Block Affected: ACMP

When using external Vref source, the ACMP comparison may happen at wrong threshold if the external Vref voltage is higher than a particular value (please see figure below) at high VDD values ( $> 5V$ ) and high temperature.

Avoid using ACMPs in such conditions.

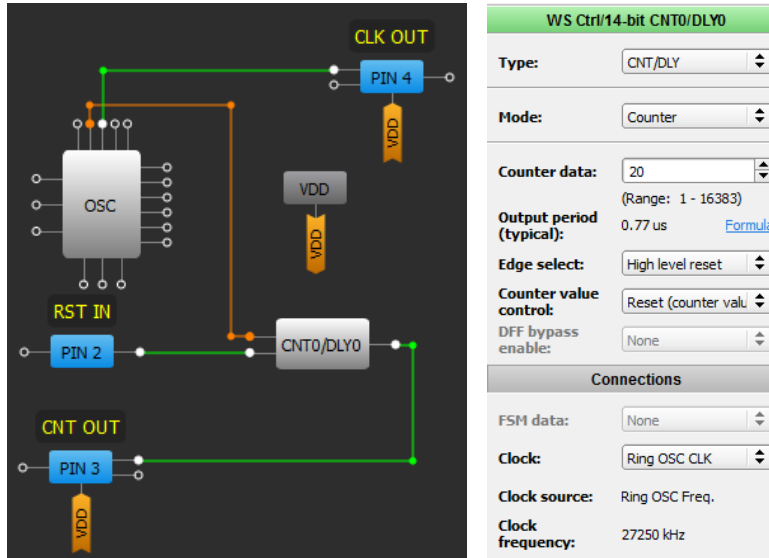
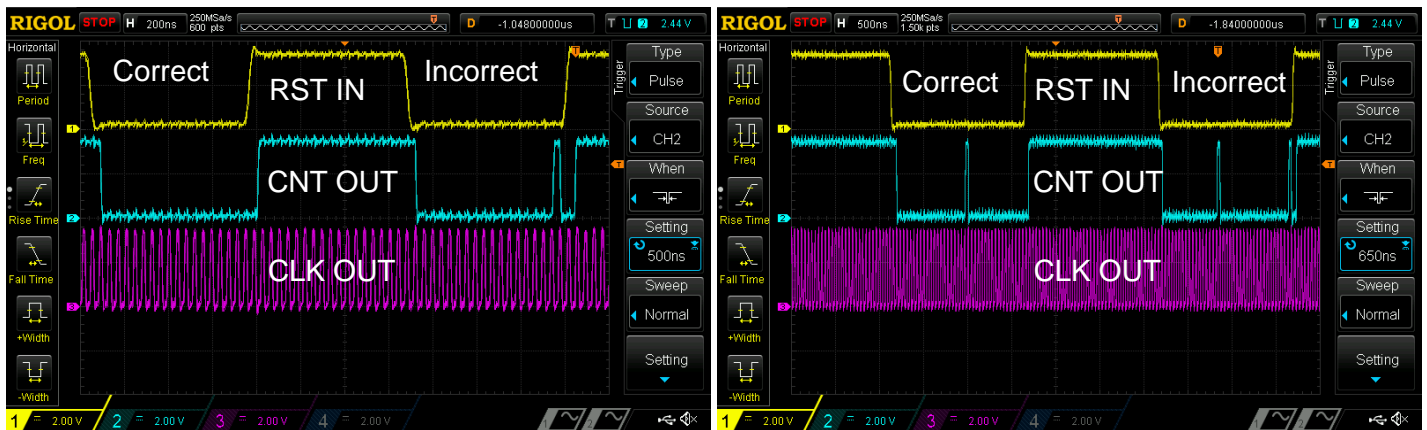
#### ISSUE 2: Incorrect Counter Operation after the Reset Functional Block Affected: Counter

If the Counter Reset occurs at a time very close to a rising edge of the clock signal during clock signal generation (for example OSC operation), there is a possibility that the Counter Data of the Counter is reset incorrectly and the counter end signal (HIGH pulse) may appear faster than expected. This phenomena appears more frequently the higher the clock frequency is.

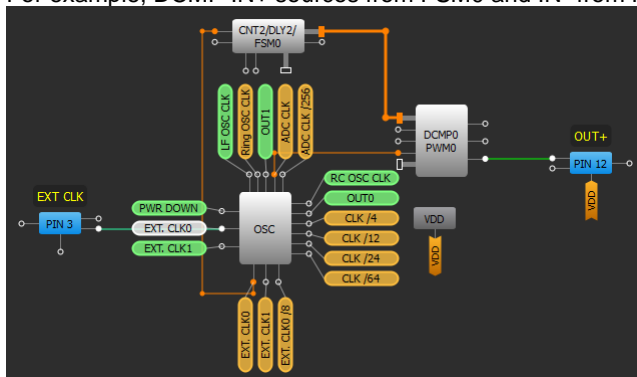
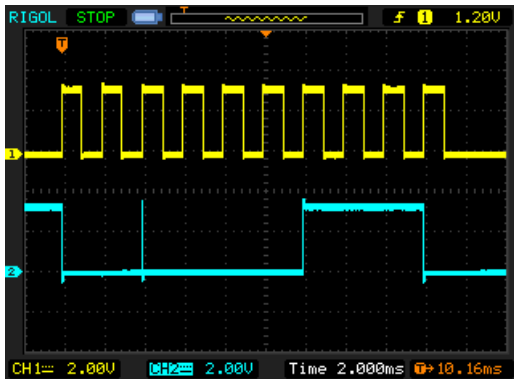
### ISSUE 3: DCMP OUT+ Output Glitch

DCMP's OUT+ output may have a glitch when the input data is changed. This issue appears more frequently the higher the DCMP clock is.

For example, DCMP IN+ sources from FSM0 and IN- from Register0. DCMP is clocked from the Ring OSC.

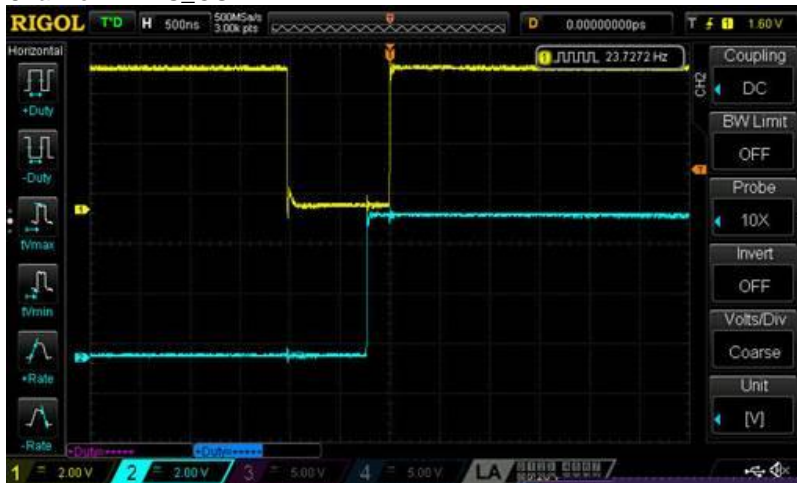
Channel 1 – ACMP out  
Channel 2 – WS\_OUT

### ISSUE 6: ACMP Output Glitch due to Ring OSC Operation Functional Blocks Affected: W/S Control, ACMP

The output of the ACMP incorrectly goes low even when IN+ is greater than IN- if the RING OSC is active when the WS signal rises

- Avoid using the RING OSC with the WS Controller, or add a filtering block on the ACMP output to filter out the glitch.

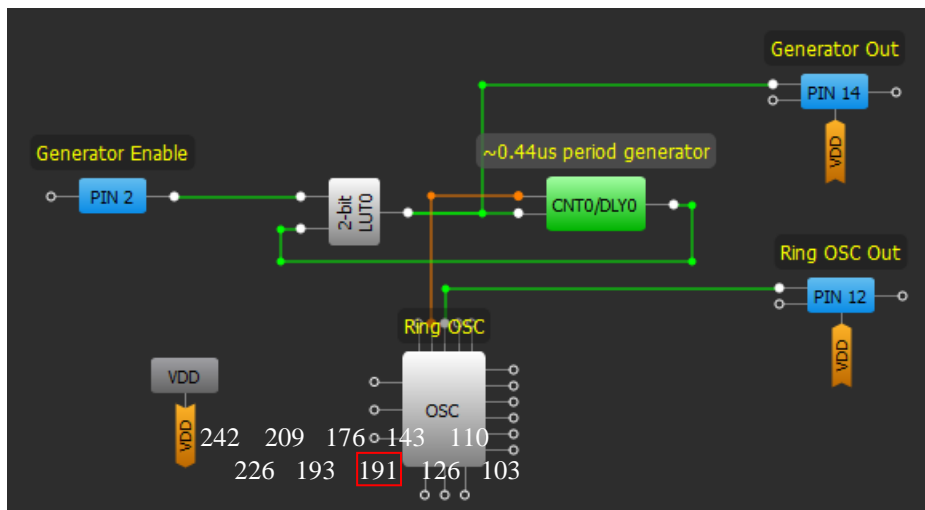
### ISSUE 7: Long Ring OSC Settling Time Functional Block Affected: Ring OSC, Delay, Counter

The Ring OSC has a longer settling time when configured as Auto Power On in the designs that have very short Ring OSC disable time. An example of such issue is in the following configuration:

- Set Ring OSC power mode to “Force Power On”
- or, Set Turn on by register option in BG (Band Gap) block as “Enable”

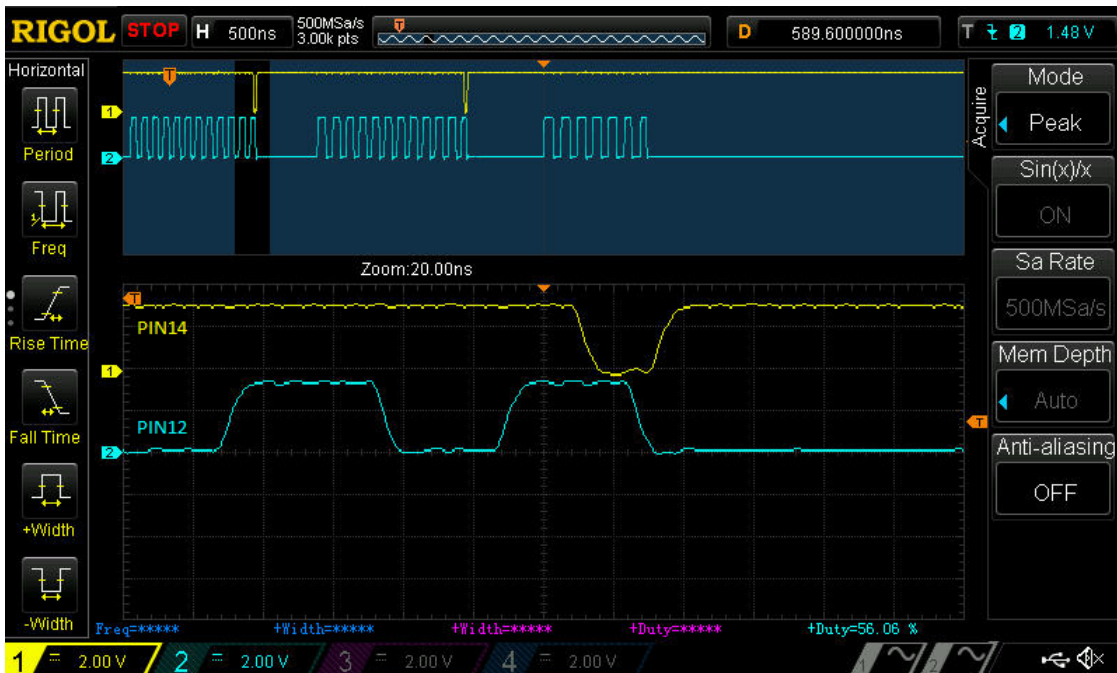
Channel 1 – 2-bit LUT0 output; Channel 2 – Ring OSC output

The configuration shown above generates a periodical signal with a frequency defined by the Delay cell and started by a high signal on PIN2. The issue becomes apparent in a longer settling time when the scheme generates short pulses (Delay is configured as a rising edge delay only). See waveform below.

Such behavior will lead to substantial error in period calculations if the delay time is relatively small.

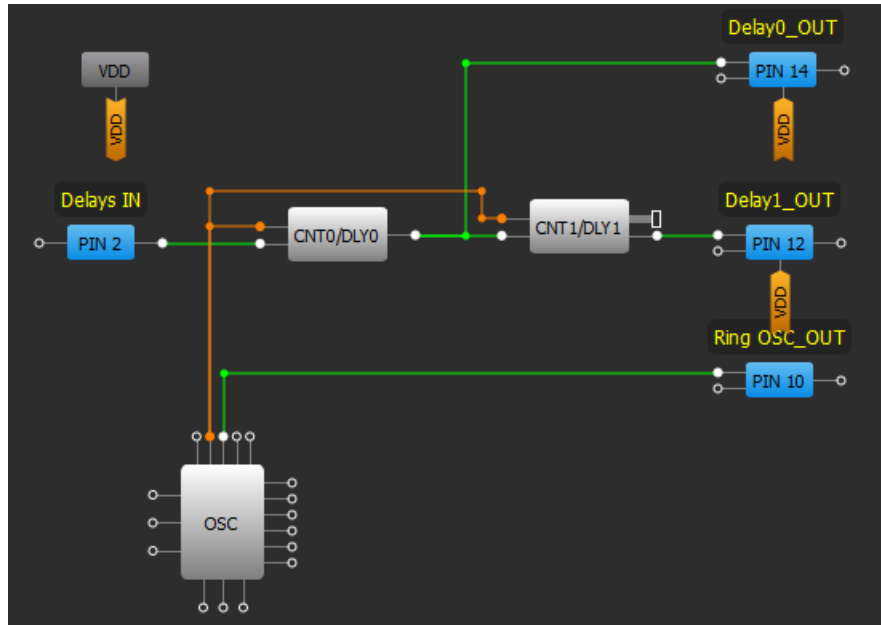
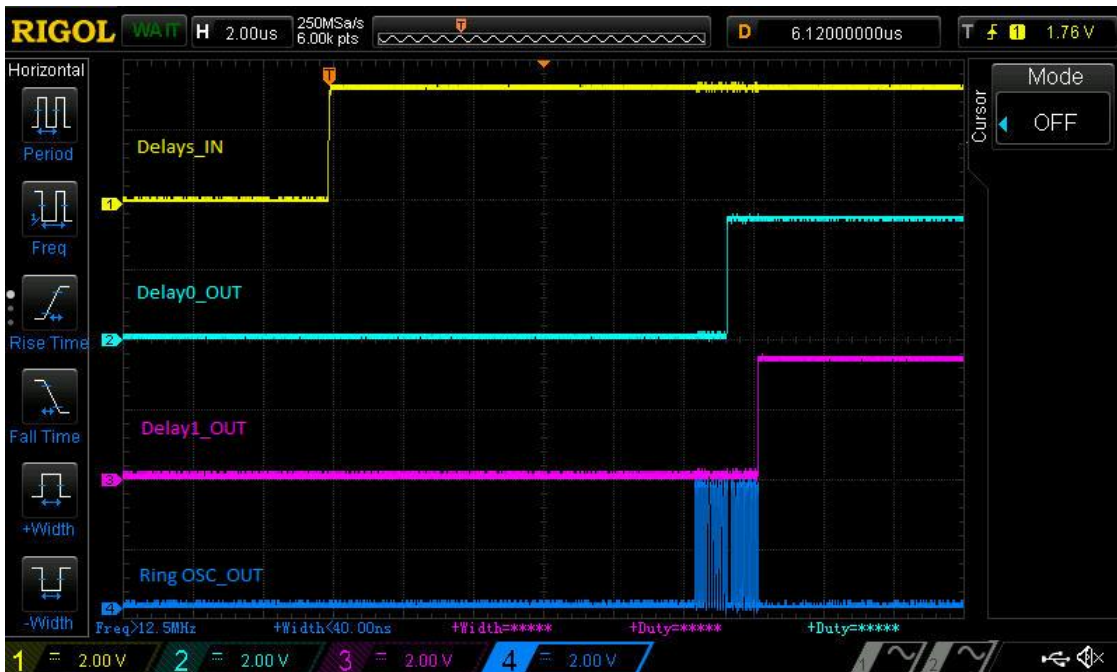
A similar situation occur while using two connected delays (all edge detect types except for a pair “Rising edge DLY – Falling edge DLY”).

In the following example, Delay0 and Delay1 are configured in the same way. However, Delay0 time is 11.4us instead of expected 0.4us (Delay0 time).

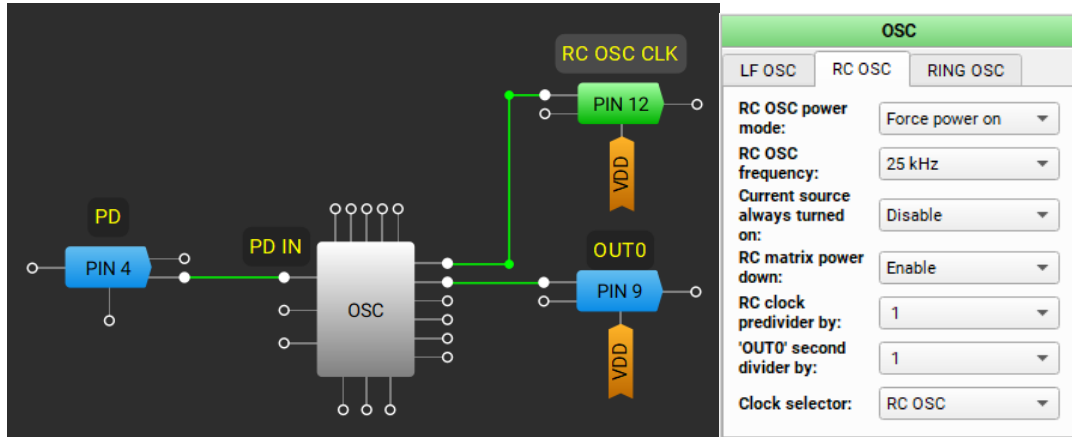
#### **ISSUE 10: OSC Long Start-Up Time** **Functional Block Affected: OSCs**

If a pulse with a duration of less than ~40 ns is applied to the PWR DOWN input of an oscillator, the oscillator outputs remain stuck for milliseconds.

The issue is observed for all available oscillators.

Avoid applying glitches to the PWR DOWN input of an OSC.
