# Errata

## SLG46517

### CE-GP-001

*This document contains the known errata for SLG46517 and the recommended workarounds.*

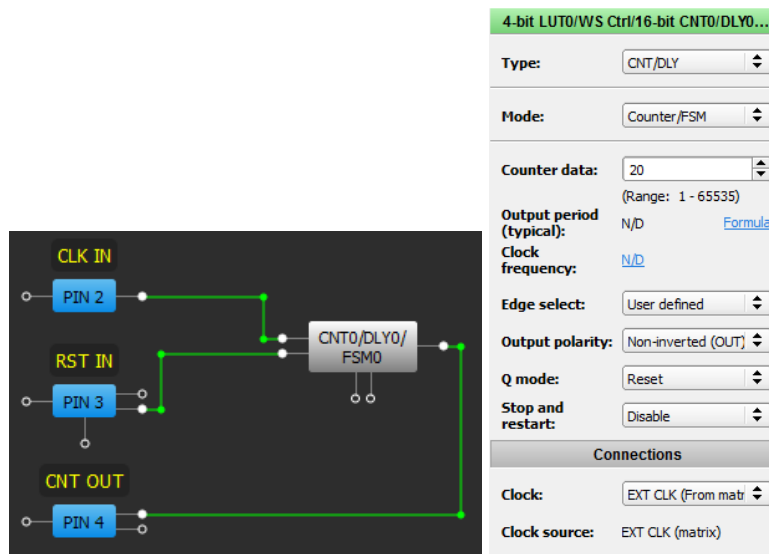
Figure 1

If the Counter Reset is asserted at the same time as a rising clock edge, it is possible that the Counter Data will be reset incorrectly and the counter output may appear faster than expected. This phenomenon appears more often as the clock frequency increases.

Synchronize RESET input of the Counter with its CLK using 2 DFF cells as shown on Figure 3.

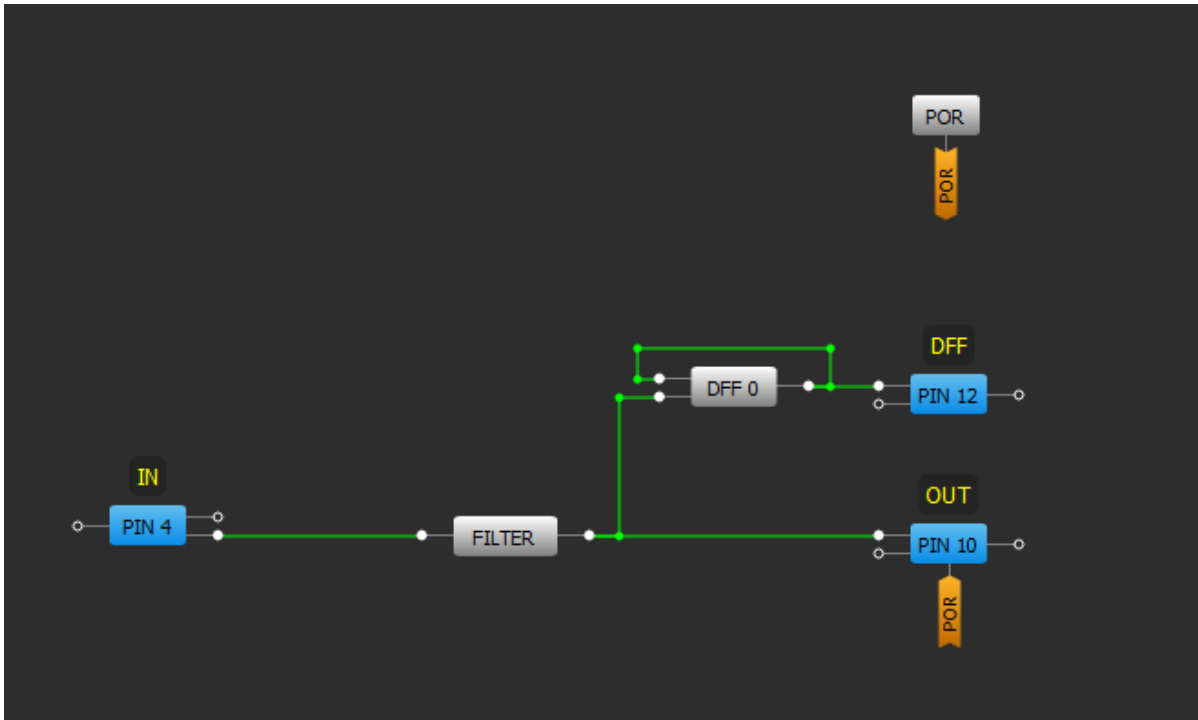
**Figure 4**

If clock type high frequency input comes in, the FILTER cell may not filter out it. There are several factors like input frequency, duty cycle and LOW duration in such signal that may lead to its passing through FILTER block.

1. Period is 60ns. Pulse width is 10ns DC=16.7% (Correct functionality)

Currently there is no workaround for this issue. Filter block is good at filtering short spontaneous glitches. It is intended to be used in series connection before the delay cell to avoid its latching.

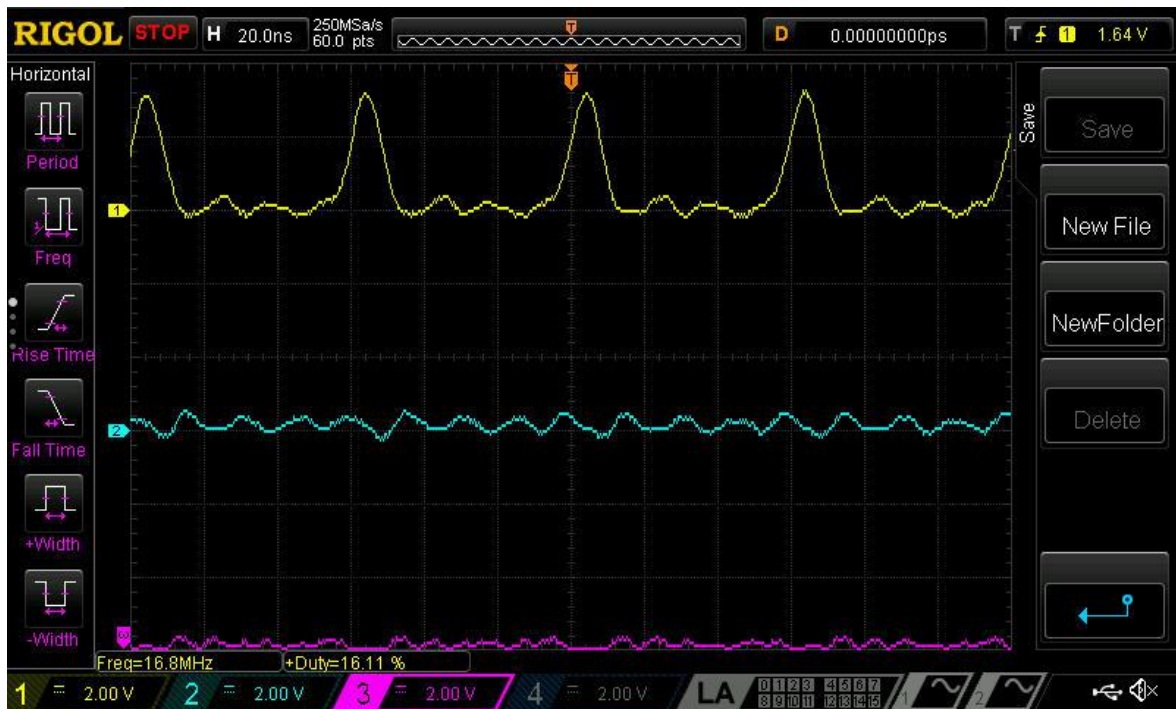
Figure 5

2. Period is 60ns. Pulse width is 20ns DC = 33.3% (Incorrect functionality)

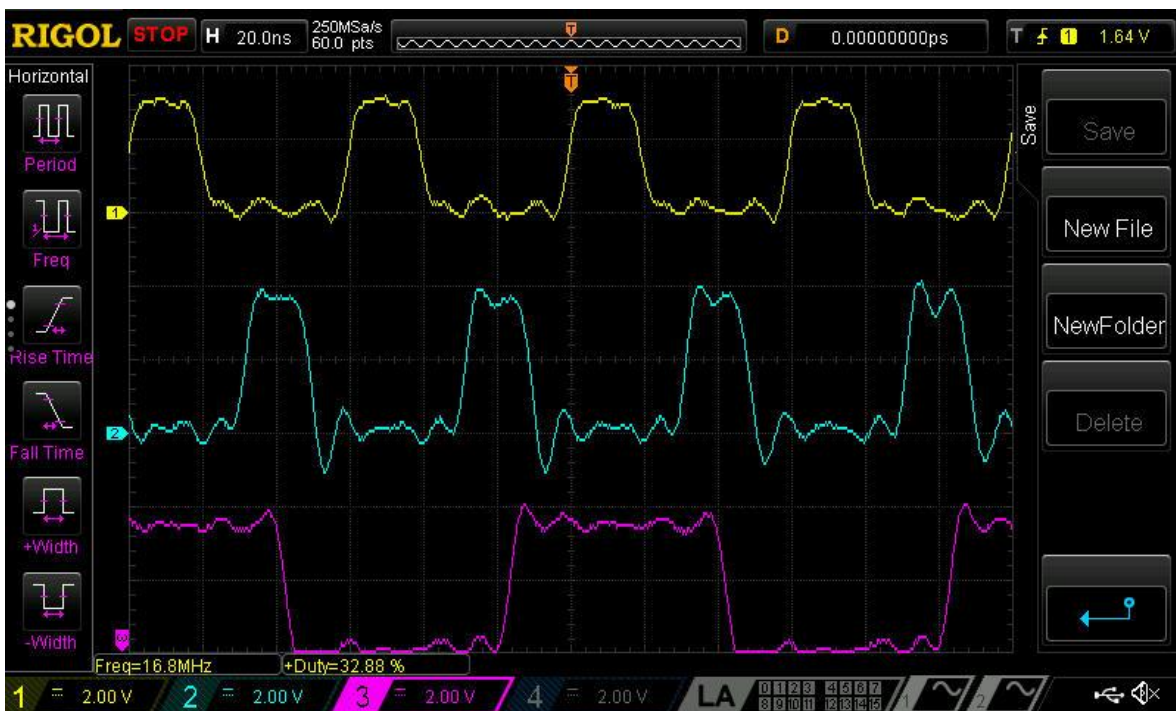
Figure 6

3. Period is 60ns. Pulse width is 30ns DC=50% (Incorrect functionality)

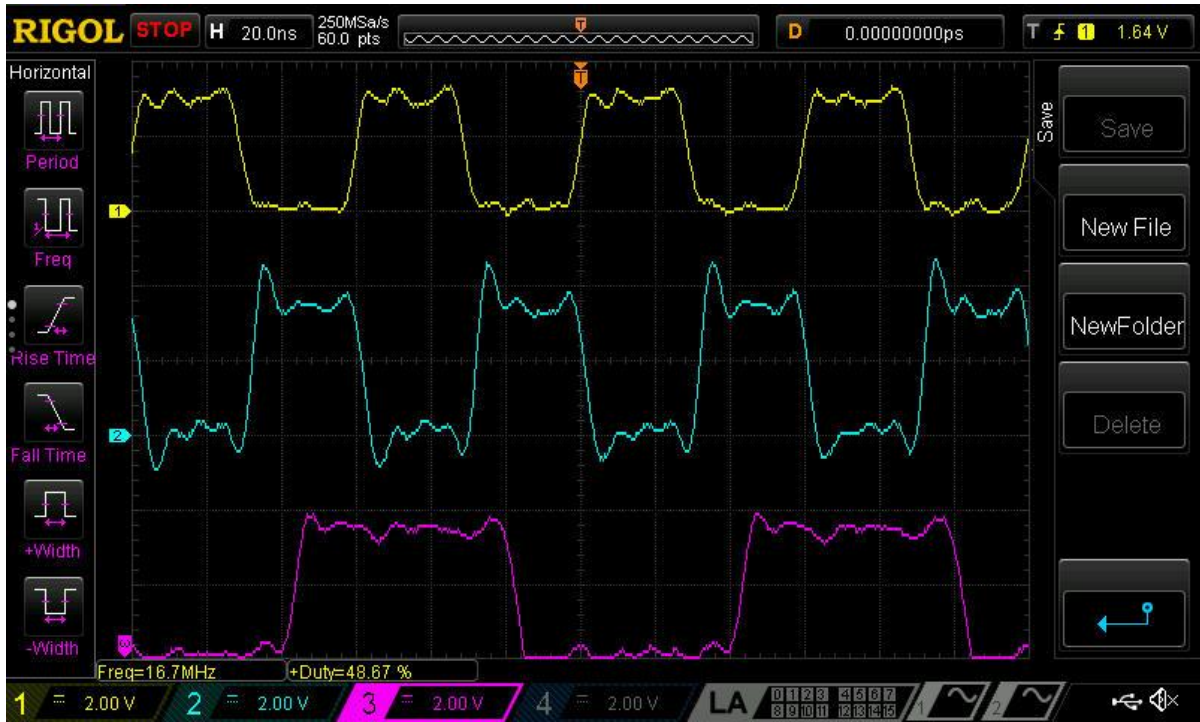
Figure 7

4. Period is 60ns. Pulse width is 40ns DC=66.67% (Correct functionality)

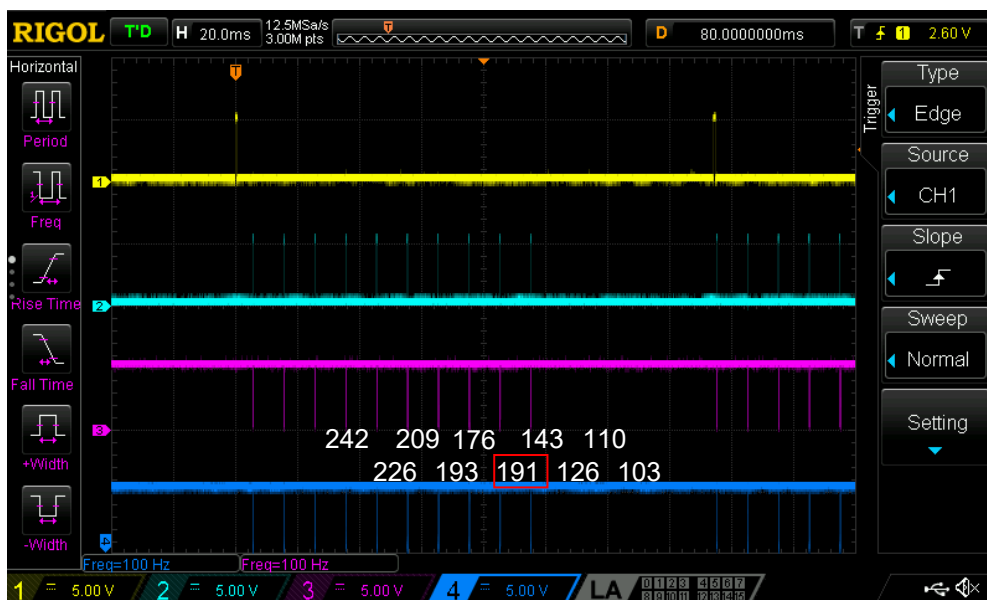
Figure 9

Asynchronous interaction between the CNT/DLY clock input and the I2C latch signal (generated by an I2C read command of the CNT/DLY block's count value) can result in an incorrect I2C data read. The CNT/DLY block will count accurately, but the count value transferred into the block's I2C read register might be loaded incompletely if the I2C latch signal and the clock input occur at about the same time.

The example data capture below shows ten periodic I2C reads of CNT2/DLY2 configured to count down at about 16 clocks per read. The sixth read sample erroneously shows a value greater than that of the fifth. The seventh sample reads as if the previous I2C error never occurred - the difference from the fifth sample (176) to the seventh (143) is 33 clocks or 16 clocks + 17 clocks as expected.

If the possibility of incorrect I2C data reads can't be accommodated for by external software checks, one can guarantee proper operation by stopping the CNT/DLY block's clock during I2C reads

through one of the following methods: by disabling the oscillator block, by reconfiguring the CNT/DLY block's clock source, or by gating an external clock using a LUT (Look-up Table) in the signal matrix. After disabling the CNT/DLY block's clock, the count registers can be read without error. Please note that this workaround will add the I2C read and processing time to the counter's overall clock period.

The best workaround depends on the resource constraints of the application. If the oscillator block doesn't clock other logic elements within the design, a matrix output can be used to manually power down the oscillators for the I2C read. When the CNT/DLY block's clock source is routed internally from the oscillator block, I2C commands can temporarily reconfigure the CNT/DLY block's clock source registers to select "Ext. CLK. (From Matrix)." This action will disable the clock by connecting it to ground. If the CNT/DLY block is clocked from the signal matrix, a LUT can be used to gate the clock during an I2C read.

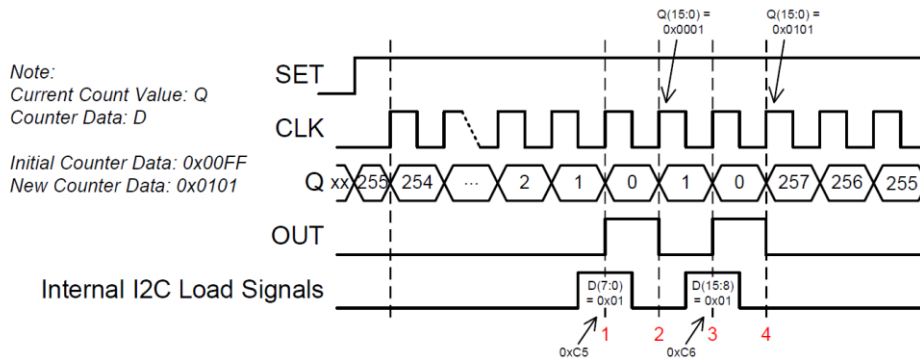
Figure 10: I2C Write of 16-Bit Counter Data Example

The timing diagram in [Figure 10](#) sets up a case where an improper output will be seen on the counter. In this example, the initial Counter Data value (D) is set up as 0x00FF. As you can see, the

Current Count Value (Q) decrements from 255 down to 0 with rising edges on CLK. At time “1” denoted by a red number 1, an I2C command (not shown) has just been sent to the GreenPAK device to reconfigure the Counter Data value to 0x0101.

As previously mentioned, the 16-bit value is loaded from the I2C buffers to the Counter Data registers in 8-bit chunks. Right at time “1”, the LSB byte (0x01) is loaded into the Counter Data registers. This makes the Counter Data value temporarily equal to 0x0001. At time “2” between the internal I2C load signals, the counter receives a rising edge on its clock input. This causes the Current Count Value to underflow and to be loaded with the Counter Data value which is 0x0001. At time “3”, the MSB byte (0x01) is loaded into the Counter Data registers setting the Counter Data value to 0x0101. At time “4”, the Current Count Value underflows again and is set to the Counter Data value of 0x0101.

This behavior results in two output pulses on OUT when only one pulse is expected. Observing this behavior depends upon the asynchronous timing between the counter’s clock and the I2C write command to the Counter Data registers. For some applications, the extra pulse on OUT can be ignored and the counter will self-correct after underflowing, overflowing, or being SET/RESET through the GreenPAK connection matrix.

won't be gated internally which avoids the loss of count values during Tstop. In order to guarantee the current count value after an I2C write to the Counter Data registers, the clock should be manually stopped for the I2C write or a SET/RESET command should be generated after the I2C write. (Case 1)

Disable the counter's clock during the I2C write.

Manually SET/RESET the counter after the I2C write is complete.

Disregard the first set of pulses on the counter output after an I2C write by waiting for one counter cycle to complete. This allows the counter's DFF chain to be loaded with the new Counter Data value after the counter overflows/underflows.

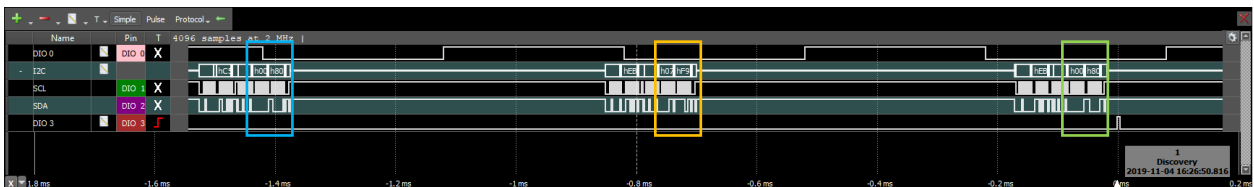
Figure 12: Counter Behavior

For the following condition, the Counter Data register contents are unexpectedly loaded into the counter's DFF chain. This behavior occurs when there is a falling edge on the counter block's clock input during the data return portion of an I2C read of the Counter Data registers. Figure 10 shows this falling edge boxed in light blue followed by two I2C reads of the Current Count Value registers.

As you can see by the MCU data log below, the Current Count Value gradually increases from 0xF904 to 0xF907 but is unexpectedly reset to 0x8000. Please note that the colored HEX values in the MCU Log correspond to the boxed I2C read commands shown in the waveform above. As previously described, this reset occurs because there is a falling edge on the counter's clock input while the GreenPAK device is responding to an I2C read request to 0xC5 and 0xC6. (Note that 0xC5/0xC6 are the Counter Data registers and 0xEB/0xEC are the Current Count Value registers for CNT0.)

The reason that the counter isn't set to 0x8000 on the I2C read immediately following the Counter Data query is because the counter requires two rising edges on its clock input to load the data from the Counter Data registers into the DFF chain. Note that all rising edges during  $T_{stop}$  will be gated internally by the "Stop and Restart" feature.

For systems that require I2C write access to the Counter Data registers while the counter is clocking, enable the "Stop and Restart Bit." (Case 2)

I2C Read of Counter Data: Avoid reading Counter Data via I2C while the counter is being clocked.

Within the MCU, we recommend saving the Counter Data register configuration as a software variable so that the Counter Data register doesn't need to be read during counter operation.

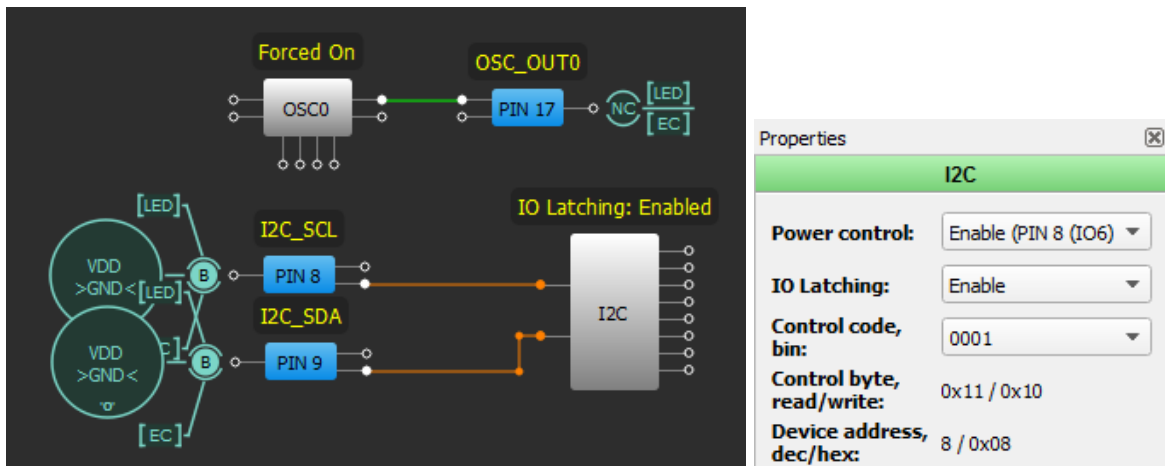
Figure 11

The GreenPAK device does not check for a matching I2C Target (Slave) address condition before triggering 'IO Latching'. A Start bit on the I2C bus will trigger IO Latching. A Start bit is when I2C\_SDA goes low first followed by I2C\_SCL going low after.

In the example below, we will be monitoring the OSC output, which is measured by a scope on Channel 3 via PIN17 ("OSC\_OUT0"). The I2C bus will be forced low to create a START bit.

Disable IO Latching in programmed OTP. This register is I2C-write locked during normal operation and therefore should be disabled in configuration file.  
 Do not share I2C bus with other devices and make sure the I2C bus is not powered down while the GreenPAK is still powered through VDD.

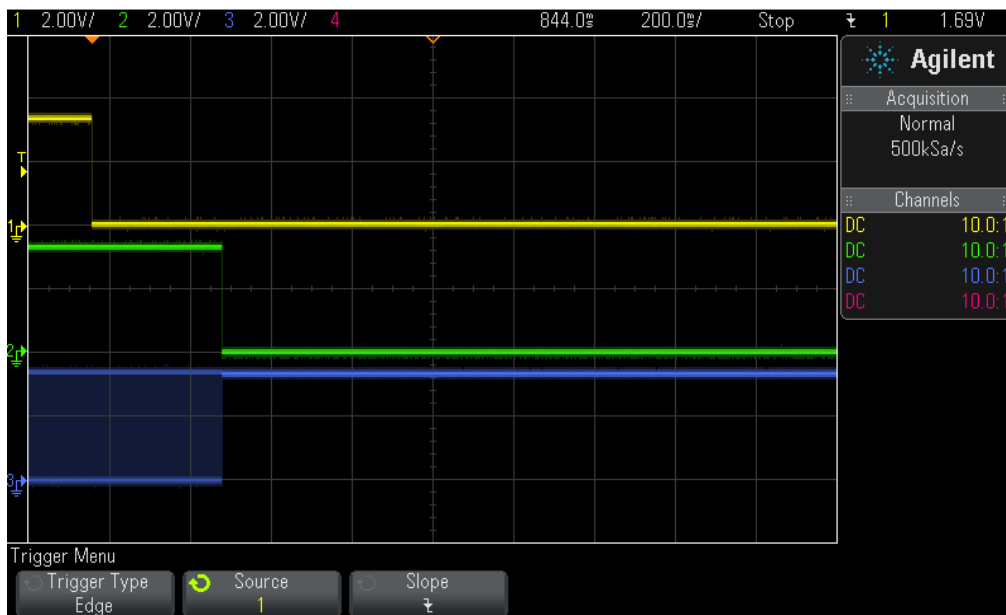
Figure 12

By toggling I2C\_SDA low and then I2C\_SCL low, the GreenPAK registers this as a start bit and latches all General Purpose Outputs such as PIN#17(“OSC\_OUT0”). In the Figure 12, notice that PIN#17 (OSC\_OUT0) stops toggling.

If the above cannot be satisfied, then consider using the SLG4658x devices, where this errata has been fixed.

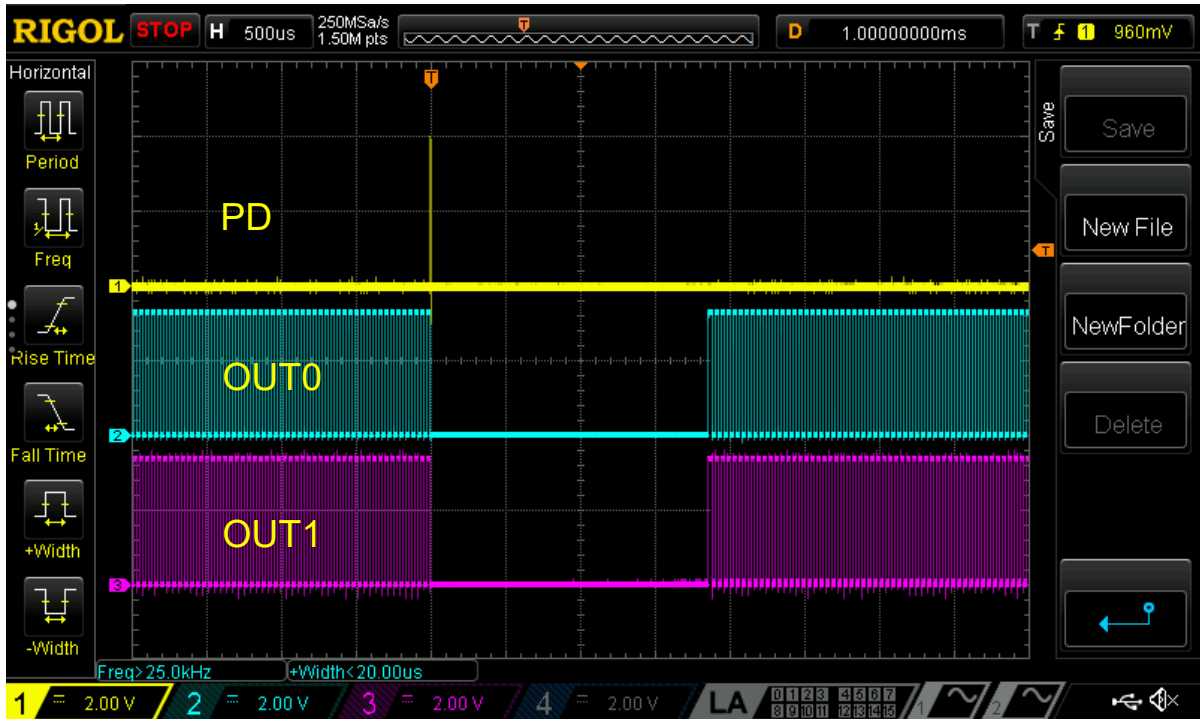
If a pulse with a duration of less than ~40 ns is applied to the PWR DOWN input of the oscillator, the oscillator outputs remain stuck for milliseconds, as shown in figures below. The issue is observed for all available oscillators.

Figure 14. 25 kHz OSC Long Start-Up

Change Fast start-up setting to Enable or omit applying glitches at PWR DOWN input in OSC.

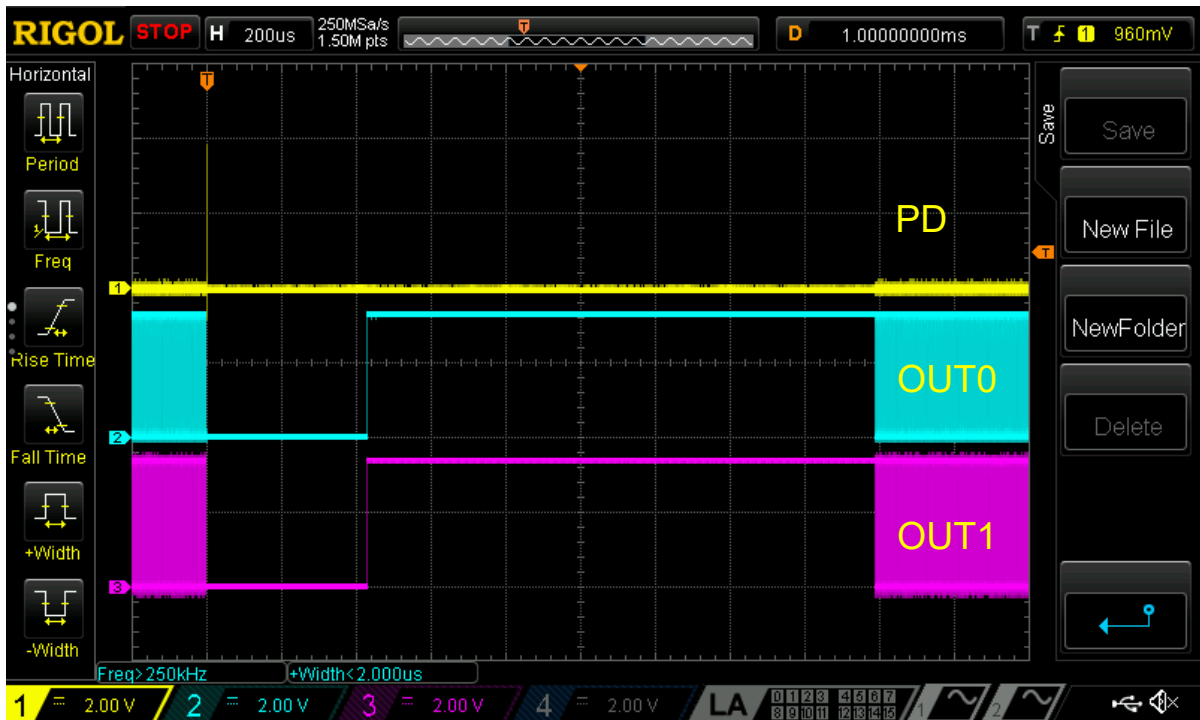
Figure 15. 2 MHz OSC Long Start-Up
