## SLG4653x-E Errata Note

This document contains the known errata for SLG46533-E, SLG46534-E, SLG46535-E, SLG46536-E, SLG46537-E, SLG46538-E and the recommended workarounds.

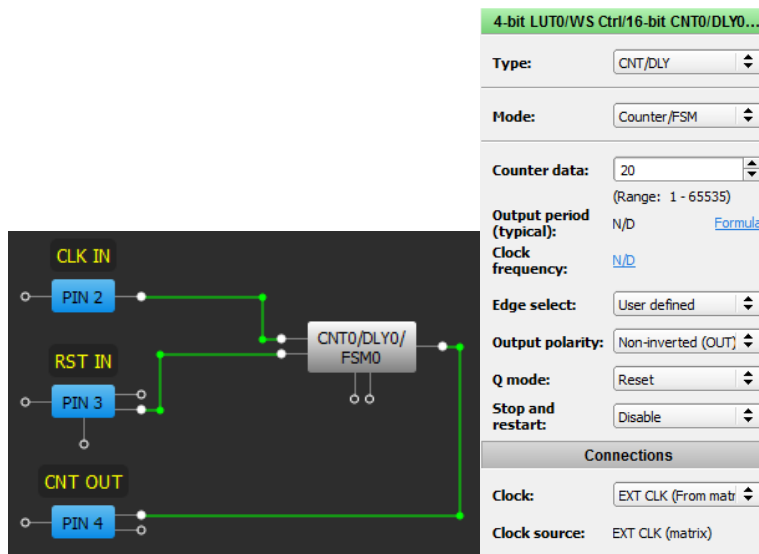
Figure 1

If the Counter Reset is asserted at the same time as a rising clock edge, it is possible that the Counter Data will be reset incorrectly and the counter output may appear faster than expected. This phenomenon appears more often as the clock frequency increases.

Synchronize RESET input of the Counter with its CLK using 2 DFF cells as shown on Figure 3.

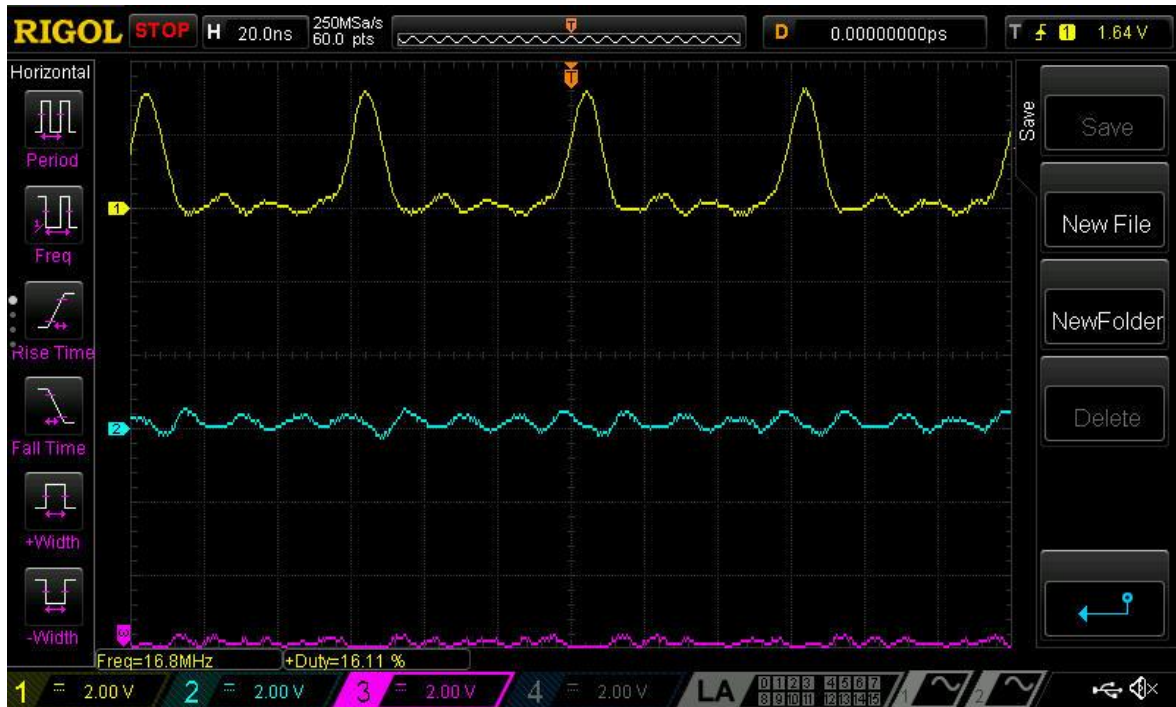
Figure 5

1. Period is 60 ns. Pulse width is 10 ns, DC = 16.7 % (correct functionality).

Currently there is no workaround for this issue. Filter block is good at filtering short spontaneous glitches. It is intended to be used in series connection before the delay cell to avoid its latching.

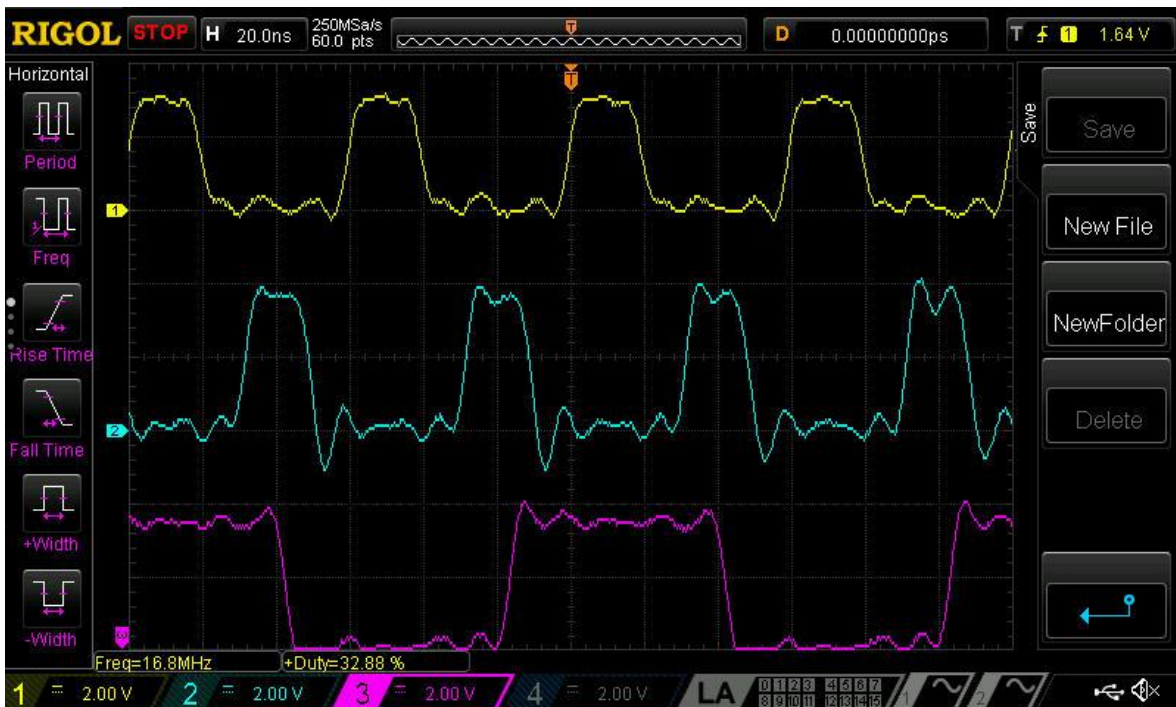
Figure 6

2. Period is 60 ns. Pulse width is 20 ns, DC = 33.3 % (incorrect functionality).

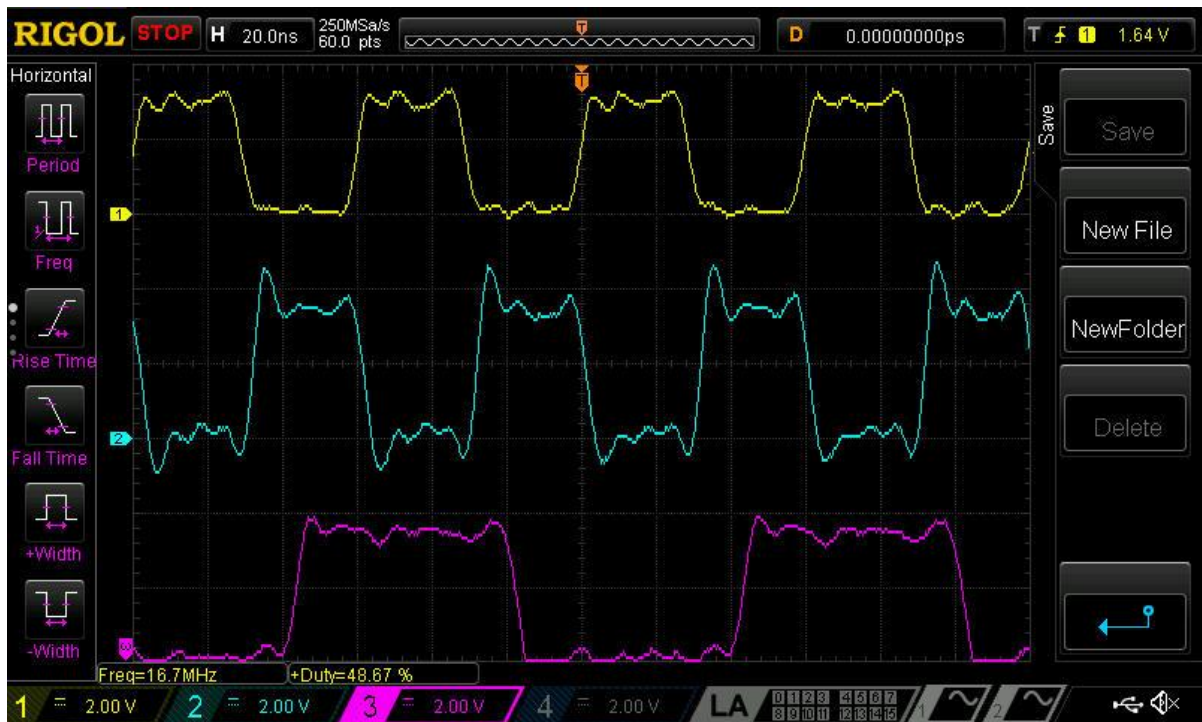
Figure 7

- Period is 60 ns. Pulse width is 30 ns, DC = 50 % (incorrect functionality).

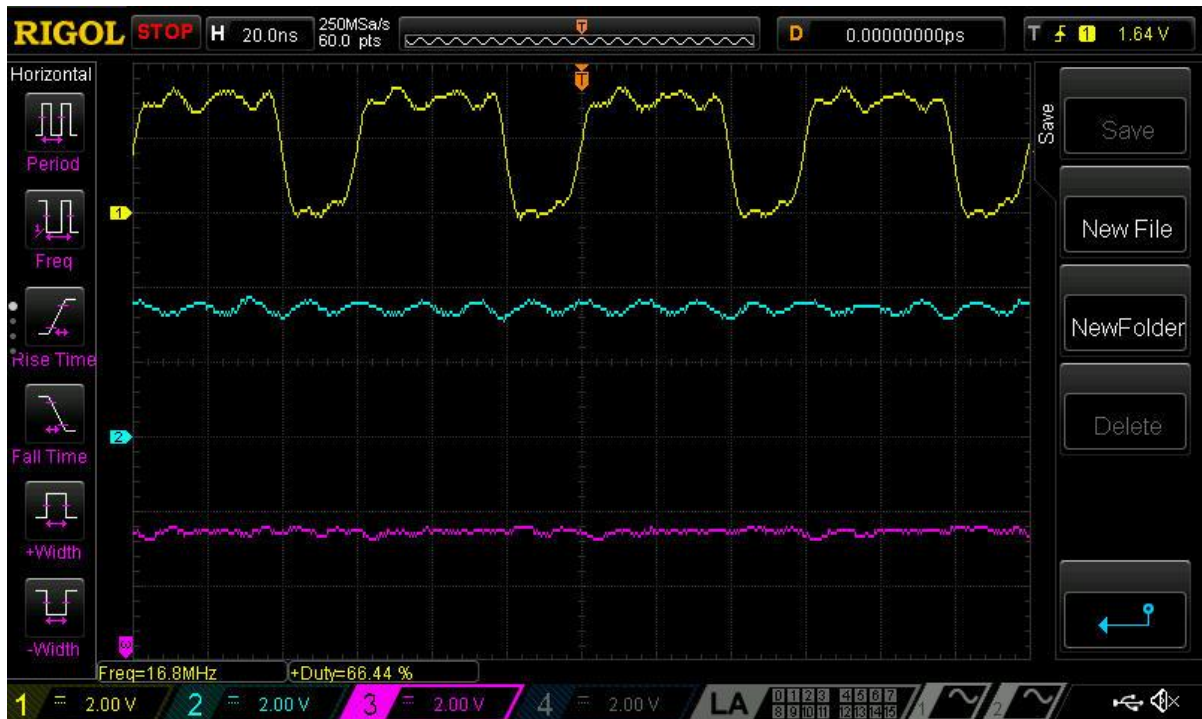
Figure 8

- Period is 60 ns. Pulse width is 40 ns, DC = 66.67 % (correct functionality).

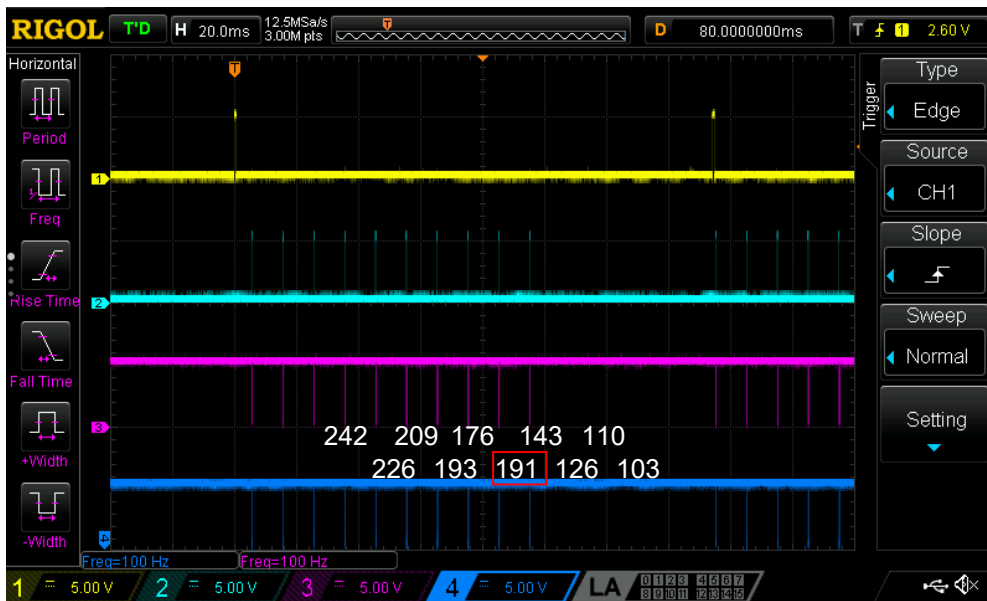
The example data capture in Figure 9 shows ten periodic I<sup>2</sup>C reads of CNT2/DLY2 configured to count down at about 16 clocks per read. The sixth read sample erroneously shows a value greater than that of the fifth. The seventh sample reads as if the previous I<sup>2</sup>C error never occurred - the difference from the fifth sample (176) to the seventh (143) is 33 clocks or 16 clocks + 17 clocks as expected.

If the possibility of incorrect I<sup>2</sup>C data reads cannot be accommodated for by external software checks, one can guarantee proper operation by stopping the CNT/DLY block's clock during I<sup>2</sup>C reads through one of the following methods: by disabling the oscillator block, by reconfiguring the CNT/DLY block's clock source, or by gating an external clock using a LUT (Look Up Table) in the signal matrix. After disabling the CNT/DLY block's clock, the count registers can be read without error. Please note that this workaround will add the I<sup>2</sup>C read and processing time to the counter's overall clock period.

The best workaround depends on the resource constraints of the application. If the oscillator block does not clock other logic elements within the design, a matrix output can be used to manually power down the oscillators for the I<sup>2</sup>C read. When the CNT/DLY block's clock source is routed internally from the oscillator block, I<sup>2</sup>C commands can temporarily reconfigure the CNT/DLY block's clock source registers to select "Ext. CLK. (From Matrix)". This action will disable the clock by connecting it to ground. If the CNT/DLY block is clocked from the signal matrix, a LUT can be used to gate the clock during the I<sup>2</sup>C read.

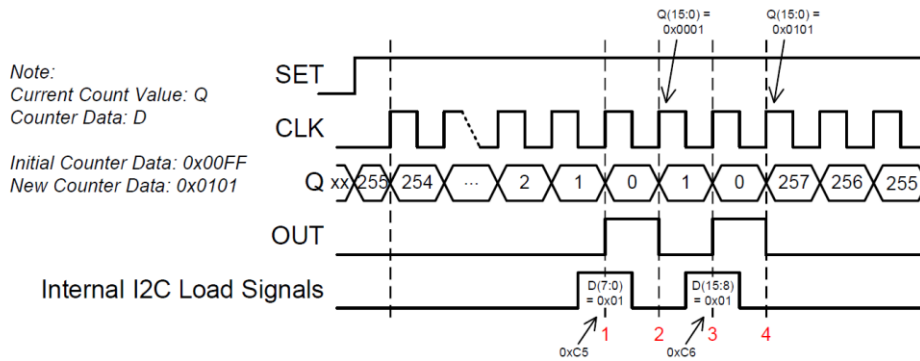
The timing diagram in [Figure 10](#) sets up a case where an improper output will be seen on the counter. In this example, the initial Counter Data value (D) is set up as 0x00FF. As you can see, the Current Count Value (Q) decrements from 255 down to 0 with rising edges on CLK. At time "1" denoted by a red number 1, an I<sup>2</sup>C command (not shown) has just been sent to the GreenPAK device to reconfigure the Counter Data value to 0x0101.

Figure 10. I<sup>2</sup>C Write of 16-Bit Counter Data Example

As previously mentioned, the 16-bit value is loaded from the I<sup>2</sup>C buffers to the Counter Data registers in 8-bit chunks. Right at time “1”, the LSB byte (0x01) is loaded into the Counter Data registers. This makes the Counter Data value temporarily equal to 0x0001. At time “2” between the internal I<sup>2</sup>C load signals, the counter receives a rising edge on its clock input. This causes the Current Count Value to underflow and to be loaded with the Counter Data value which is 0x0001. At time “3”, the MSB byte (0x01) is loaded into the Counter Data registers setting the Counter Data value to 0x0101. At time “4”, the Current Count Value underflows again and is set to the Counter Data value of 0x0101.

This behavior results in two output pulses on OUT when only one pulse is expected. Observing this behavior depends upon the asynchronous timing between the counter’s clock and an I<sup>2</sup>C write command to the Counter Data registers. For some applications, the extra pulse on OUT can be ignored and the counter will self-correct after underflowing, overflowing, or being SET/RESET through the GreenPAK connection matrix.

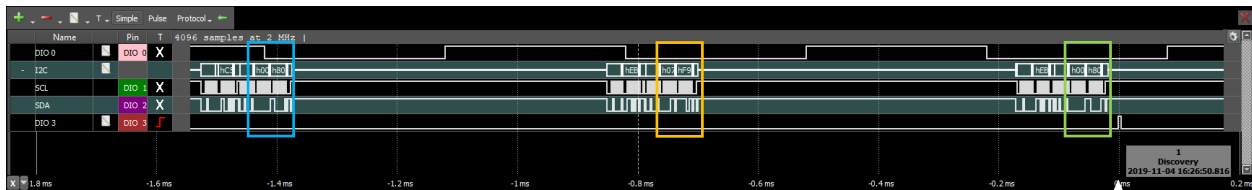
For the following condition, the Counter Data register contents are unexpectedly loaded into the counter’s DFF chain. This behavior occurs when there is a falling edge on the counter block’s clock input during the data return

portion of the I<sup>2</sup>C read of the Counter Data registers. Figure 12 shows this falling edge boxed in light blue followed by two I<sup>2</sup>C reads of the Current Count Value registers.

Figure 12. Counter Behavior

As you can see by the MCU data log below, the Current Count Value gradually increases from 0xF904 to 0xF907 but is unexpectedly reset to 0x8000. Please note that the colored HEX values in the MCU Log correspond to the boxed I<sup>2</sup>C read commands shown in the waveform above. As previously described, this reset occurs because there is a falling edge on the counter’s clock input while the GreenPAK device is responding to the I<sup>2</sup>C read request to 0xC5 and 0xC6 (note that 0xC5/0xC6 are the Counter Data registers and 0xEB/0xEC are the Current Count Value registers for CNT0).

The reason that the counter is not set to 0x8000 on the I<sup>2</sup>C read immediately following the Counter Data query is because the counter requires two rising edges on its clock input to load the data from the Counter Data registers into the DFF chain. Note that all rising edges during T<sub>stop</sub> will be gated internally by the “Stop and Restart” feature.

For systems that require I<sup>2</sup>C write access to the Counter Data registers while the counter is clocking, enable the “Stop and Restart Bit” (Case 2).

I<sup>2</sup>C Read of Counter Data: avoid reading Counter Data via I<sup>2</sup>C while the counter is being clocked.

Within the MCU, it is recommended saving the Counter Data register configuration as a software variable so that the Counter Data register does not need to be read during counter operation.

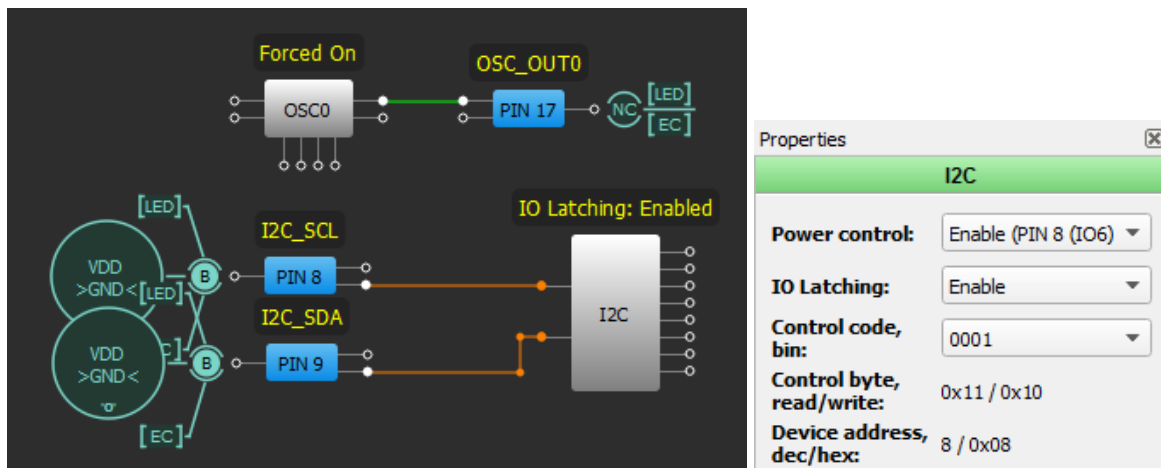
Figure 13.

The GreenPAK device does not check for a matching I<sup>2</sup>C Target address condition before triggering ‘IO Latching’. A Start bit on the I<sup>2</sup>C bus will trigger IO Latching. A Start bit is when I2C\_SDA goes low first followed by I2C\_SCL going low after.

In the example in Figure 13, it will be monitored the OSC output, which is measured by a scope on Channel 3 via PIN17 (“OSC\_OUT0”). The I<sup>2</sup>C bus will be forced low to create a START bit.

Disable IO Latching in programmed OTP. This register is I<sup>2</sup>C-write locked during normal operation and therefore should be disabled in configuration file.

Do not share I<sup>2</sup>C bus with other devices and make sure the I<sup>2</sup>C bus is not powered down while the GreenPAK is still powered through V<sub>DD</sub>.

If the above cannot be satisfied, then consider using the SLG4658x devices, where this errata has been fixed.

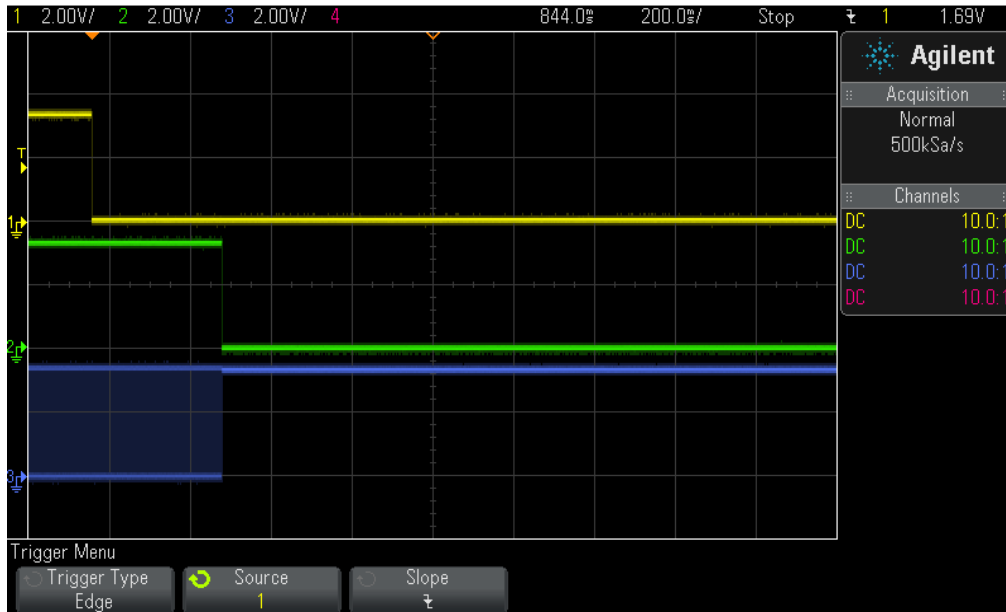
Figure 14.

By toggling I2C\_SDA low and then I2C\_SCL low, the GreenPAK registers this as a start bit and latches all General Purpose Outputs such as PIN#17 (“OSC\_OUT0”). In [Figure 14](#), notice that PIN#17 (OSC\_OUT0) stops toggling.

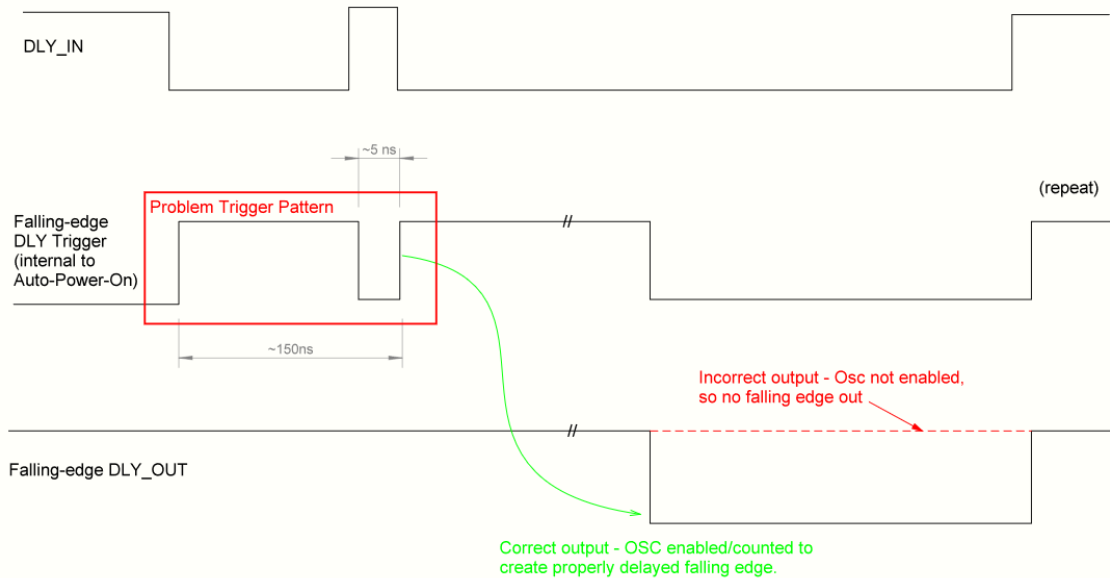
For this chip, the Auto Power On circuitry of the 25 kHz/2 MHz generators contains a circuit errata, which can potentially fail to power on the OSC for a specific pattern and timing of the OR of all related DLY trigger signals. The pattern is shown in Figure 15 (boxed in red) and consists of a relatively longer pulse (~145 ns) followed by a shorter (~5 ns) glitch of opposite polarity.

Figure 15. Problem Trigger Pattern

1. Use signal conditioning circuits to prevent glitch on DLY inputs < 200 ns. Examples:
  - a. ACMP with Hysteresis

- b. External RC in front of Digital Input with Schmitt Trigger
  - c. Filter cell.
2. Set OSC power mode to Force Power On mode instead of Auto Power On.
  3. Use different oscillator, such as 25 MHz Ring OSC, which does not have Auto Power On issue.

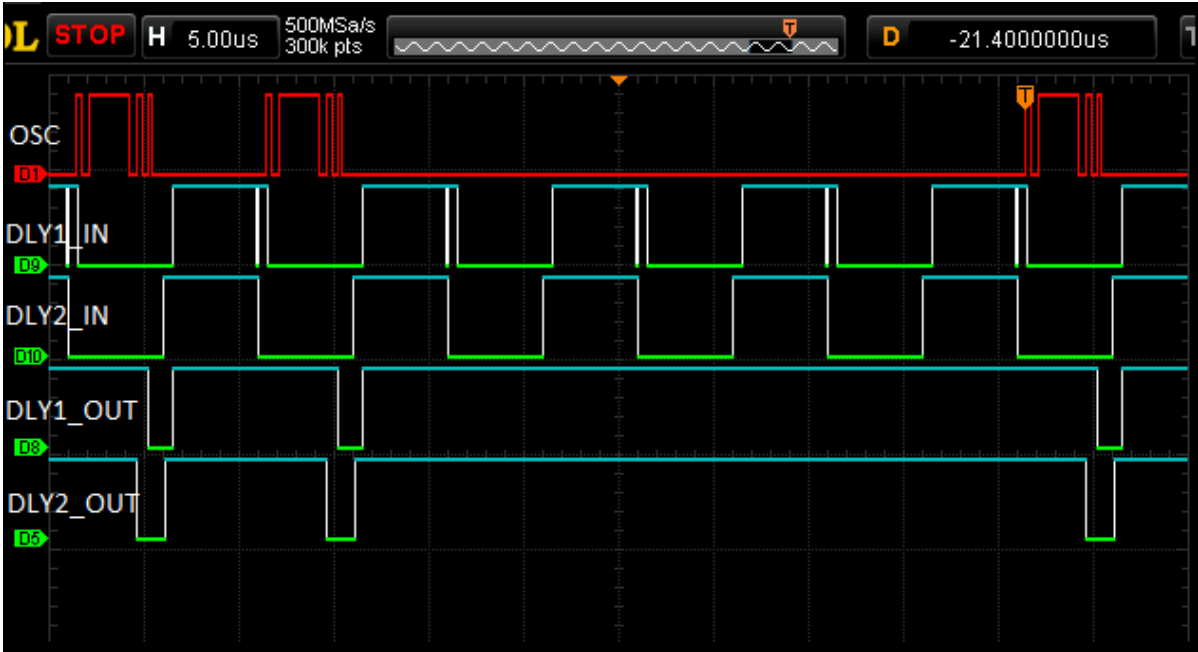
Figure 17 shows a series of DLY output events are missing, where the OSC is correspondingly not triggering when it was supposed to. Figure 18 is a zoom in of the boxed region from Figure 17. The total glitch/chatter time was measured in this case at 152 ns. By using the composite OR of the two delay channels, it can be strobed asynchronously with tiny frequency variations, and so tune the timing to induce this errata. Note that the error is not persistent – the system is recovered when all DLYs are returned to inactive state, such as when input of falling edge DLY goes high, thus canceling delay, or after DLY out finishes.

Figure 17. Errata Capture (Zoom Out)

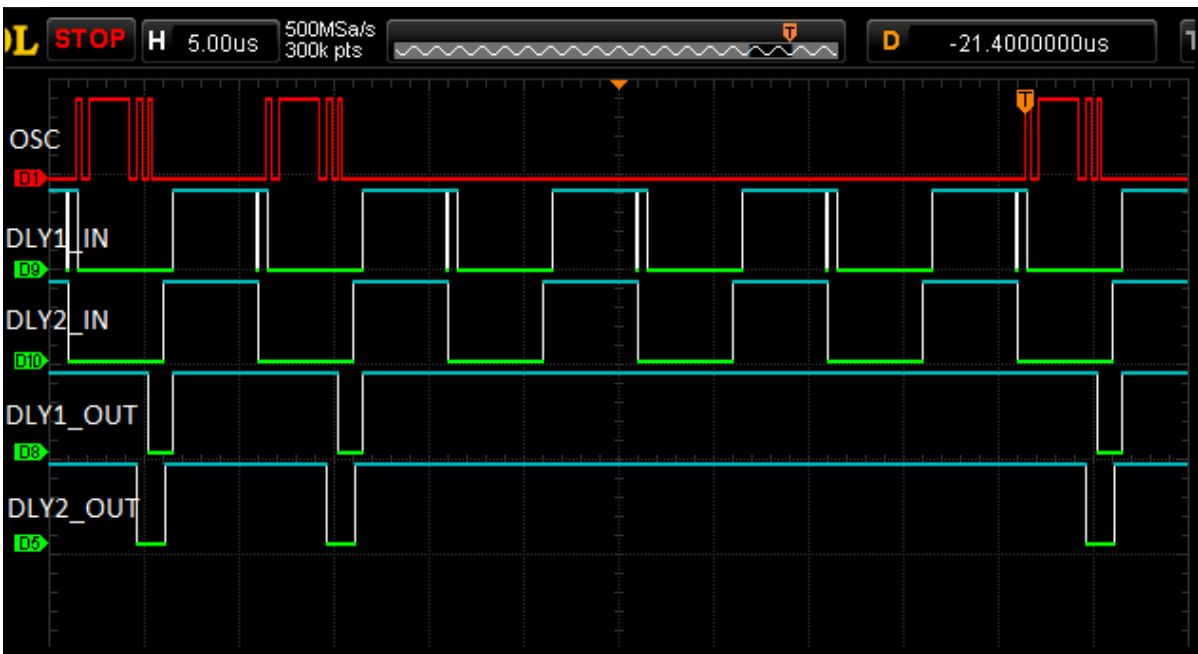
Figure 18. Errata Capture (Zoom In)

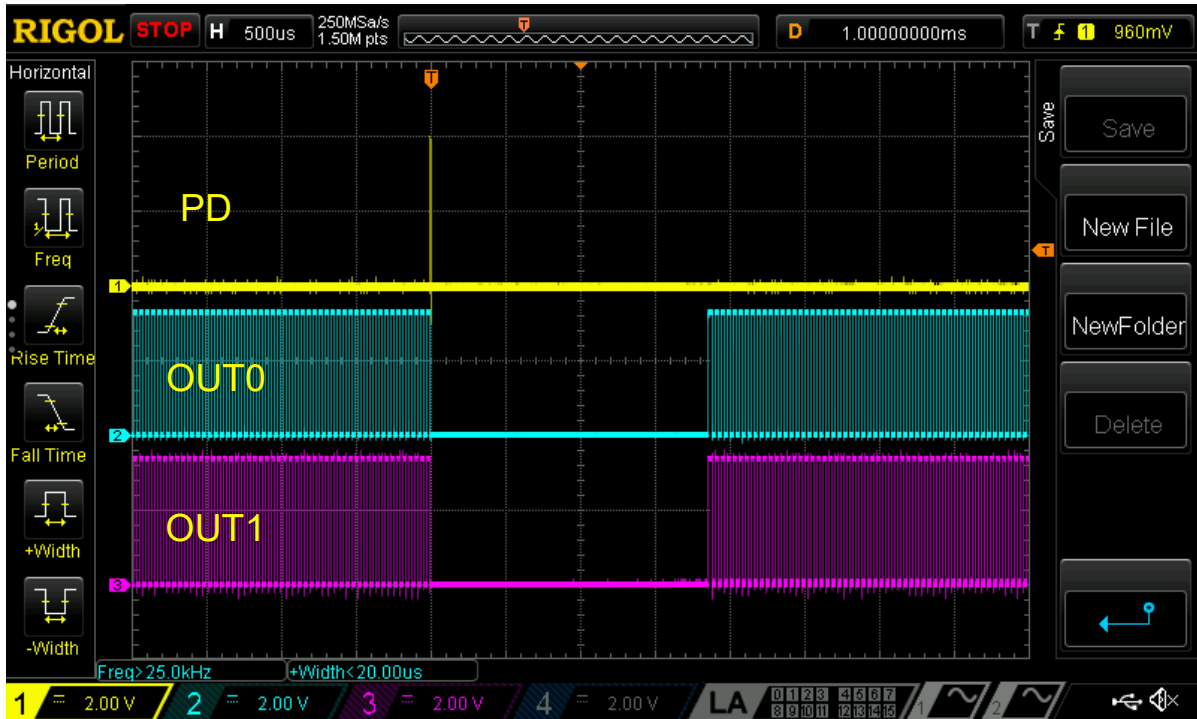
If a pulse with a duration of less than ~40 ns is applied to the PWR DOWN input of the oscillator, the oscillator outputs remain stuck for milliseconds, as shown in [Figure 20](#) and [Figure 21](#). The issue is observed for all available oscillators.

Figure 20. 25 kHz OSC Long Start-Up

Change Fast start-up setting to Enable or omit applying glitches at PWR DOWN input in OSC.

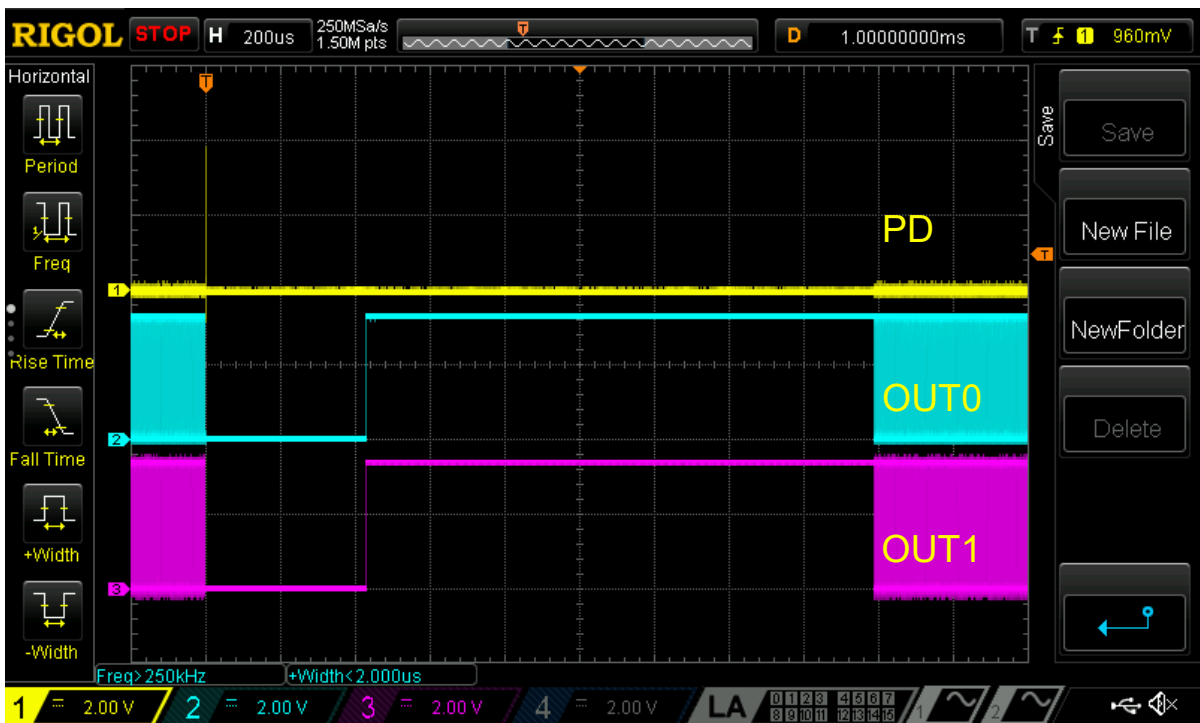
Figure 21. 2 MHz OSC Long Start-Up

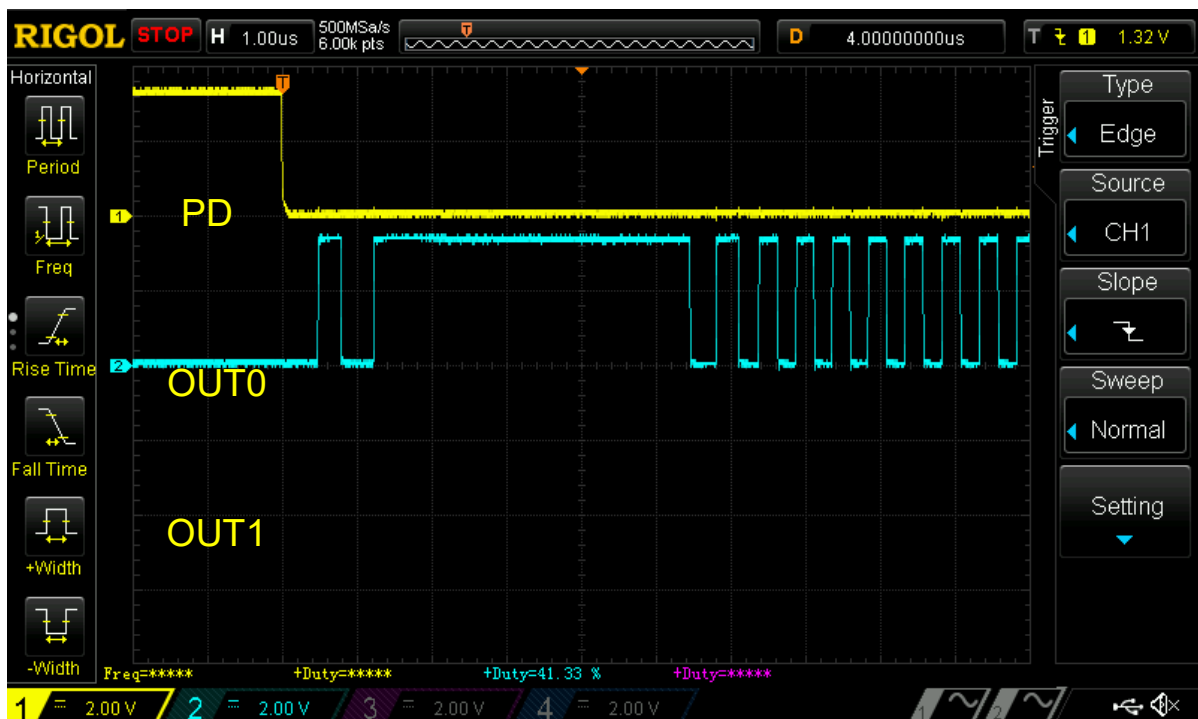
2 MHz OSC has an additional ~ 9 cycles settling period. Higher  $V_{DD}$  shows longer settling time.

Figure 23. Channel 1 – OSC Power Down; Channel 2 –OSC Output

Such behavior will lead to substantial error in period calculations if the delay time is relatively small.

Enable Fast Start-up option. Fast Start-up means forcing bias ready at the power-up instead of automatic enabling at OSC event. The standby current consumption difference between Fast start-up disabled and enabled is only an additional 300 nA.

Use the “Force power on” OSC power control option to make the OSC operate at all times. However, this will cause increased constant current consumption.
