ISSUE 1: FILTER Cell does not Filter Out Repetitive Glitches

SLG46585

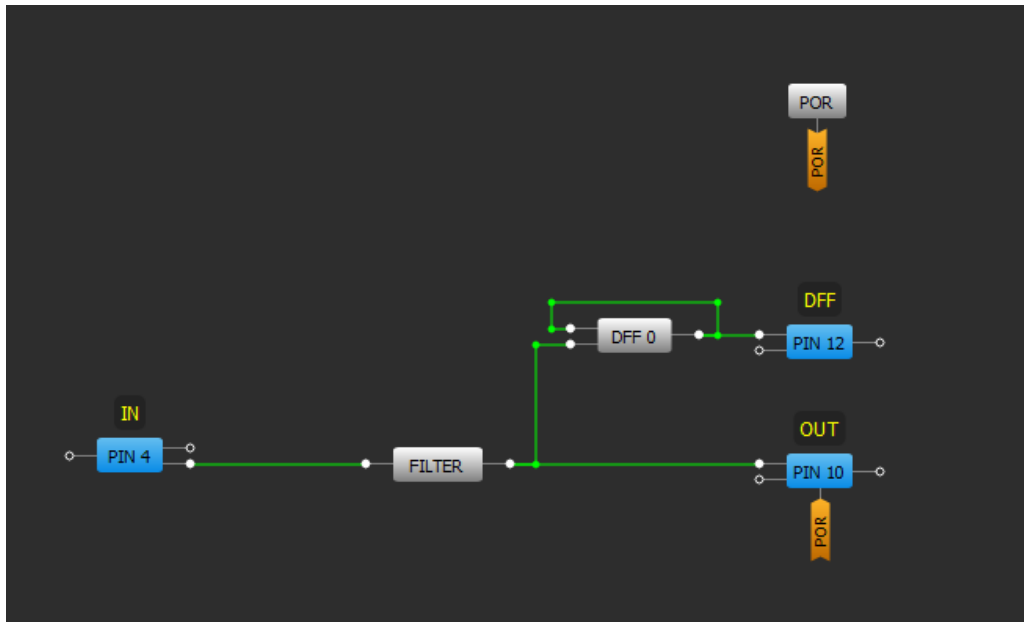
If the FILTER cell's input signal contains multiple consecutive pulses within short time intervals, the FILTER cell may not filter the input pulses as expected. The errant behavior applies only to repeated input pulses and depends on both their frequency and duty cycle.

Channel 1 (yellow/top line) – PIN#4 (IN).
 Channel 2 (light blue/2nd line) – PIN#10 (OUT).
 Channel 3 (magenta /3rd line) – PIN#12 (DFF).

Currently, there is no workaround for this issue. The FILTER block correctly filters isolated glitches, but it shouldn't be used to filter repetitive, high frequency input signals.

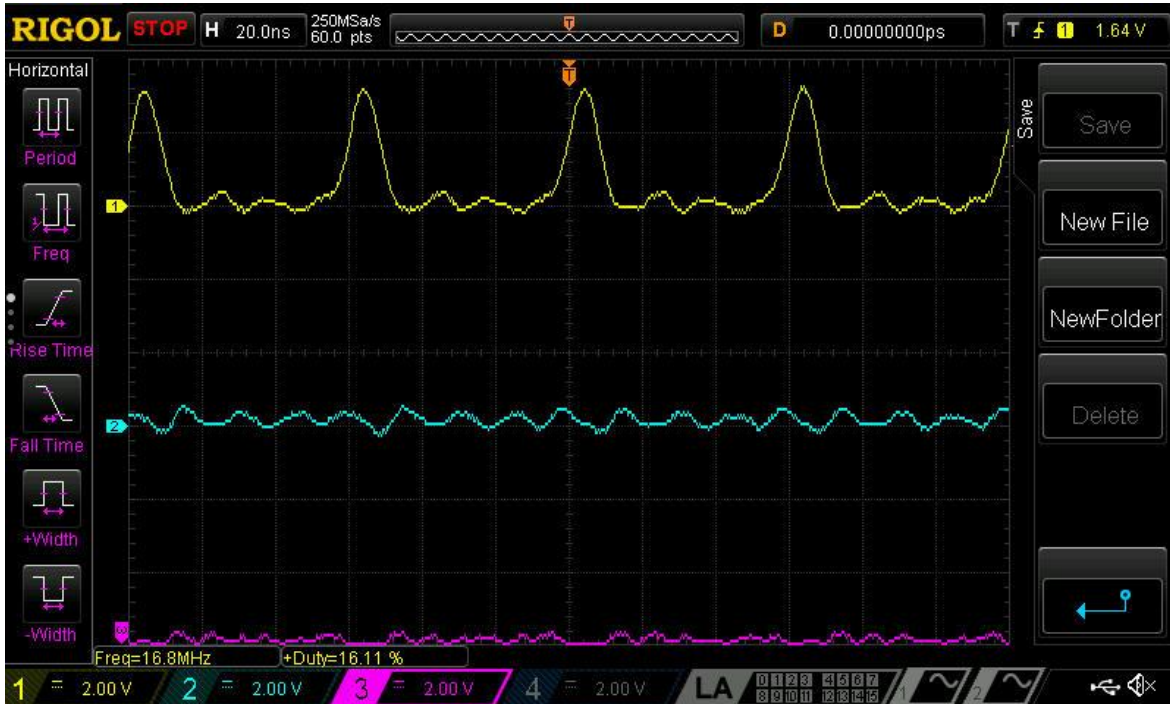
1. Period is 60 ns. Pulse width is 10 ns, DC = 16.7 % (correct functionality).

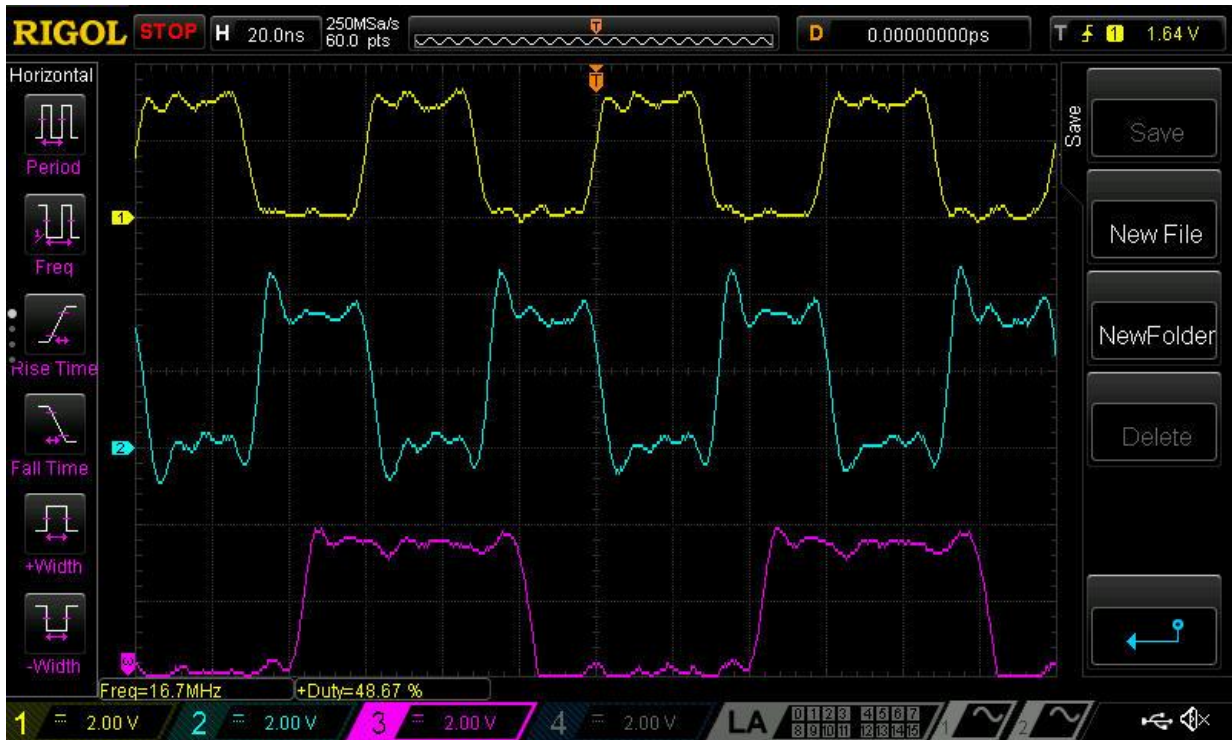
3. Period is 60 ns. Pulse width is 30 ns, DC = 50 % (incorrect functionality).

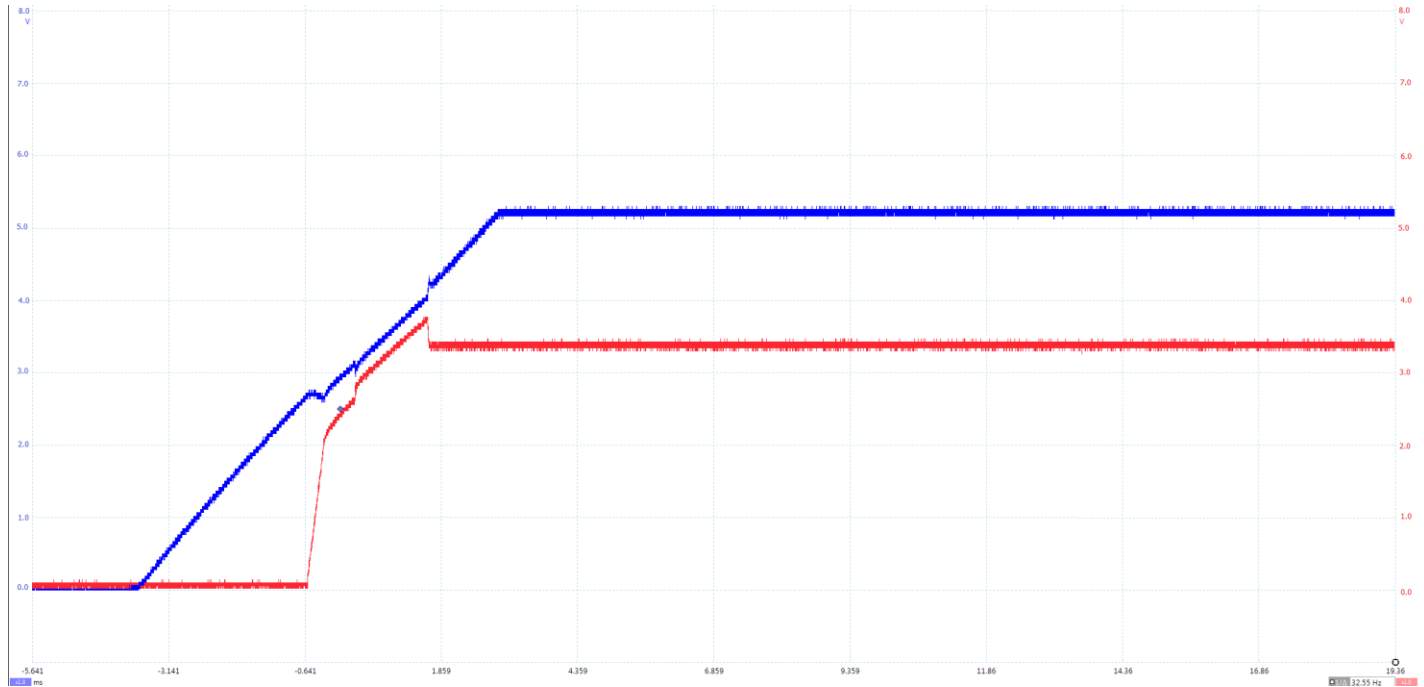
The maximum DC_VOUT to DC_VIN duty cycle ratio is 80 % for fsw=1.5 MHz and 75 % for fsw=2 MHz (See Table 20 in Datasheet section 5.11 parameter *Maximum Duty Cycle*). This voltage glitch issue only occurs if the DC_VOUT to DC_VIN ratio exceeds this maximum, meaning DC_VIN does not have enough headroom above DC_VOUT.

For DC_VOUT selections 1.2 V, 1.5 V, and 1.8 V, the UVLO can block the ON/OFF signal from enabling the DC/DC Buck Converter until DC_VIN is greater than 2.3 V. However, for selections 2.5 V, 3.0 V, and 3.3 V, which are greater than the UVLO threshold, there is no protection against enabling the DC/DC while the DC_VIN does not satisfy the Maximum Duty Cycle ratio specified above.

This glitch can be seen in an application where there is a slow DC_VIN/VDD ramp and the DC/DC’s enable signal is tied to DC_VIN/VDD, as shown in the example capture below.

The example capture below shows DC_VIN/VDD ramping from 0 V to 5.5 V at 1 V/ms. The output voltage is set to 3.3 V.

Channel 1 (blue/top line) – PIN#14/PIN#16 (DC_VIN/VDD).
 Channel 2 (red/2nd line) – PIN#10 (DC_VOSNS).

Use an ACMP to detect when DC_VIN is greater than DC_VOUT divided by Maximum Duty Cycle, and then AND the ACMP output with the ON/OFF signal.

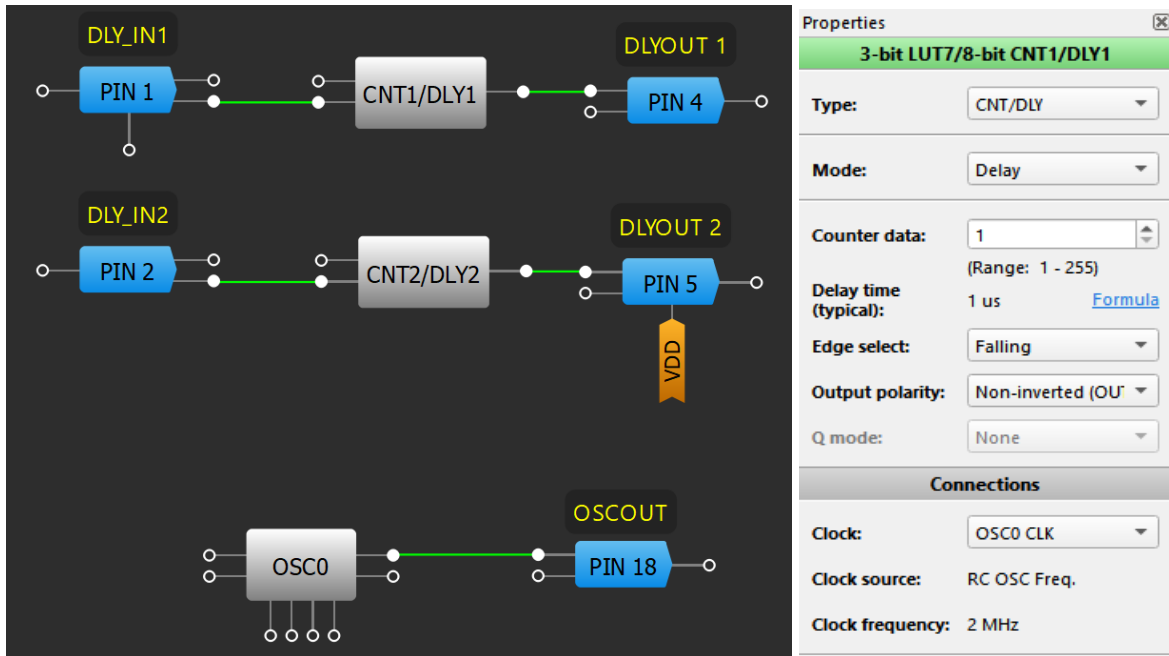
Figure 2: Test Circuit

The error is difficult to capture as the timing must be exact within ns, and short (ns) pulses are difficult to generate glitch precise enough to induce the problem. GPIO naturally filter out ns pulses, so for purposes of errata capture, two simultaneous falling-edge DLY circuits (as shown in [Figure 2](#)) were used. By lining up two delays precisely at a particular timing relationship, we can use the internal Auto Power On (OR logic) to generate the glitch pattern necessary to cause the error.

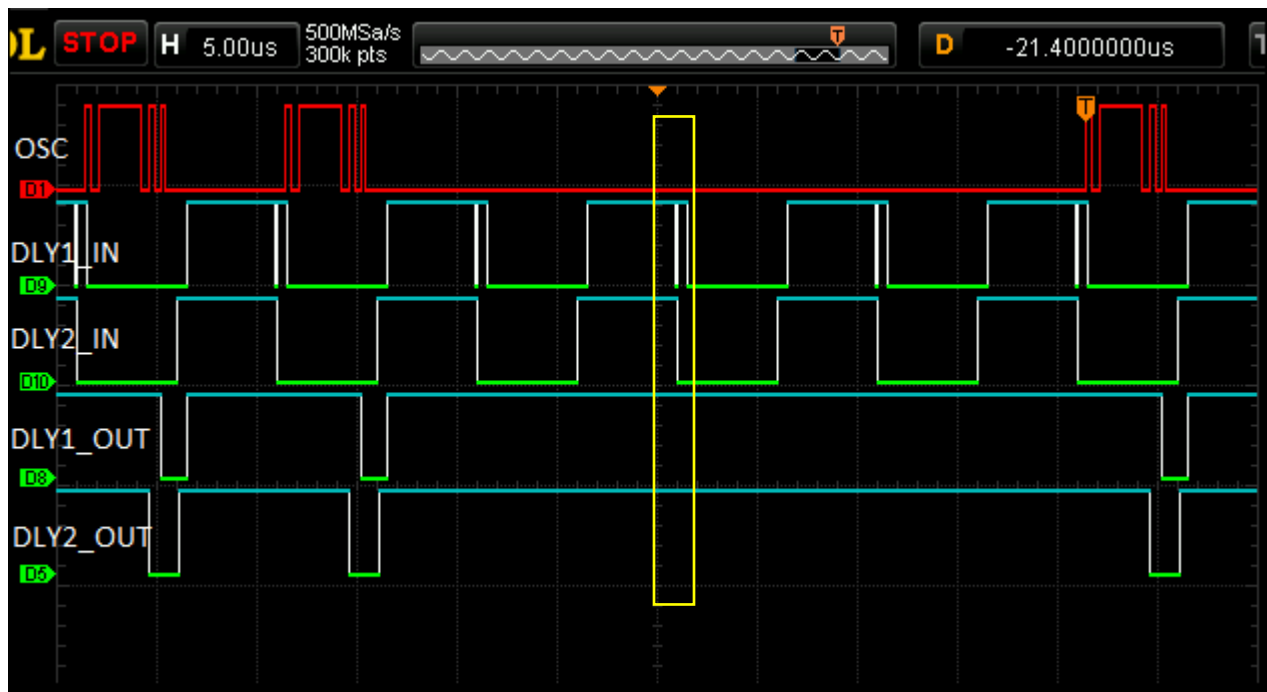
Figure 3: Errata Capture (Zoom Out)

Figure 3 shows a series of DLY output events are missing, where the OSC is correspondingly not triggering when it was supposed to. Figure 4 is a zoom in of the boxed region from Figure 3. The total glitch/chatter time was measured in this case at 152 ns. By using the composite OR of the two delay channels, we can asynchronously strobe with tiny frequency variations, and so tune the timing to induce this errata. Note that the error is not persistent – the system is recovered when all DLYs are returned to inactive state, such as when input of falling edge DLY goes high, thus canceling delay, or after DLY out finishes.

1. Use signal conditioning circuits to prevent glitch on DLY inputs < 200 ns. Examples:
 - a. ACMP with Hysteresis
 - b. External RC in front of Digital Input with Schmitt Trigger
 - c. Filter cell.
2. Set OSC power mode to Force Power On mode instead of Auto Power On.
3. Use different oscillator, such as 25 MHz Ring OSC, which does not have Auto Power On issue.
