## SLG46620

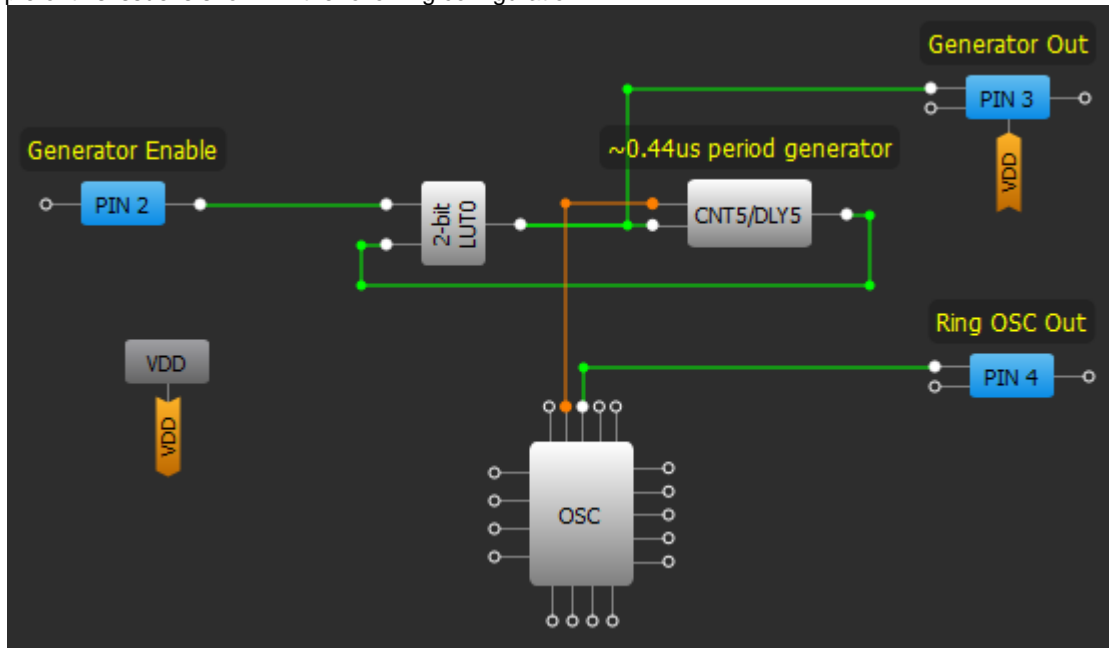
**ISSUE 4: Long Ring OSC Settling Time**  
**Functional Block Affected: Ring OSC, Delay, Counter**

The Ring OSC has a longer settling time when configured as Auto Power On in the designs that have very short Ring OSC disable time. An example of this issue is shown in the following configuration:

- Set Ring OSC power mode to “Force Power On”
- or, Set Turn on by register option in BG (Band Gap) block as “Enable”

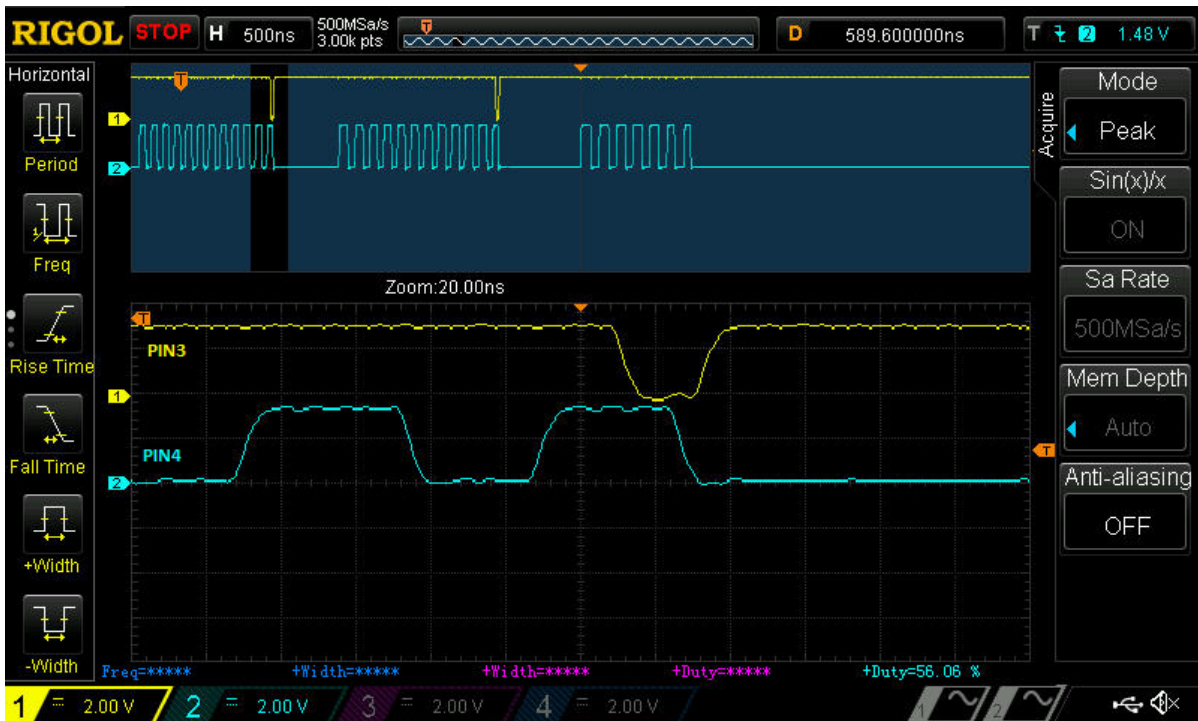
The configuration shown above generates a periodical signal with a frequency defined by the Delay cell and started by a high signal on PIN2. The issue becomes apparent in a longer settling time when the scheme generates short pulses (Delay is configured as a rising edge delay only). See waveform below.

Channel 1 – 2-bit LUT0 output; Channel 2 – Ring OSC output

Such behavior will lead to substantial error in period calculations if the delay time is relatively small.

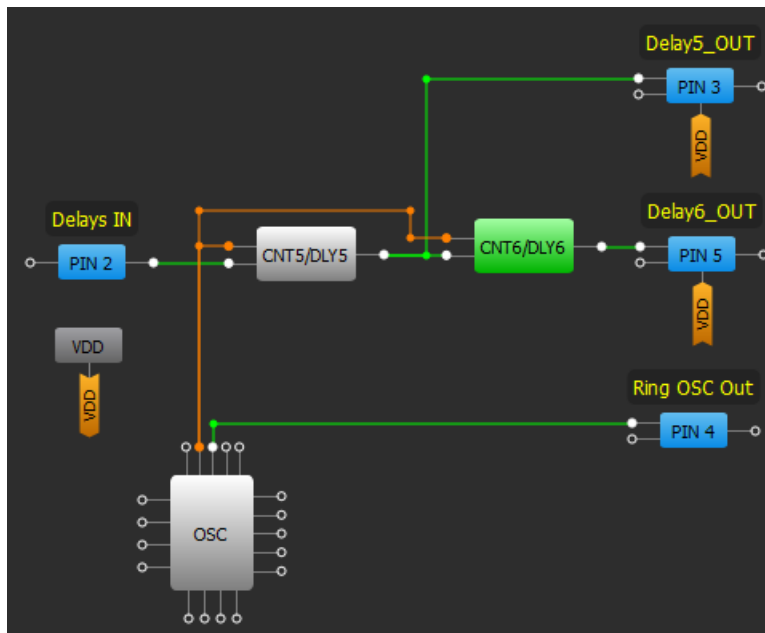
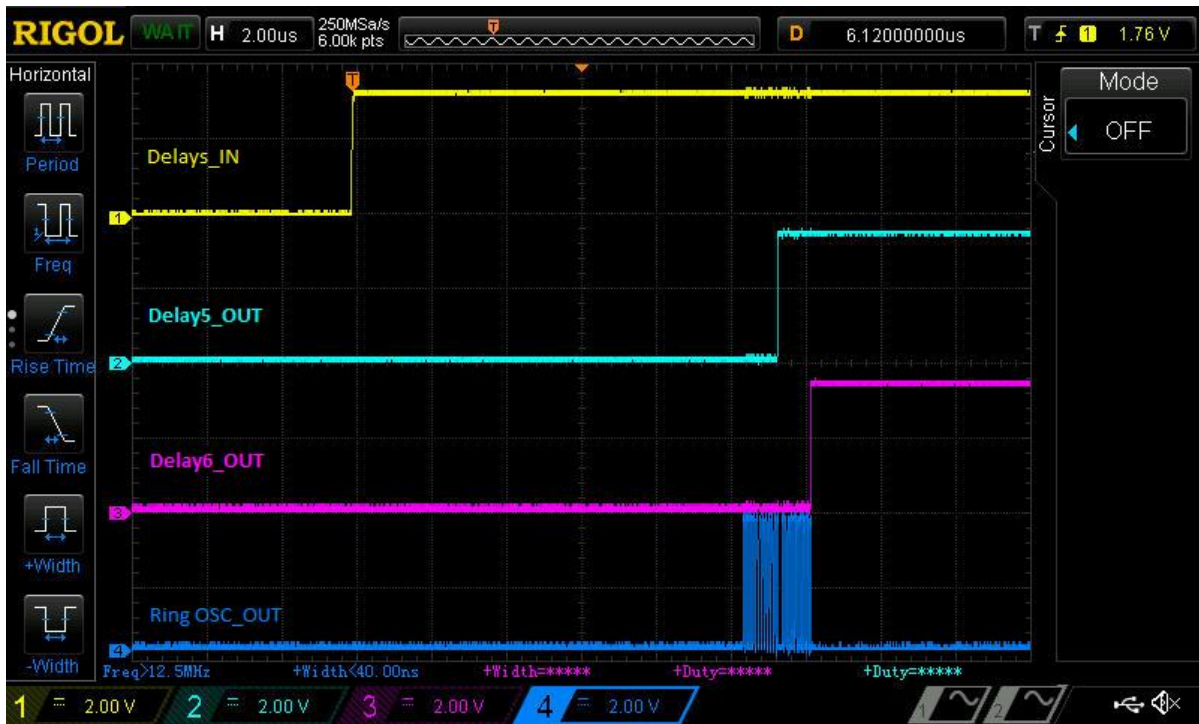
A similar situation can occur while using two connected delays (all edge detect types except for a pair “Rising edge DLY – Falling edge DLY”).

In the following example, Delay5 and Delay6 are configured in the same way. However, Delay5 time is 11.4us instead of expected 0.4us (Delay5 time).

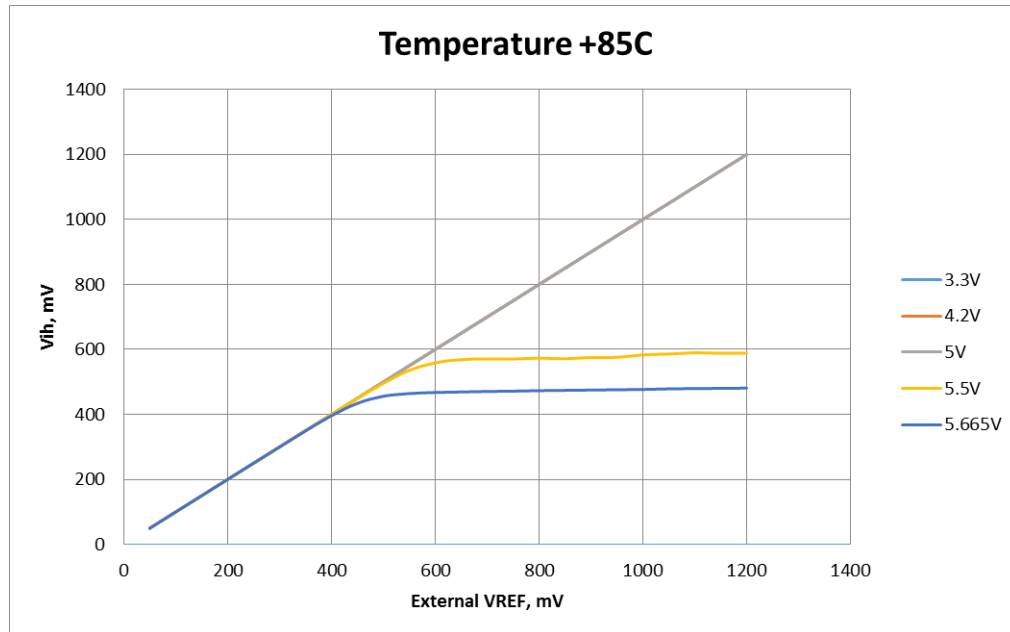
**ISSUE 6: ACMP Output is Inaccurate when using External Vref at High VDD and Temperature**  
**Functional Block Affected: ACMP**

When using external Vref source, the ACMP comparison may happen at wrong threshold if the external Vref voltage is higher than a particular value (please see figure below) at high VDD values (> 5V) and high temperature.

- Avoid using ACMPs in such conditions.

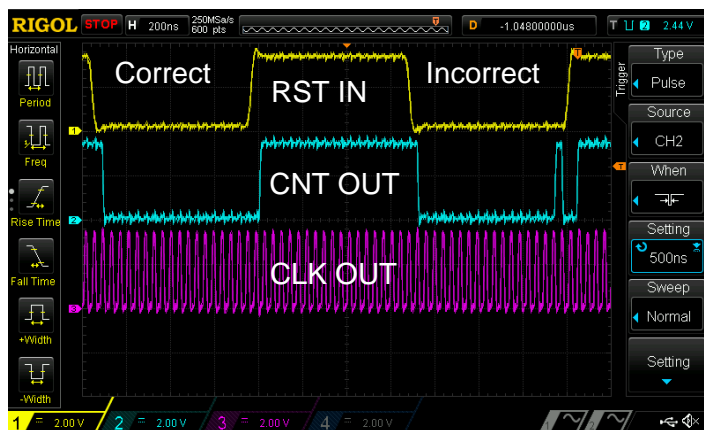
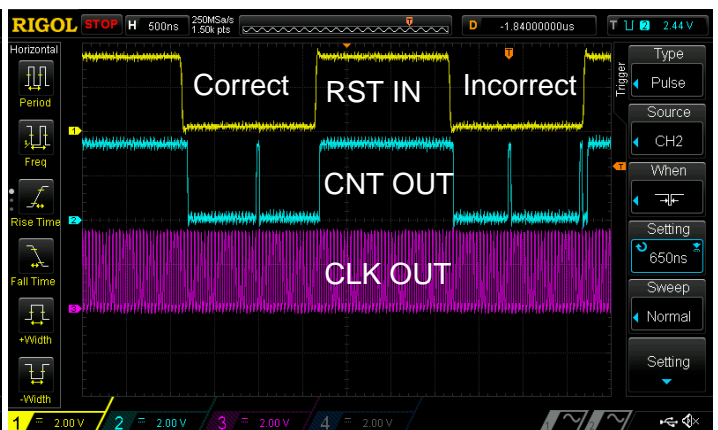
**ISSUE 7: Incorrect Counter Operation after the Reset**  
**Functional Block Affected: Counter**

If the Counter Reset occurs at a time very close to a rising edge of the clock signal during clock signal generation (for example OSC operation), there is a possibility that the Counter Data of the Counter is reset incorrectly and the counter end signal (HIGH pulse) may appear faster than expected. This phenomena appears more frequently the higher the clock frequency is.

- Synchronize RESET input of the Counter with its CLK using 2 DFF cells as shown in the image below.

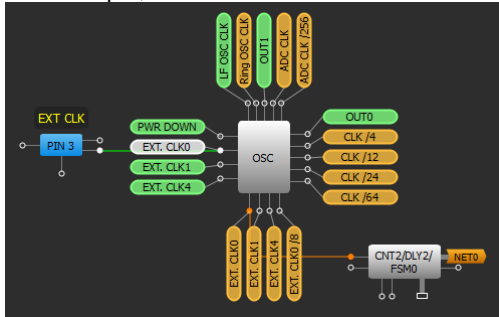
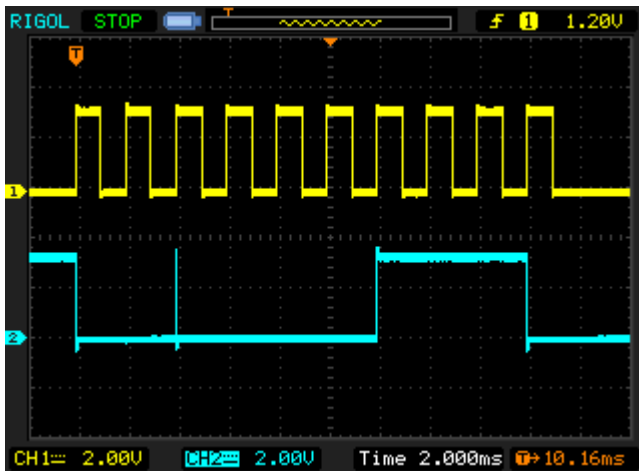
**ISSUE 8: DCMP OUT+ Output Glitch**  
**Functional Block Affected: DCMPs**

DCMP's OUT+ output may have a glitch when the input data is changed. This issue appears more frequently the higher DCMP clock is.

For example, DCMP IN+ sources from FSM0 and IN- from Register0. DCMP is clocked from the Ring OSC.

- Synchronize the data source clock with the DCMP clock source using 2 DFF cells as shown in the images below.
