## Errata Sheet

### SLG46620

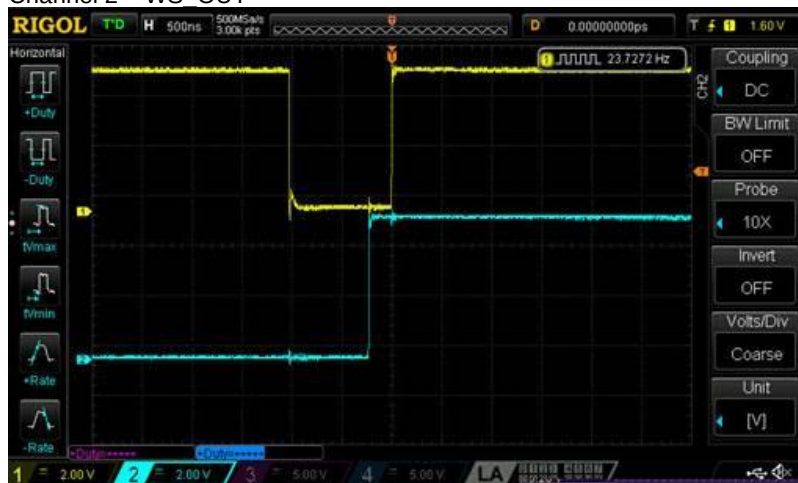
The output of the ACMP incorrectly goes low even when IN+ is greater than IN- if the RING OSC is active when the WS signal rises

Channel 1 – ACMP out

Channel 2 – WS OUT

- Avoid using the RING OSC with the WS Controller, or add a filtering block on the ACMP output to filter out the glitch.

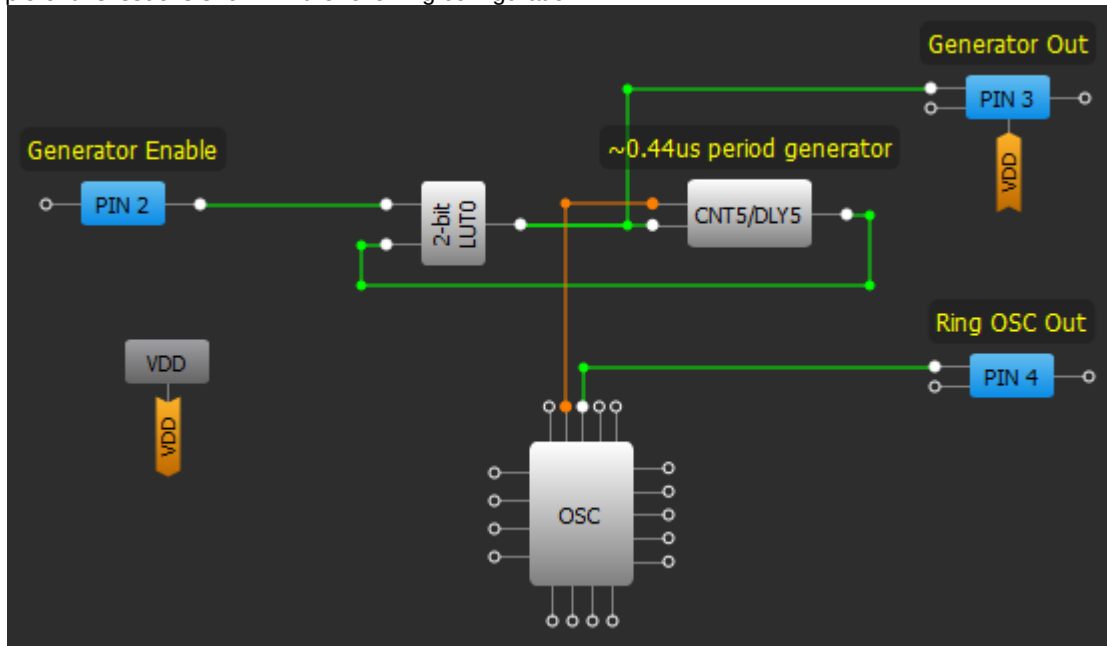
The Ring OSC has a longer settling time when configured as Auto Power On in the designs that have very short Ring OSC disable time. An example of this issue is shown in the following configuration:

The configuration shown above generates a periodical signal with a frequency defined by the Delay cell and started by a high signal on PIN2. The issue becomes apparent in a longer settling time when the scheme generates short pulses (Delay is configured as a rising edge delay only). See waveform below.

- Set Ring OSC power mode to “Force Power On”
- or, Set Turn on by register option in BG (Band Gap) block as “Enable”

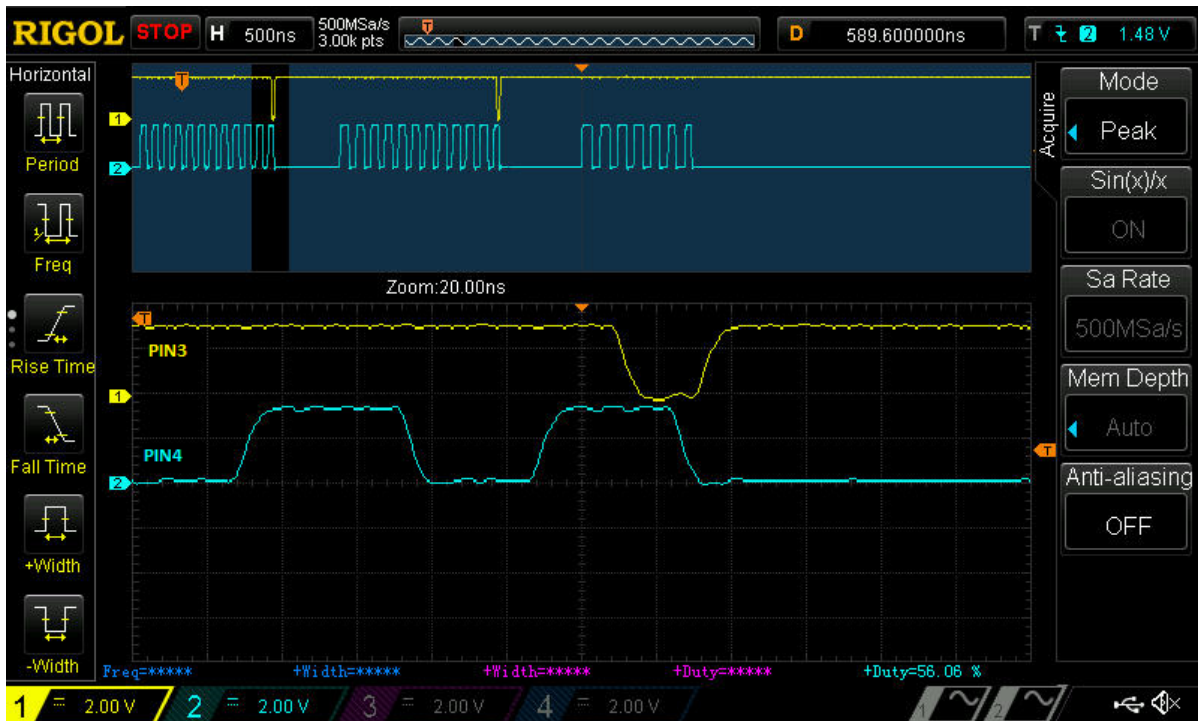
Channel 1 – 2-bit LUT0 output; Channel 2 – Ring OSC output

Such behavior will lead to substantial error in period calculations if the delay time is relatively small.

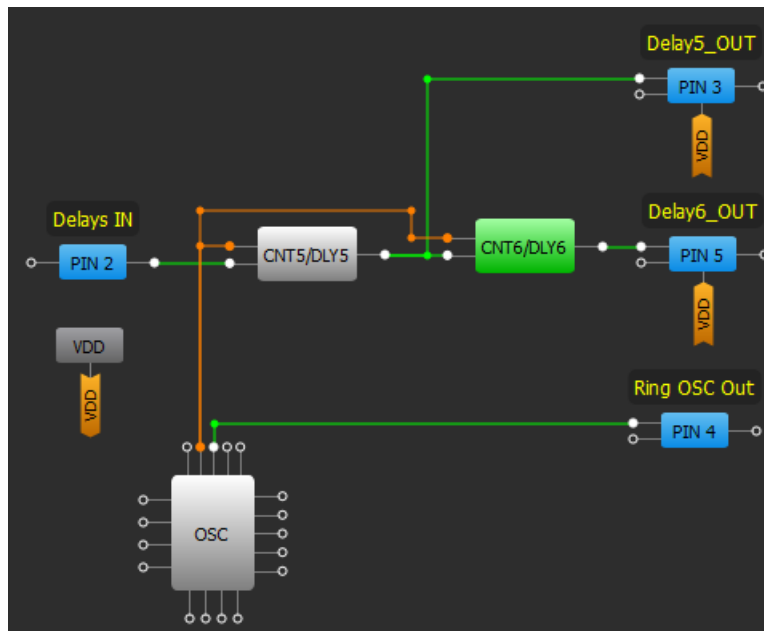
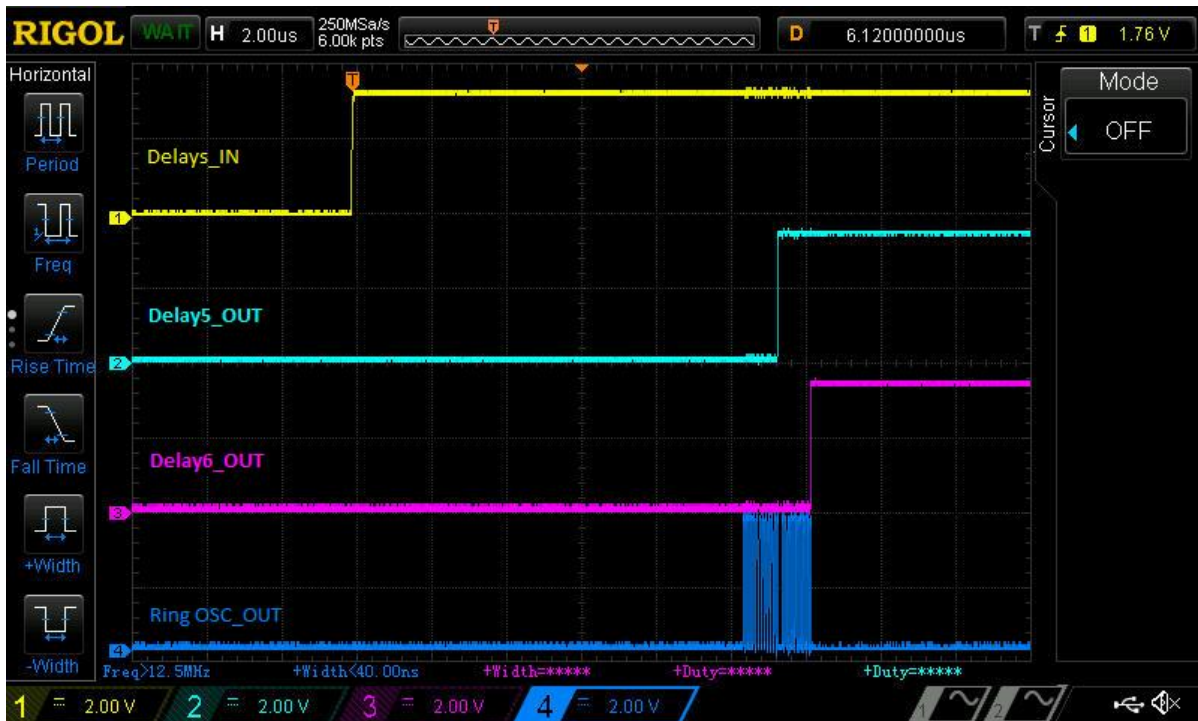
A similar situation can occur while using two connected delays (all edge detect types except for a pair “Rising edge DLY – Falling edge DLY”).

In the following example, Delay5 and Delay6 are configured in the same way. However, Delay5 time is 11.4us instead of expected 0.4us (Delay5 time).

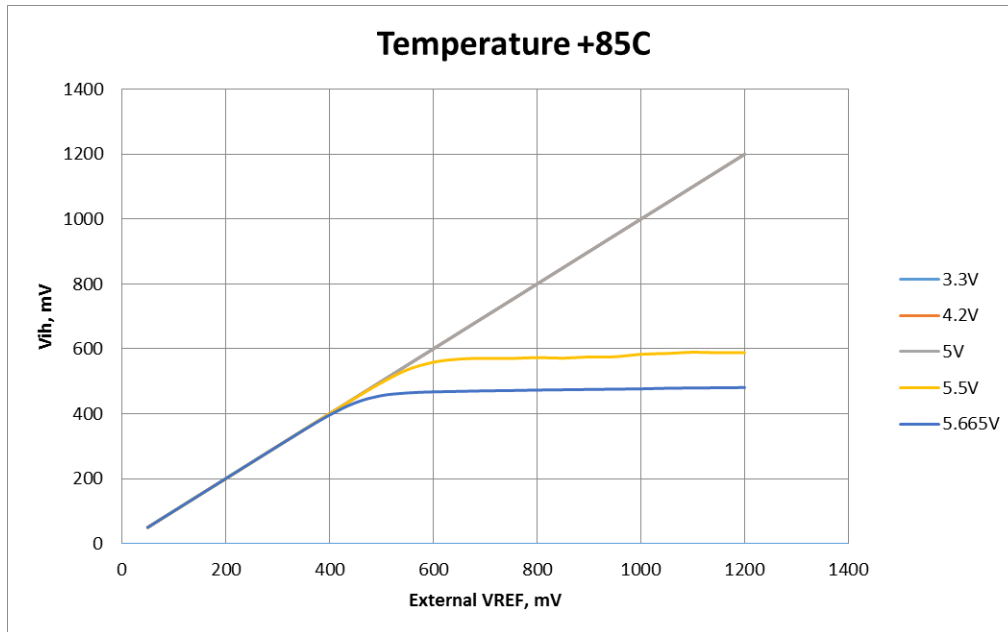
When using external Vref source, the ACMP comparison may happen at wrong threshold if the external Vref voltage is higher than a particular value (please see figure below) at high VDD values (> 5V) and high temperature.

- Avoid using ACMPs in such conditions.

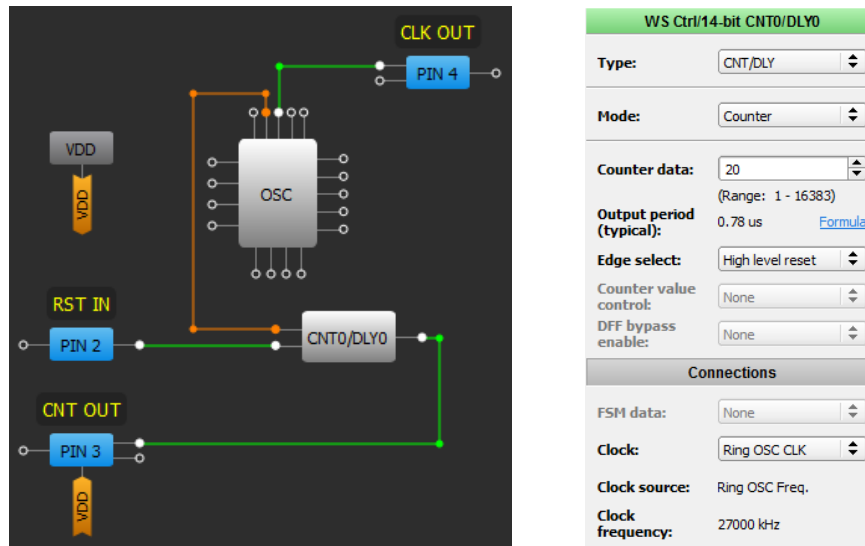
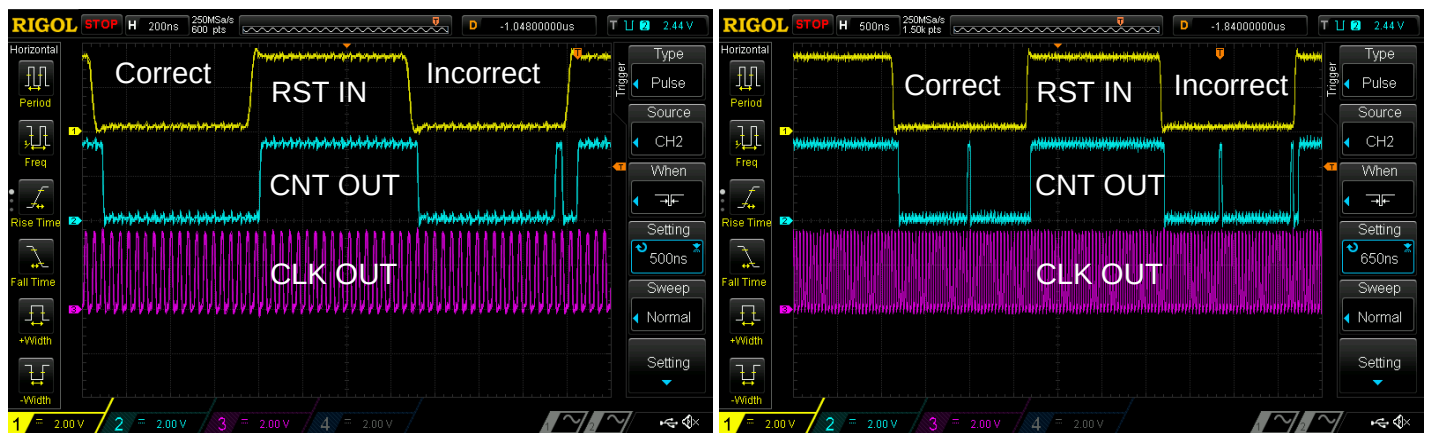
If the Counter Reset occurs at a time very close to a rising edge of the clock signal during clock signal generation (for example OSC operation), there is a possibility that the Counter Data of the Counter is reset incorrectly and the counter end signal (HIGH pulse) may appear faster than expected. This phenomena appears more frequently the higher the clock frequency is.

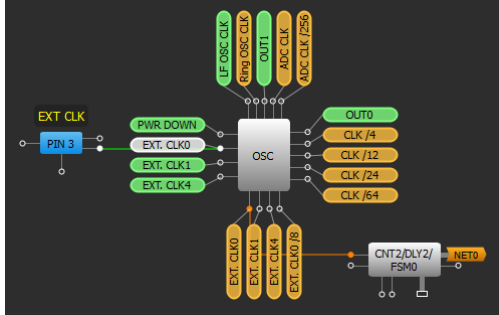
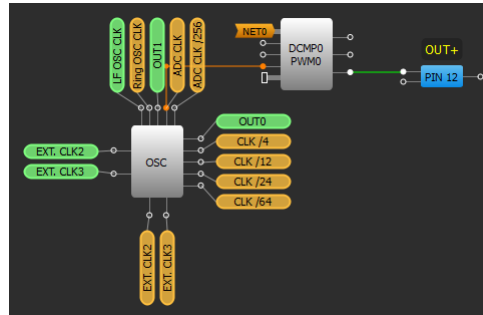
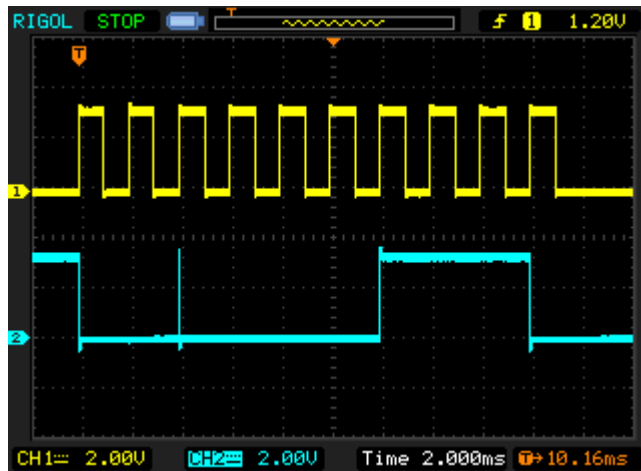
DCMP's OUT+ output may have a glitch when the input data is changed. This issue appears more frequently the higher DCMP clock is.

For example, DCMP IN+ sources from FSM0 and IN- from Register0. DCMP is clocked from the Ring OSC.

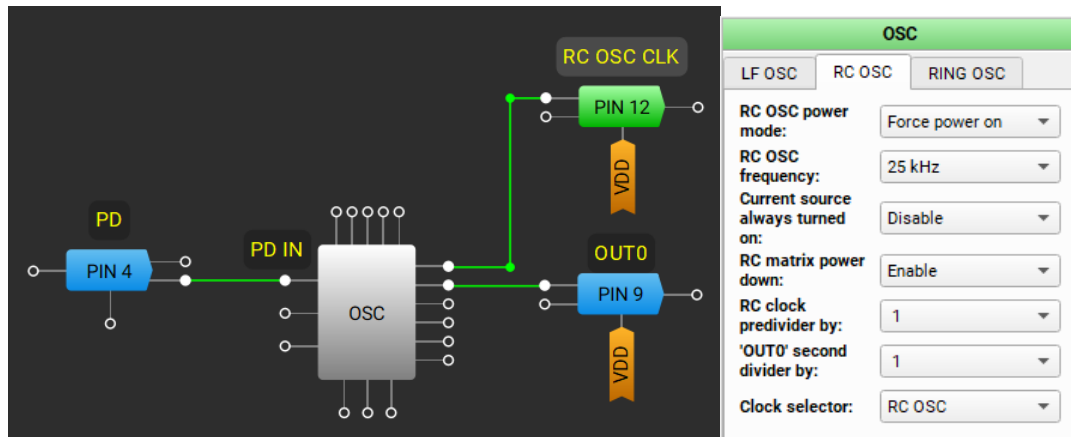
If a pulse with a duration of less than ~40 ns is applied to the PWR DOWN input of an oscillator, the oscillator outputs remain stuck for milliseconds.

The issue is observed for all available oscillators.

Avoid applying glitches to the PWR DOWN input of an OSC.
