## SLG46620-EV Errata Note

This document contains the known errata for SLG46620-EV and the recommended workarounds.

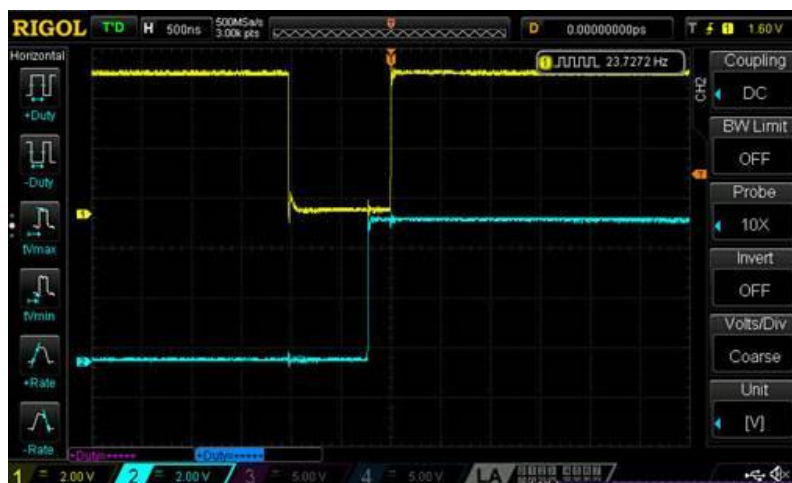
The output of the ACMP incorrectly goes low even when IN+ is greater than IN- if the RING OSC is active when the WS signal rises.

Channel 1 – ACMP out

Channel 2 – WS\_OUT

Avoid using the RING OSC with the WS Controller, or add a filtering block on the ACMP output to filter out the glitch.

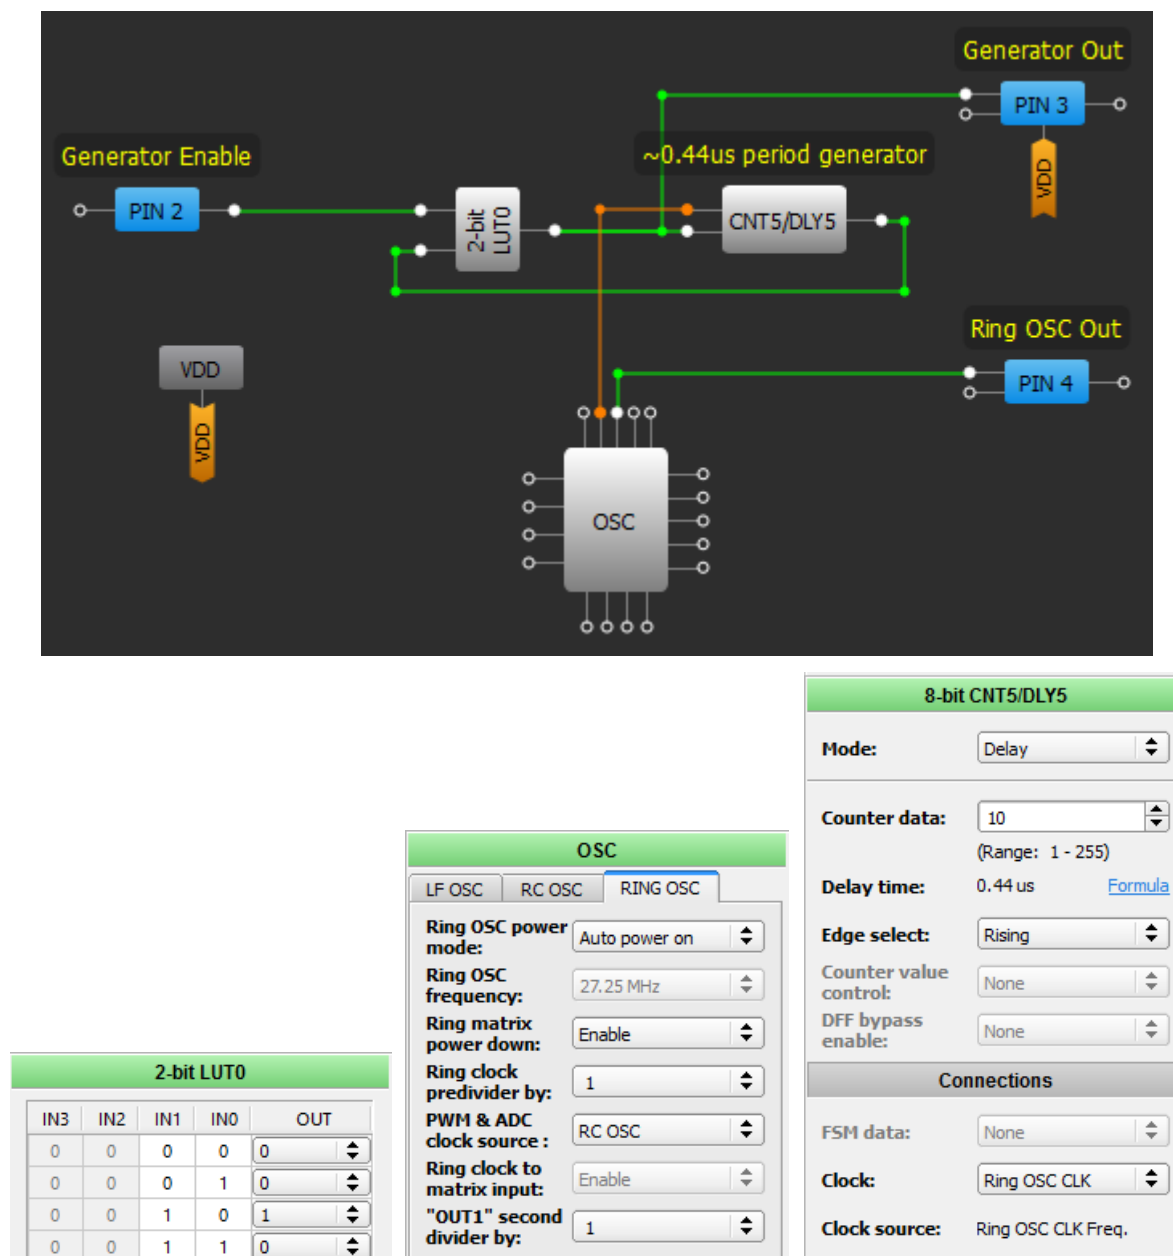
The Ring OSC has a longer settling time when configured as Auto Power On in the designs that have very short Ring OSC disable time. An example of this issue is shown in the following configuration:

The configuration shown above generates a periodical signal with a frequency defined by the Delay cell and started by a high signal on PIN2. The issue becomes apparent in a longer settling time when the scheme generates short pulses (Delay is configured as a rising edge delay only). See waveform below.

- Set Ring OSC power mode to “Force Power On”
- or, Set Turn on by register option in BG (Band Gap) block as “Enable”

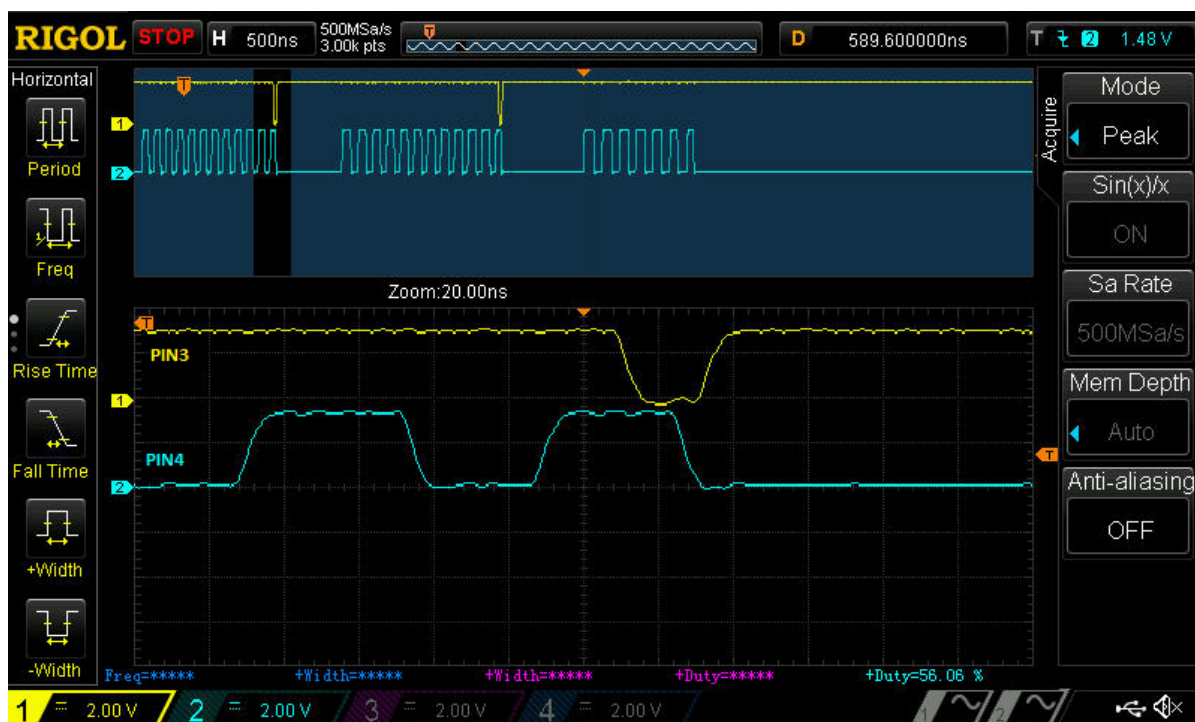
Channel 1 – 2-bit LUT0 output; Channel 2 – Ring OSC output

Such behavior will lead to substantial error in period calculations if the delay time is relatively small.

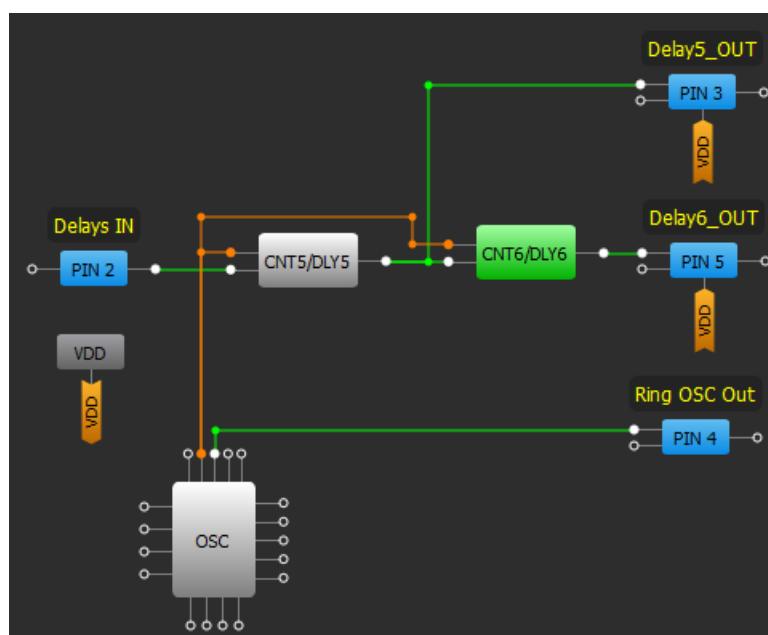
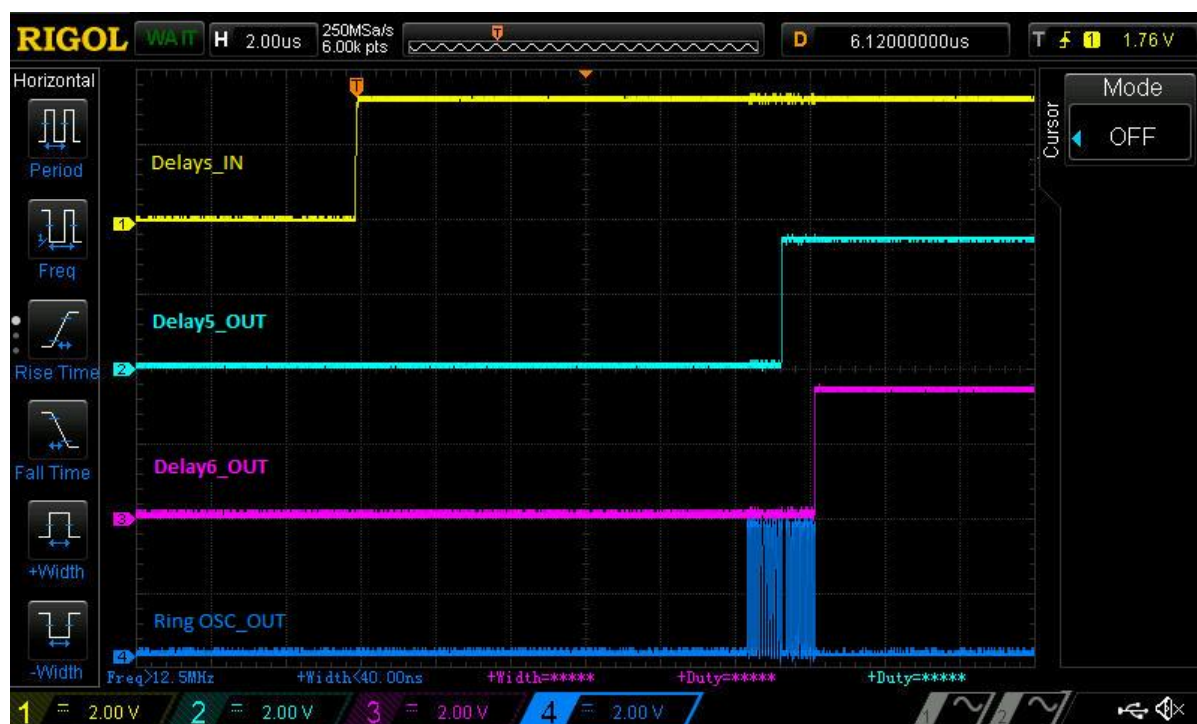
A similar situation can occur while using two connected delays (all edge detect types except for a pair “Rising edge DLY – Falling edge DLY”).

In the following example, Delay5 and Delay6 are configured in the same way. However, Delay5 time is 11.4us instead of expected 0.4us (Delay5 time).

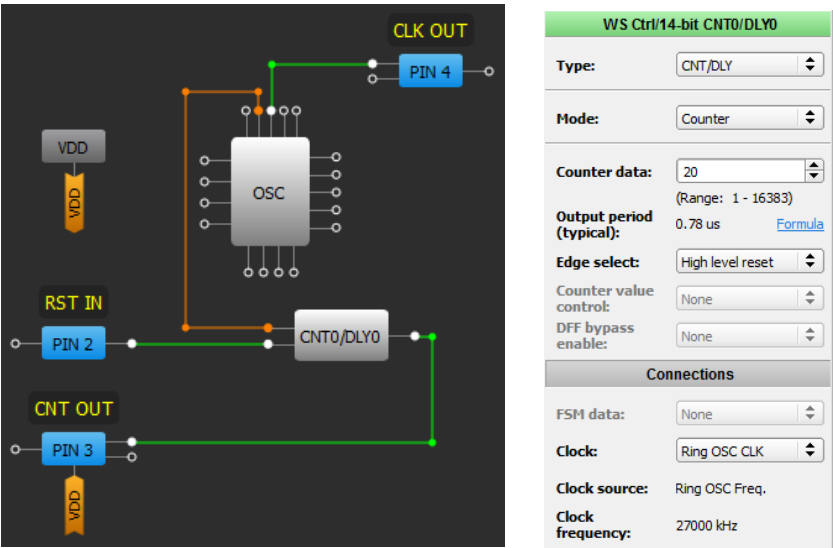
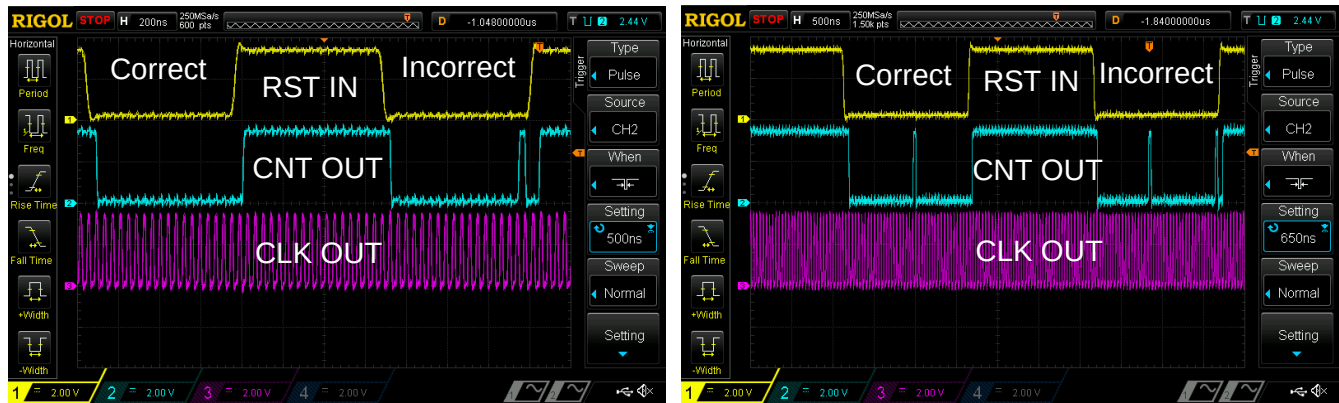
If the Counter Reset occurs at a time very close to a rising edge of the clock signal during clock signal generation (for example OSC operation), there is a possibility that the Counter Data of the Counter is reset incorrectly and the counter end signal (HIGH pulse) may appear faster than expected. This phenomena appears more frequently the higher the clock frequency is.

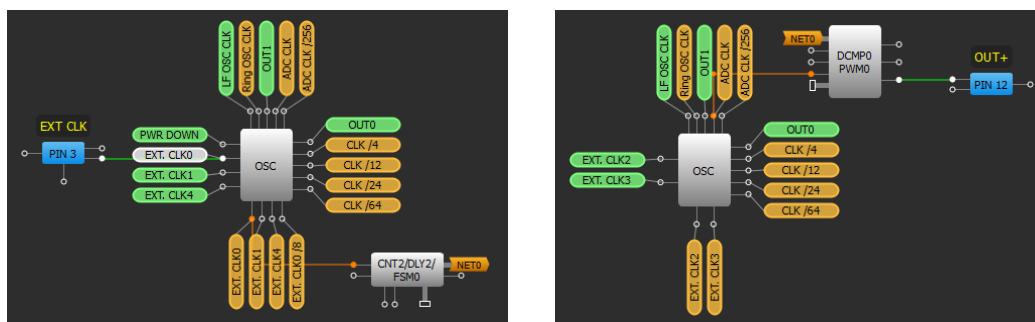
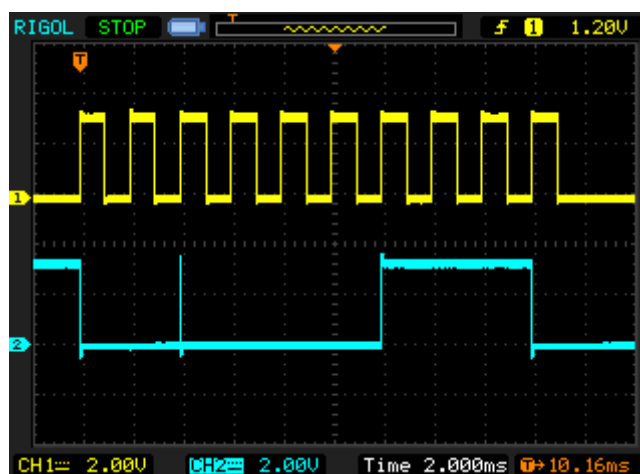
DCMP's OUT+ output may have a glitch when the input data is changed. This issue appears more frequently the higher DCMP clock is.

For example, DCMP IN+ sources from FSM0 and IN- from Register0. DCMP is clocked from the Ring OSC.

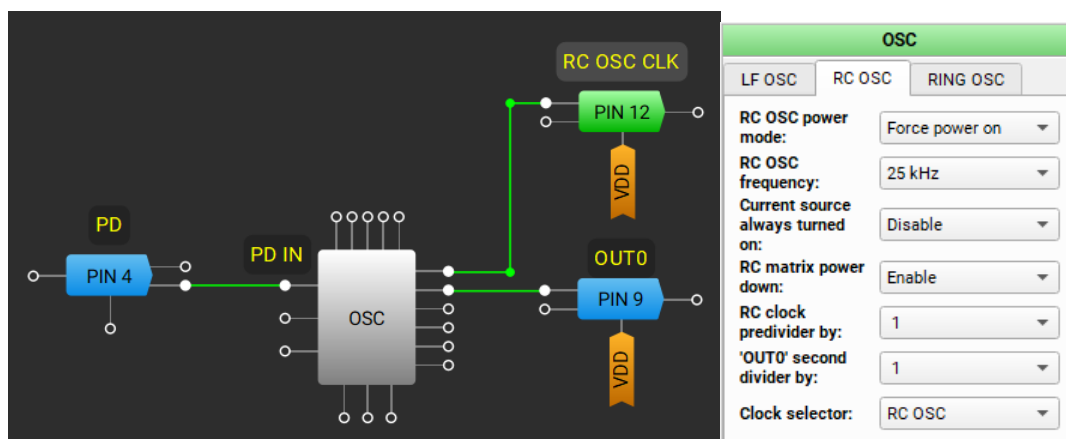
When a short pulse is applied to the PWR DOWN input, the oscillator exhibits a long start-up time.

When a short pulse of less than ~40 ns is applied to the PWR DOWN input.

Avoid applying glitches to the PWR DOWN input of an OSC.

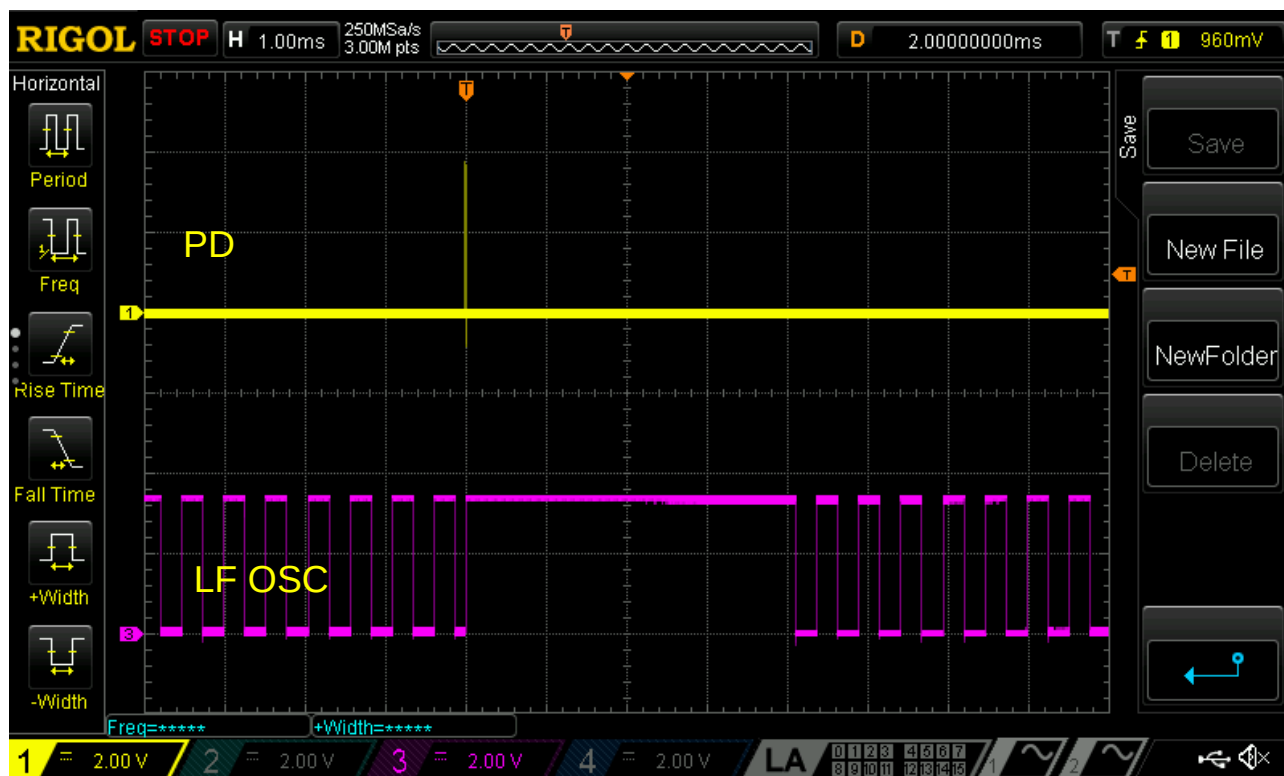
1.9 kHz OSC long start-up

If a pulse with a duration of less than ~40 ns is applied to the PWR DOWN input of the oscillator, the oscillator outputs remain stuck for milliseconds, as shown in Figure 16 and Figure 17. The issue is observed for all available oscillators.
