SLG46620-A

ISSUE 1: ACMP IN- Leakage Current when Powered Down Functional Block Affected: ACMPs

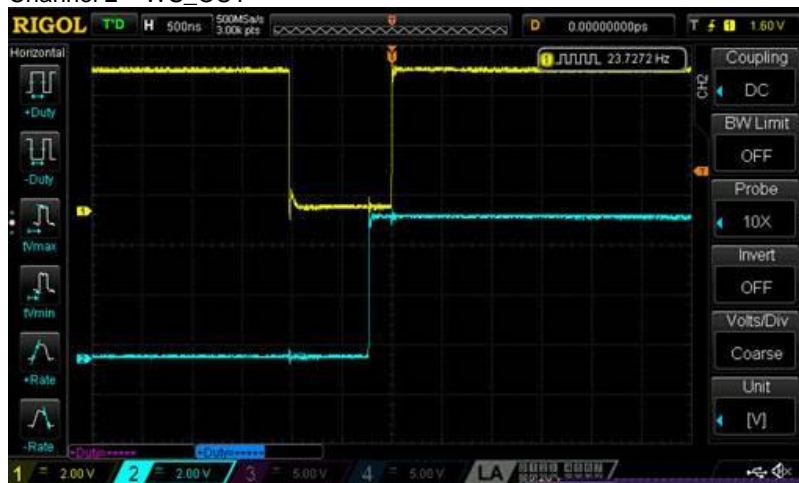
The output of the ACMP incorrectly goes low even when IN+ is greater than IN- if the RING OSC is active when the WS signal rises

Channel 1 – ACMP out
Channel 2 – WS_OUT

- Avoid using the RING OSC with the WS Controller, or add a filtering block on the ACMP output to filter out the glitch.

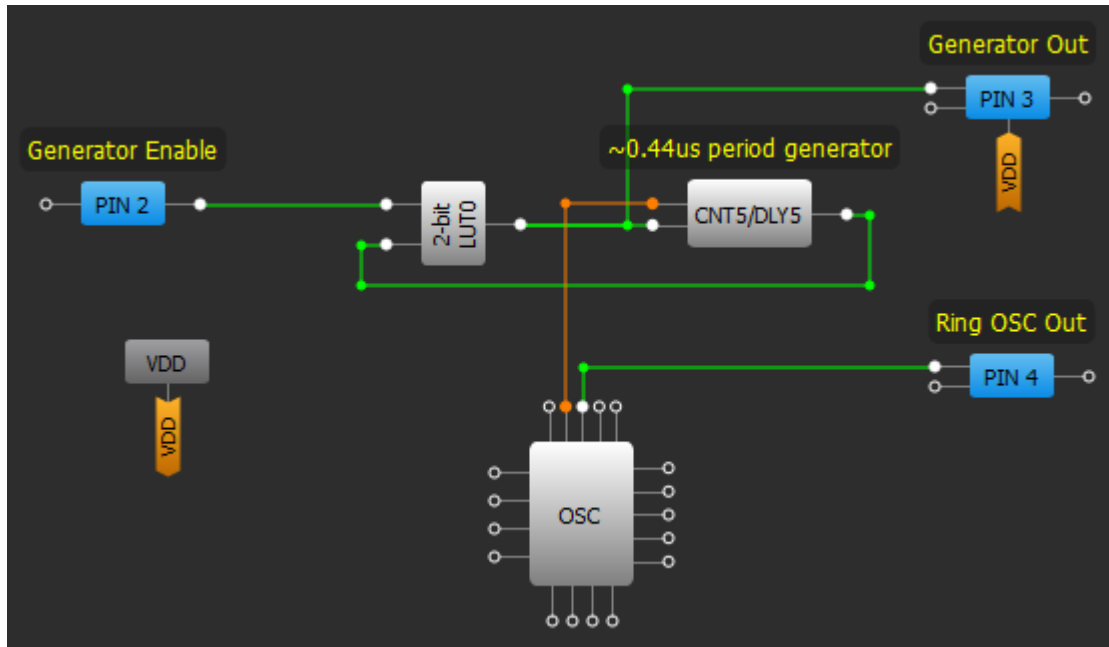
The Ring OSC has a longer settling time when configured as Auto Power On in the designs that have very short Ring OSC disable time. An example of this issue is shown in the following configuration:

The configuration shown above generates a periodical signal with a frequency defined by the Delay cell and started by a high signal on PIN2. The issue becomes apparent in a longer settling time when the scheme generates short pulses (Delay is configured as a rising edge delay only). See waveform below.

- Set Ring OSC power mode to “Force Power On”
- or, Set Turn on by register option in BG (Band Gap) block as “Enable”

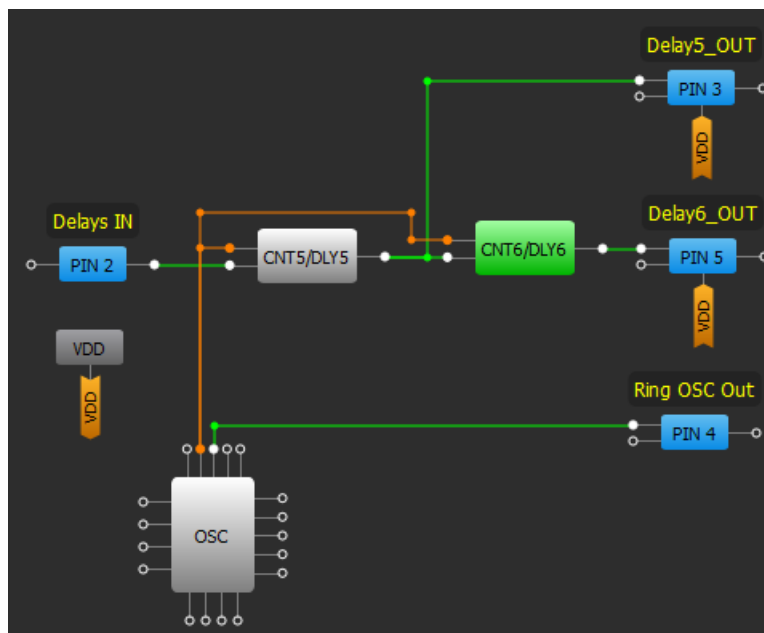
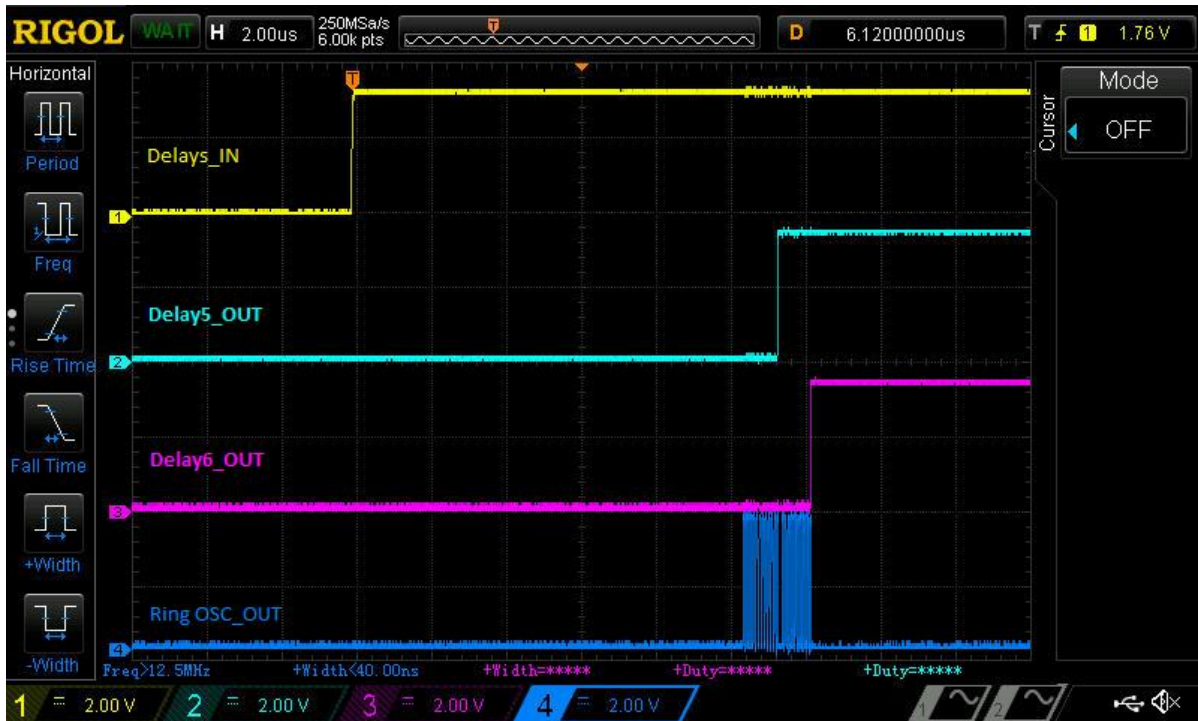
A similar situation can occur while using two connected delays (all edge detect types except for a pair “Rising edge DLY – Falling edge DLY”).

In the following example, Delay5 and Delay6 are configured in the same way. However, Delay5 time is 11.4us instead of expected 0.4us (Delay5 time).

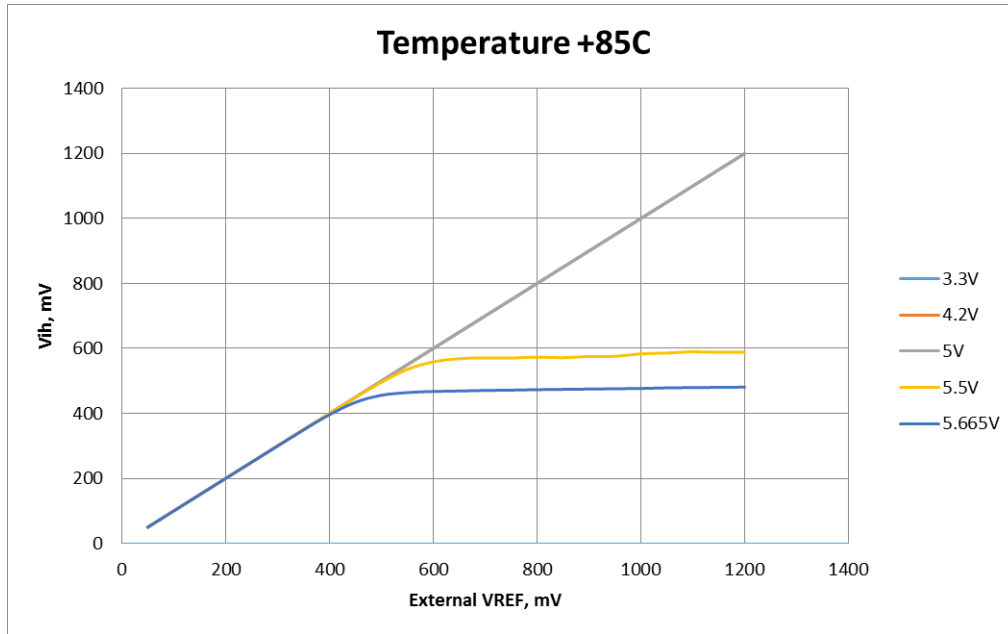
When using external Vref source, the ACMP comparison may happen at wrong threshold if the external Vref voltage is higher than a particular value (please see figure below) at high VDD values (> 5V) and high temperature.

- Avoid using ACMPs in such conditions.

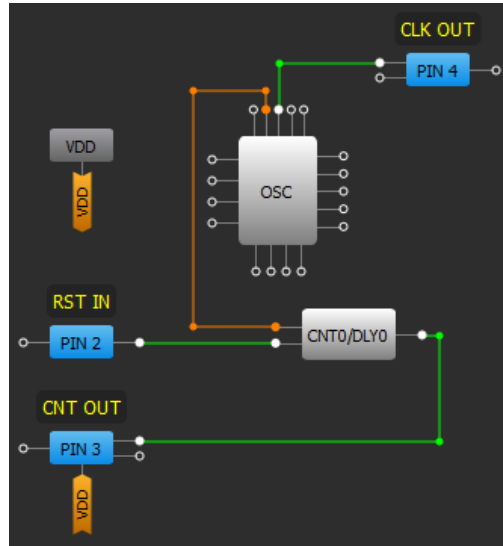
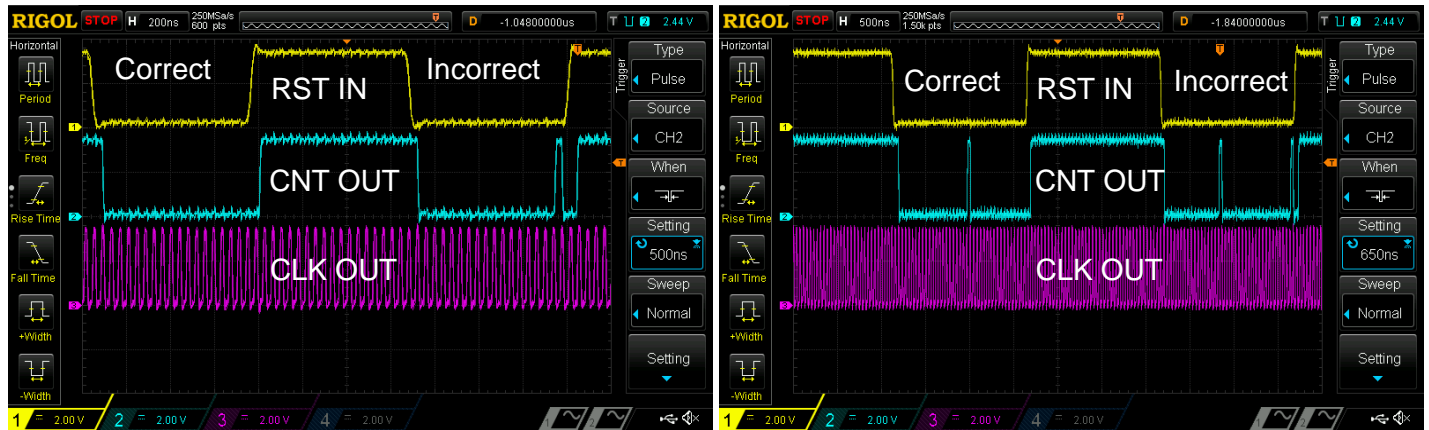
If the Counter Reset occurs at a time very close to a rising edge of the clock signal during clock signal generation (for example OSC operation), there is a possibility that the Counter Data of the Counter is reset incorrectly and the counter end signal (HIGH pulse) may appear faster than expected. This phenomena appears more frequently the higher the clock frequency is.

- Synchronize RESET input of the Counter with its CLK using 2 DFF cells as shown in the image below.

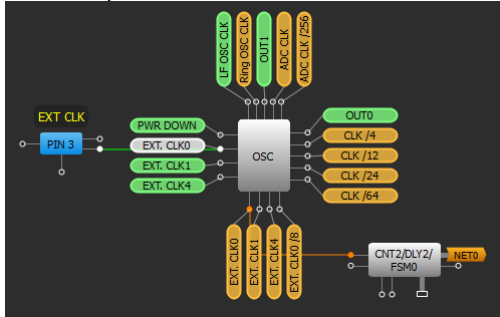
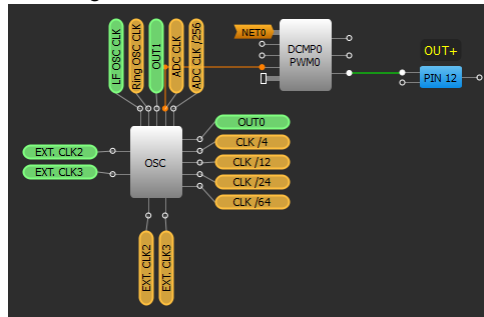
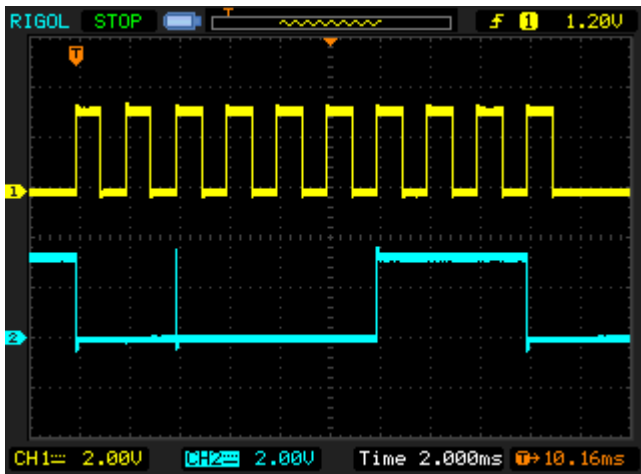
DCMP's OUT+ output may have a glitch when the input data is changed. This issue appears more frequently the higher DCMP clock is.

For example, DCMP IN+ sources from FSM0 and IN- from Register0. DCMP is clocked from the Ring OSC.
