SLG47525/28 Errata Note

This document contains the known errata for SLG47525/28 and the recommended workarounds.

Package(s)	14-pin STQFN (SLG47525): 2.0 mm x 2.2 mm x 0.55 mm, 0.4 mm pitch
	20-pin STQFN (SLG47528): 2.0 mm x 3.0 mm x 0.55 mm, 0.4 mm pitch

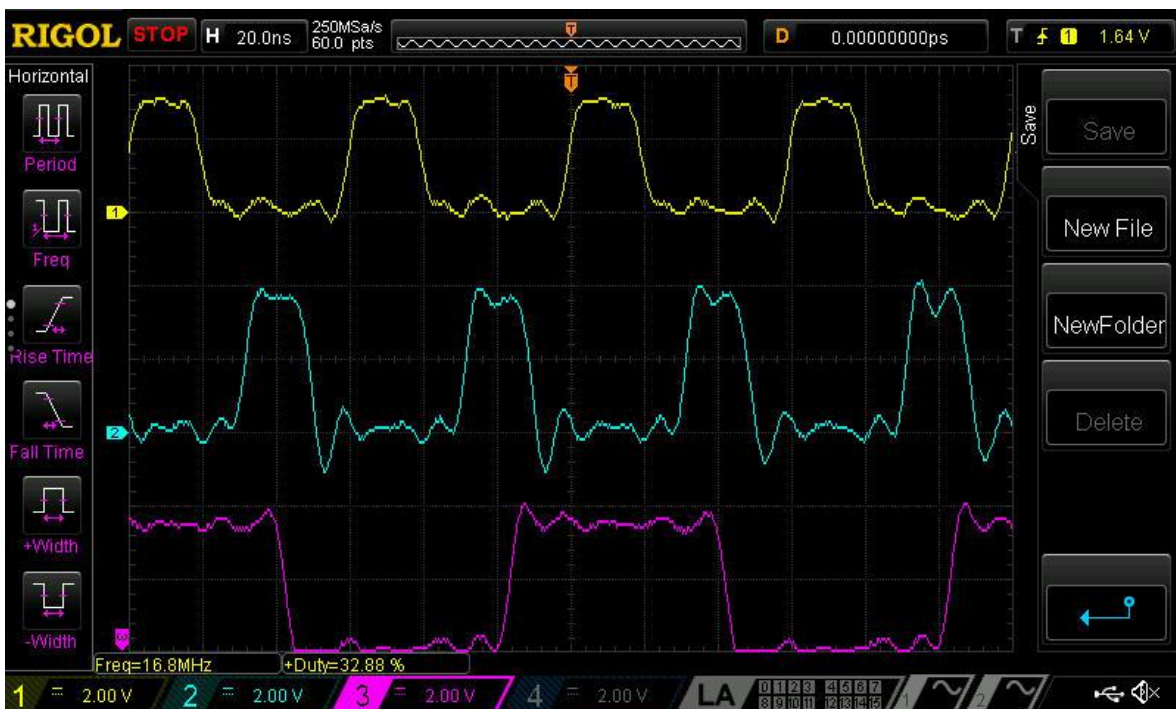
Figure 6

2. Period is 60 ns. Pulse width is 20 ns, DC = 33.3 % (incorrect functionality).

Currently there is no workaround for this issue. Filter block is good at filtering short spontaneous glitches. It is intended to be used in series connection before the delay cell to avoid its latching.
