# **IE-703288-G1-EM1<sup>TM</sup>**

## **In-Circuit-Emulator**

## **Operating Precautions**

Document No. TPS-HE-B-2844

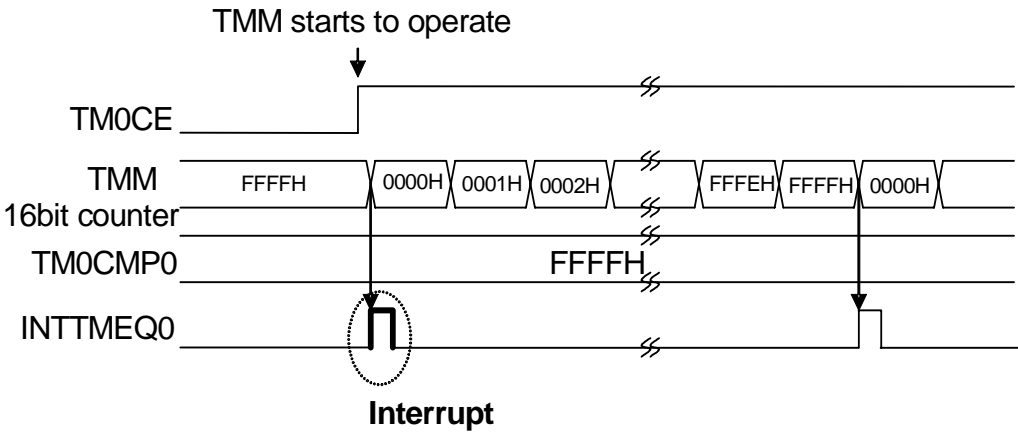
No. 7	Timer M compare interrupt (Specification change notice)
<p><u>Details</u></p> <p>An unexpected interrupt occurs after activation of timer M when the compare register TM0CMP0 contains the value 0xFFFF.</p>

<p><u>Workaround</u></p> <p>Do not set TM0CMP0 to 0xFFFF.</p>

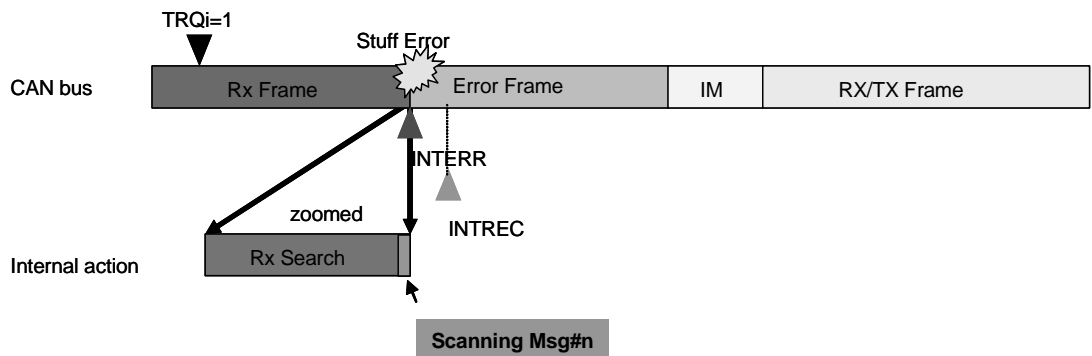
Figure 1: Behavior at pending TRQ

When the host processor has already submitted a transmit request (TRQ) for at least one buffer, the unexpected reception of the message will take place into the message buffer found by internal RX-search. This is the correct location to store the message i.e. the acceptance filter criteria are correctly fulfilled. However the data part will be updated with the contents of the shift register of the CAN protocol core. As this register is immediately stopped at detection of the bus error, the data provided to the message buffer can not be interpreted by the host processor.

As during a regular reception, the RX-interrupt (if enabled) is generated and the application processes the message object.

No. 17	aFCAN: Rx limitation (Technical limitation)
	<p><u>Workaround</u></p> <p>NEC will update the affected products. NEC does not recommend a S/W workaround as first choice as it is fairly complex. On the one hand it is based on the control of submitting transmission requests only when the bus is idle. On the other hand a less complex algorithm can be used which does not prevent the unexpected reception but detects it safely and discards the unexpected reception in the CAN S/W driver. Any of these algorithms require that message buffer #0 is not used or that a 'dummy' TRQ in an unused buffer is set. This prevents behaviors as described in 2.</p>
No. 18	RESF register after WDTM2 reset (Technical limitation)
	<p><u>Details</u></p> <p>The WDT2RF bit of the RESF register is not set to 1 when a reset by the watchdog timer occurs.</p> <p><u>Workaround</u></p> <p>There is no workaround.</p>
No. 19	Operating frequency (Direction of use)

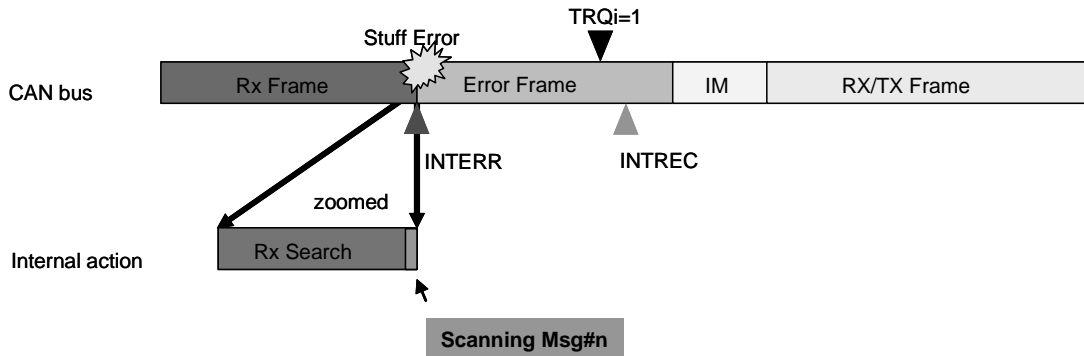
Figure 2: Behavior without pending TRQ

In case the host processor has not submitted a transmit request (TRQ) for any buffer before the detection of the bus error but submits TRQ = 1 after that point in time (see figure below) before the re-transmission of the message interrupted by the stuff bit error started, the unexpected reception of the message will take place.

The unexpected storage of the message is issued in the particular message buffer that matches the acceptance filter criteria at the time where the bus error is detected (as described in 1.) or the message buffer #0 is overwritten independently of its configuration.
