QB-V850ESSX2

In-Circuit-Emulator

Operating Precautions

Global Document No. U18080EE7V0IF00 (7th edition)

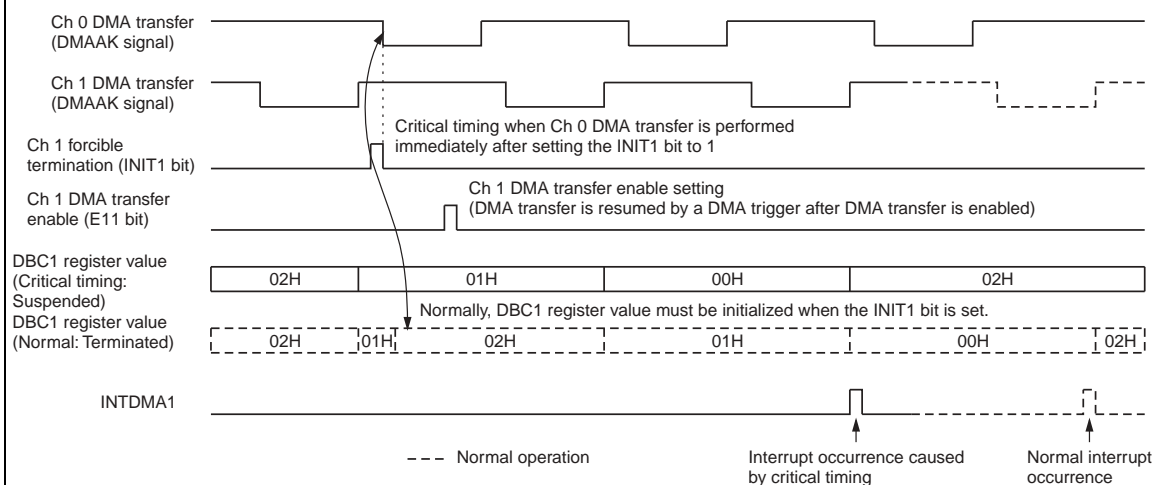
No. 12	DMA transfer forcible termination (Technical limitation)
--------	---

When terminating a DMA transfer by setting the corresponding INITn bit of the DCHCn register, the transfer may not be terminated, but just suspended, even though the INITn bit is set (1). As a result, when the DMA transfer of a channel that should have been terminated is resumed, the DMA transfer will terminate after an unexpected number of transfers are completed and a DMA transfer completion interrupt may occur. In addition, a DMA transfer of a channel n for which the INITn bit is set after forcible termination may be performed once again with the initialized value (n= 0 to 3).

The critical situation occurs if a DMA transfer is executed immediately after a forcible termination is set (by setting the INITn bit), refer to figure below.

Operation example: Both DMA channels, ch 0 and ch 1, are in single transfer mode, and ch 1 DMA transfer count is 3 (DBC1 register value = 02H).

The "initialization" in the figure above means that the contents of the master register are reflected in the slave register.

No. 12	DMA transfer forcible termination (Technical limitation)
<p>(cont.) <u>Workaround</u></p> <p>The critical situation can be avoided by implementing any of the following procedures.</p> <p><1> Stop all transfers from DMA channels temporarily. The following measure is effective if the program does not assume that the TCn bit of the DCHCn register is 1 except for the following workaround processing. (Since the TCn bit of the DCHCn register is cleared (0) when it is read, execution of the following procedure b) under <5> clears this bit.)</p> <p>Procedure to avoid the critical timing:</p> <ul style="list-style-type: none"> <1> Disable interrupts (DI state) <2> Read the DMA restart register (DRST) and transfer the ENn bit of each channel to a general purpose register (<u>value A</u>). <3> Write 00H to the DMA restart register (DRST) twice^{Note}. By executing twice^{Note}, the DMA transfer is definitely stopped before proceeding to <4>. <4> Set (1) the INITn bit of the DCHCn register of the channel that should be terminated forcibly. <5> Perform the following operations for value A read in (2) to obtain <u>value B</u>. <ul style="list-style-type: none"> a) Clear (0) the bit of the channel that is not terminated forcibly. b) If the TCn and ENn bits of the channel that is not terminated forcibly are 1, clear (0) the bit of the channel. <6> Write value B in <5> to the DRST register. <7> Enable interrupts (EI state) <p>Note: Execute three times if the transfer target (transfer source or transfer destination) is the internal RAM.</p> <p>Remarks: 1. Be sure to execute <5> to prevent the ENn bit from being set illegally for channels that are terminated normally during the period of <2> and <3></p> <p style="padding-left: 40px;">2. n = 0 to 3</p> <p><2> Repeat setting the INITn bit until the forcible DMA transfer termination is correctly performed (n = 0 to 3)</p> <p>Procedure to avoid the critical timing:</p> <ul style="list-style-type: none"> <1> Copy the initial transfer count of the channel that should be terminated forcibly to a general-purpose register. <2> Set (1) the INITn bit of the DCHCn register of the channel that should be terminated forcibly. <3> Read the value of the DMA transfer count register (DBCn) of the channel that should be terminated forcibly and compare the value with the one copied in <1>. If the value do not match, repeat <2> and <3>. <p>Remarks: 1. When the DBCn register is read in procedure <3>, the remaining transfer count will be read if the DMA is stopped due to this bug. If the forcible DMA termination is performed correctly, the initial transfer count will be read.</p> <p style="padding-left: 40px;">2. Note that it may take some time for forcible termination to take effect if this workaround is implemented in an application in which DMA transfer other than for channels subject to forcible termination are frequently performed.</p>

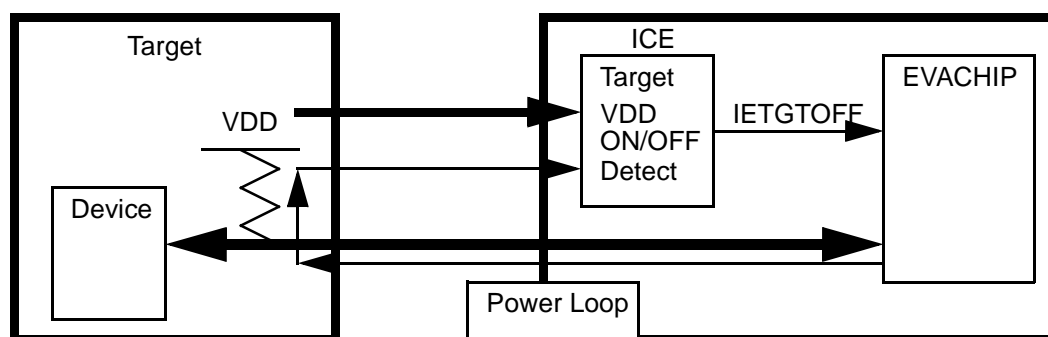
No. 15	Pin control with target power OFF (Direction for use)
--------	--

When power to the emulator is ON and that to the target is OFF, leakage current may flow from the emulator to the target.

Some external bus signals, however, drive a high level, and a current may leak into Vdd of the target via the pull-up resistor of the target.

The target supply voltage detector circuit of the emulator detects this VDD, and the emulator assumes that power is applied to the target. Consequently, reset is cleared and the external bus signals are driven. As a result, a leakage current flows.

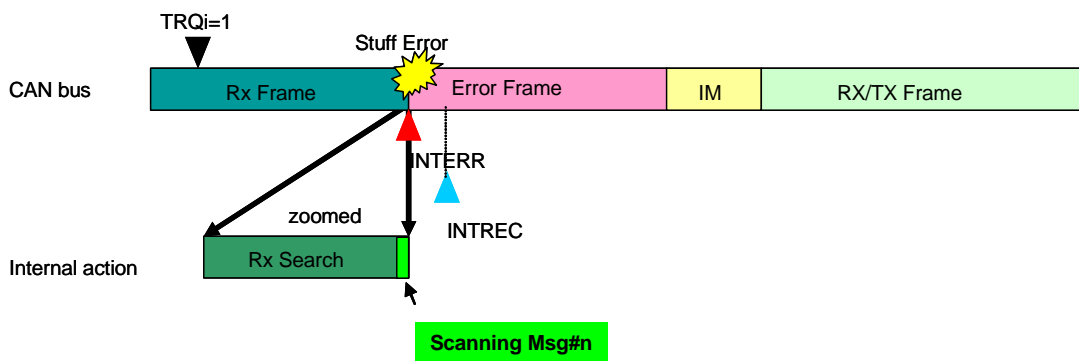
Figure 1: Behavior at pending TRQ

1. Behaviour at pending TRQ (TRQi = 1)

When the host processor has already submitted a transmit request (TRQ) for at least one buffer, the unexpected reception of the message will take place into the message buffer found by internal RX-search. This is the correct location to store the message i.e. the acceptance filter criteria are correctly fulfilled. However the data part will be updated with the contents of the shift register of the CAN protocol core. As this register is immediately stopped at detection of the bus error, the data provided to the message buffer can not be interpreted by the host processor.

As during a regular reception, the RX-interrupt (if enabled) is generated and the application processes the message object.

No. 38	aFCAN: Rx limitation (Technical limitation)
<p>(cont.)</p> <p><u>Workaround</u></p> <p>NEC will update the affected products. NEC does not recommend a S/W workaround as first choice as it is fairly complex. On the one hand it is based on the control of submitting transmission requests only when the bus is idle. On the other hand a less complex algorithm can be used which does not prevent the unexpected reception but detects it safely and discards the unexpected reception in the CAN S/W driver. Any of these algorithms require that message buffer #0 is not used or that a 'dummy' TRQ in an unused buffer is set. This prevents behaviors as described in 2.</p>

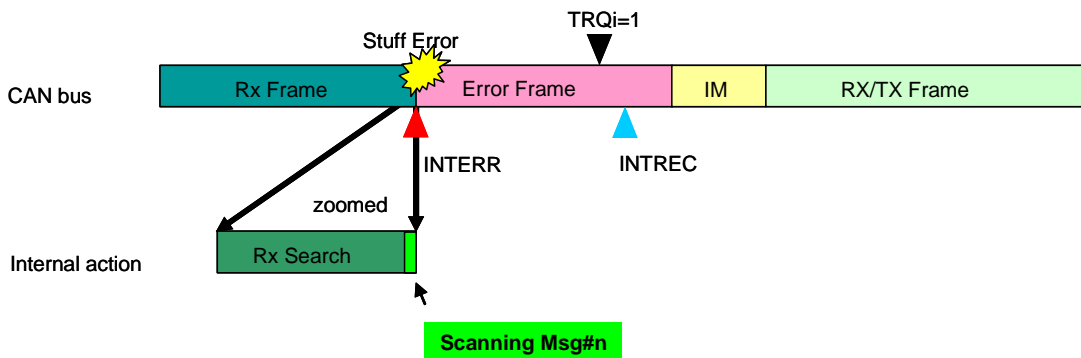
Figure 2: Behavior without pending TRQ

2. Behavior without pending TRQ (TRQi = 0)

In case the host processor has not submitted a transmit request (TRQ) for any buffer before the detection of the bus error but submits TRQ = 1 after that point in time (see figure below) before the re-transmission of the message interrupted by the stuff bit error started, the unexpected reception of the message will take place.

The unexpected storage of the message is issued in the particular message buffer that matches the acceptance filter criteria at the time where the bus error is detected (as described in 1.) or the message buffer #0 is overwritten independently of its configuration.
