# Microcomputer Technical Information

32-Bit Microcontroller V850E/MA2  Usage Restrictions	Document No.	SBG-DT-04-0056	1/3
	Date issued	February 9, 2004	
	Issued by	Microcomputer Group 2nd Solutions Division Solutions Operations Unit NEC Electronics Corporation	
Related documents V850E/MA2 Hardware User's Manual: U14980E V850E1 Architecture User's Manual: U14559E	Notification classification	<input checked="" type="checkbox"/>	Usage restriction
		<input type="checkbox"/>	Upgrade
		<input type="checkbox"/>	Document modification
		<input type="checkbox"/>	Other notification

V850E/MA2  
 $\mu$ PD703108

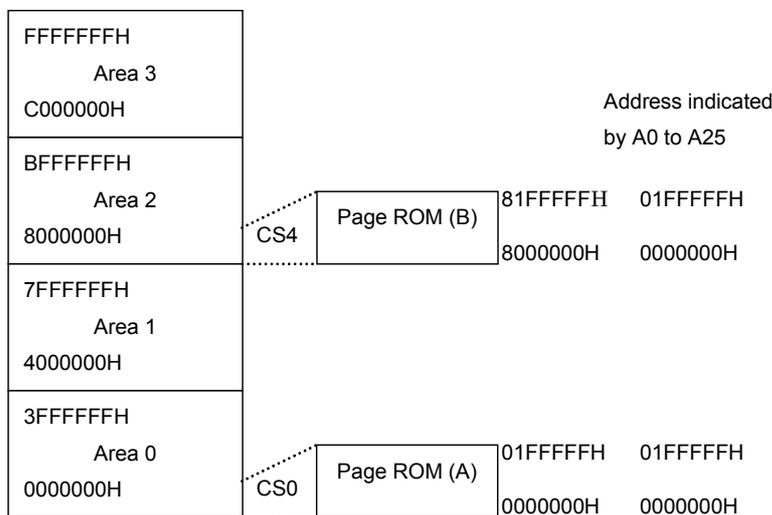
Example of configuration in which this bug can occur

When a CPU data space is used in a system in which multiple page ROMs are connected to multiple CS areas, when a page ROM access and page ROM access to another CS area occur in succession, if the address value of the former address and that of the latter are within the same page length of

the page ROM, it is judged that the same page ROM was accessed, even though the page ROMs with different CS areas were accessed. As a result, an on-page cycle will be issued for the latter access, but because the data access time for the latter access is insufficient, data cannot be read correctly.

When accessing address 0xxxx0H in the CS0 area is followed by accessing address 8xxxx2H in the CS4 area, an on-page cycle will be issued for address 8xxxx2H.

When multiple page ROMs are used, allocate addresses 25 to 0 so that they do not overlap in each page ROM.

For example, when allocating two 2 MB page ROMs to different CS areas, allocate one page ROM within addresses 0000000H to 01FFFFFFH, and the other within addresses F800000H to F9FFFFFFH.

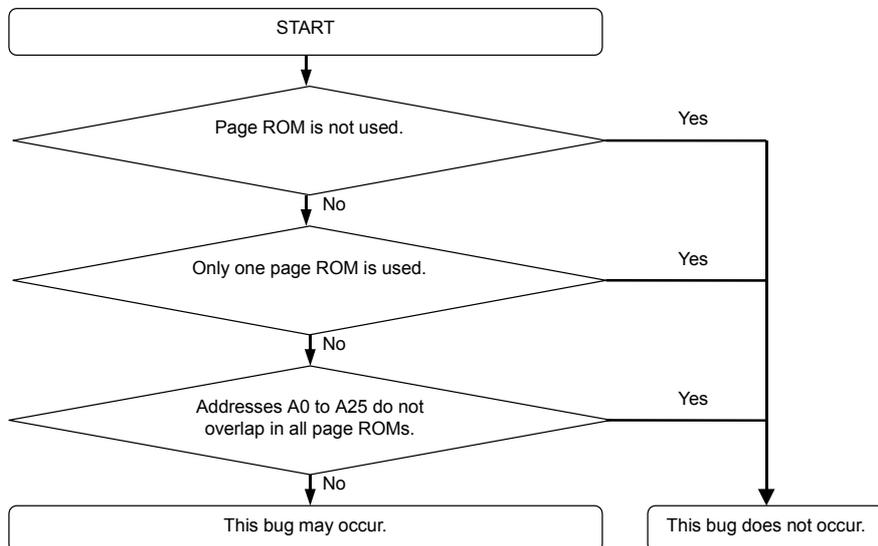
### Bug check procedure

The following flowchart can be used to check whether this bug occurs or not. Confirm if this bug applies your company's product using this flowchart.

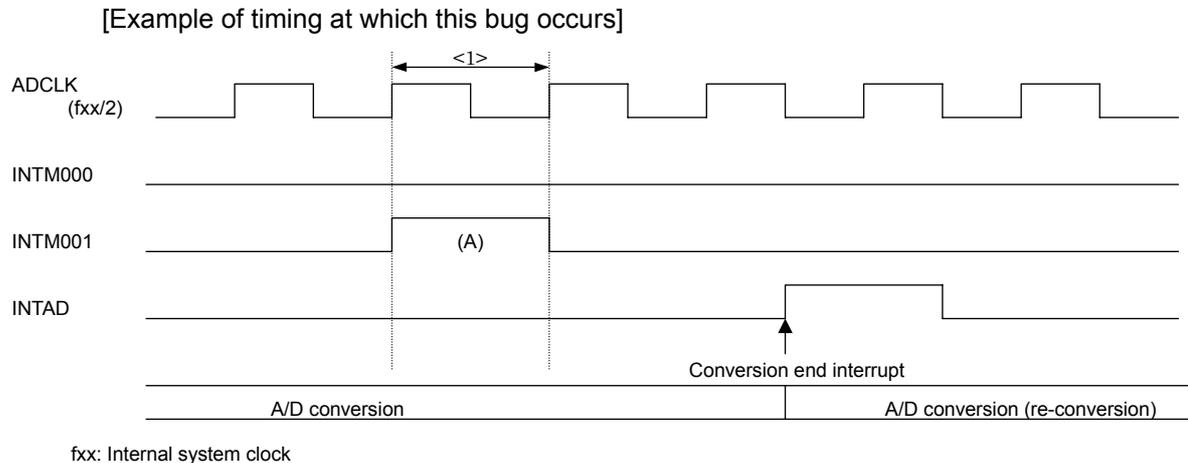
This restriction occurs when the timer 1 trigger mode of the A/D converter is used (this bug does not occur when the A/D trigger mode or timer 4 trigger mode is used).

Originally, only INTM000 can be the trigger to start the A/D converter in the timer 1 trigger mode, therefore the interrupt sources listed below should be ignored. However, if one of the interrupt sources listed below occurs immediately before the end of A/D conversion (<1> in the figure below; 2 internal system clocks), it is mistakenly judged as the A/D conversion start trigger. As a result, A/D conversion is started again after the A/D conversion end interrupt (INTAD) is issued. The first A/D conversion ends correctly and the result is stored in the ADCRn register (this value can be read during the second conversion).

The restarted A/D converter performs the conversion operation correctly, issues the A/D conversion end interrupt (INTAD) and stops. The result is overwritten to the ADCRn register.

**Note** The external interrupt signal that functions alternately as the external capture trigger input of timer C (channels 0 and 1) can also be a trigger for re-conversion. In the case of an external interrupt input, this bug occurs when a valid edge is input before the timing of (A) in the figure below by the noise eliminator (analog delay (60 to 220 ns)).

Since the conversion result is correct even when this bug occurs, the affect of this bug is small when obtaining the latest conversion value. If the re-conversion causes any problems, start A/D conversion in the A/D trigger mode by setting the ADCE bit of the ADM0 register to 1 in the interrupt service routine of the timer match interrupt.

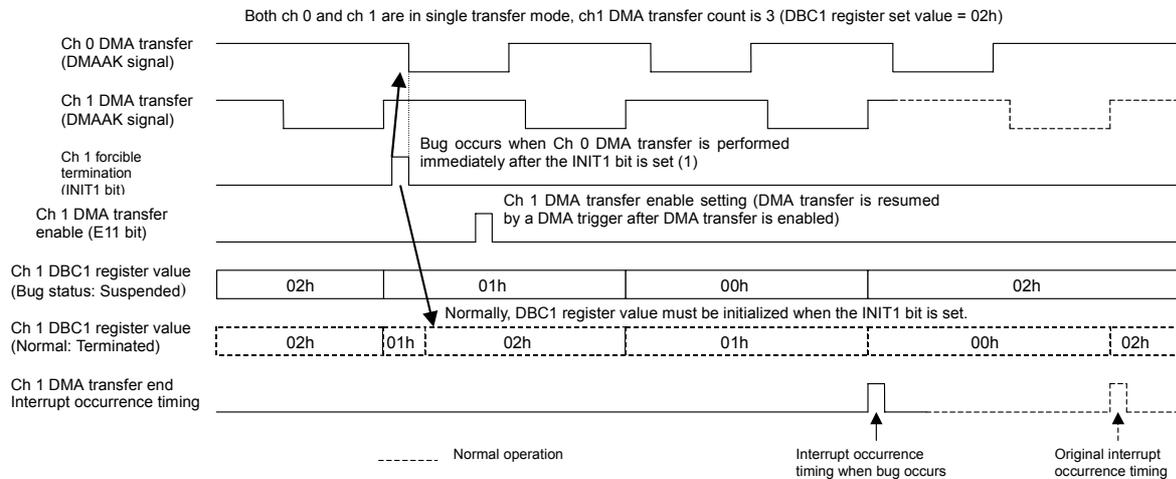
When terminating a DMA transfer by setting the INITn bit of the DCHCn register, the transfer may not be terminated, but just suspended, even though the INITn bit is set (1). As a result, when the DMA transfer of a channel that should have been terminated is resumed, the DMA transfer will terminate after an unexpected number of transfers are completed and a DMA transfer completion interrupt may occur (n = 0 to 3). This bug occurs if a DMA transfer is executed immediately after a forcible termination is set (by setting the INITn bit) (see the figure below).

This bug does not depend on the number of transfer channels, transfer type (2-cycle or flyby), transfer target (between memory and memory, memory and I/O; including internal resources), transfer mode (single, single-step, or block), or trigger (external request, interrupt from internal

peripheral I/O, or software), and can occur with any combination of the above elements that can be set under the specifications. In addition, another channel may affect the occurrence of this bug.

The “initialization” in the above figure means that the contents of the master register are reflected in the slave register.

This bug can be avoided by implementing any of the following procedures using the software.

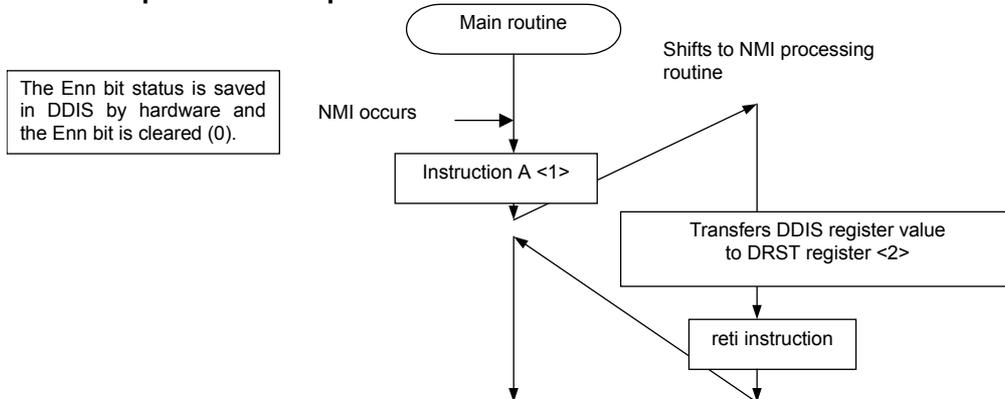
### Operation Example

DMA transfer is forcibly suspended by an NMI input during a DMA transfer. At this time, the DMA controller saves the status of the Enn bit (bit 0 of the DHCn register) of all the DMA channels to the DDIS register, clears (0) the Enn bit, and disables the DMA transfer. In addition, when an NMI interrupt is acknowledged in the CPU pipeline operation, an instruction that has already been fetched is executed (1 instruction max.).

If this instruction is the one used to manipulate the Enn bit, the contents of the DDIS register are transferred to the DRST register in the NMI processing routine in order to resume the suspended DMA transfer. Therefore, the Enn bit setting immediately after the NMI input is not reflected.

As a result, the DMA transfer suspended by the NMI input cannot be restored as expected regardless of whether DMA transfer has been disabled or enabled.

When the Enn bit of the DCHCn register is set to disable or enable DMA using instruction A, the disable/enable status of each DMA channel is inconsistent in <1> and <2>. As a result, the normally suspended DMA transfer cannot be restored correctly.

Furthermore, when the Enn bit is set (1) using instruction A while the software trigger bit (STGn) of the DCHCn register is set (1), DMA transfer is performed even in the NMI processing routine.

Initialize the DMA transfer forcibly suspended by the NMI and then execute it again.

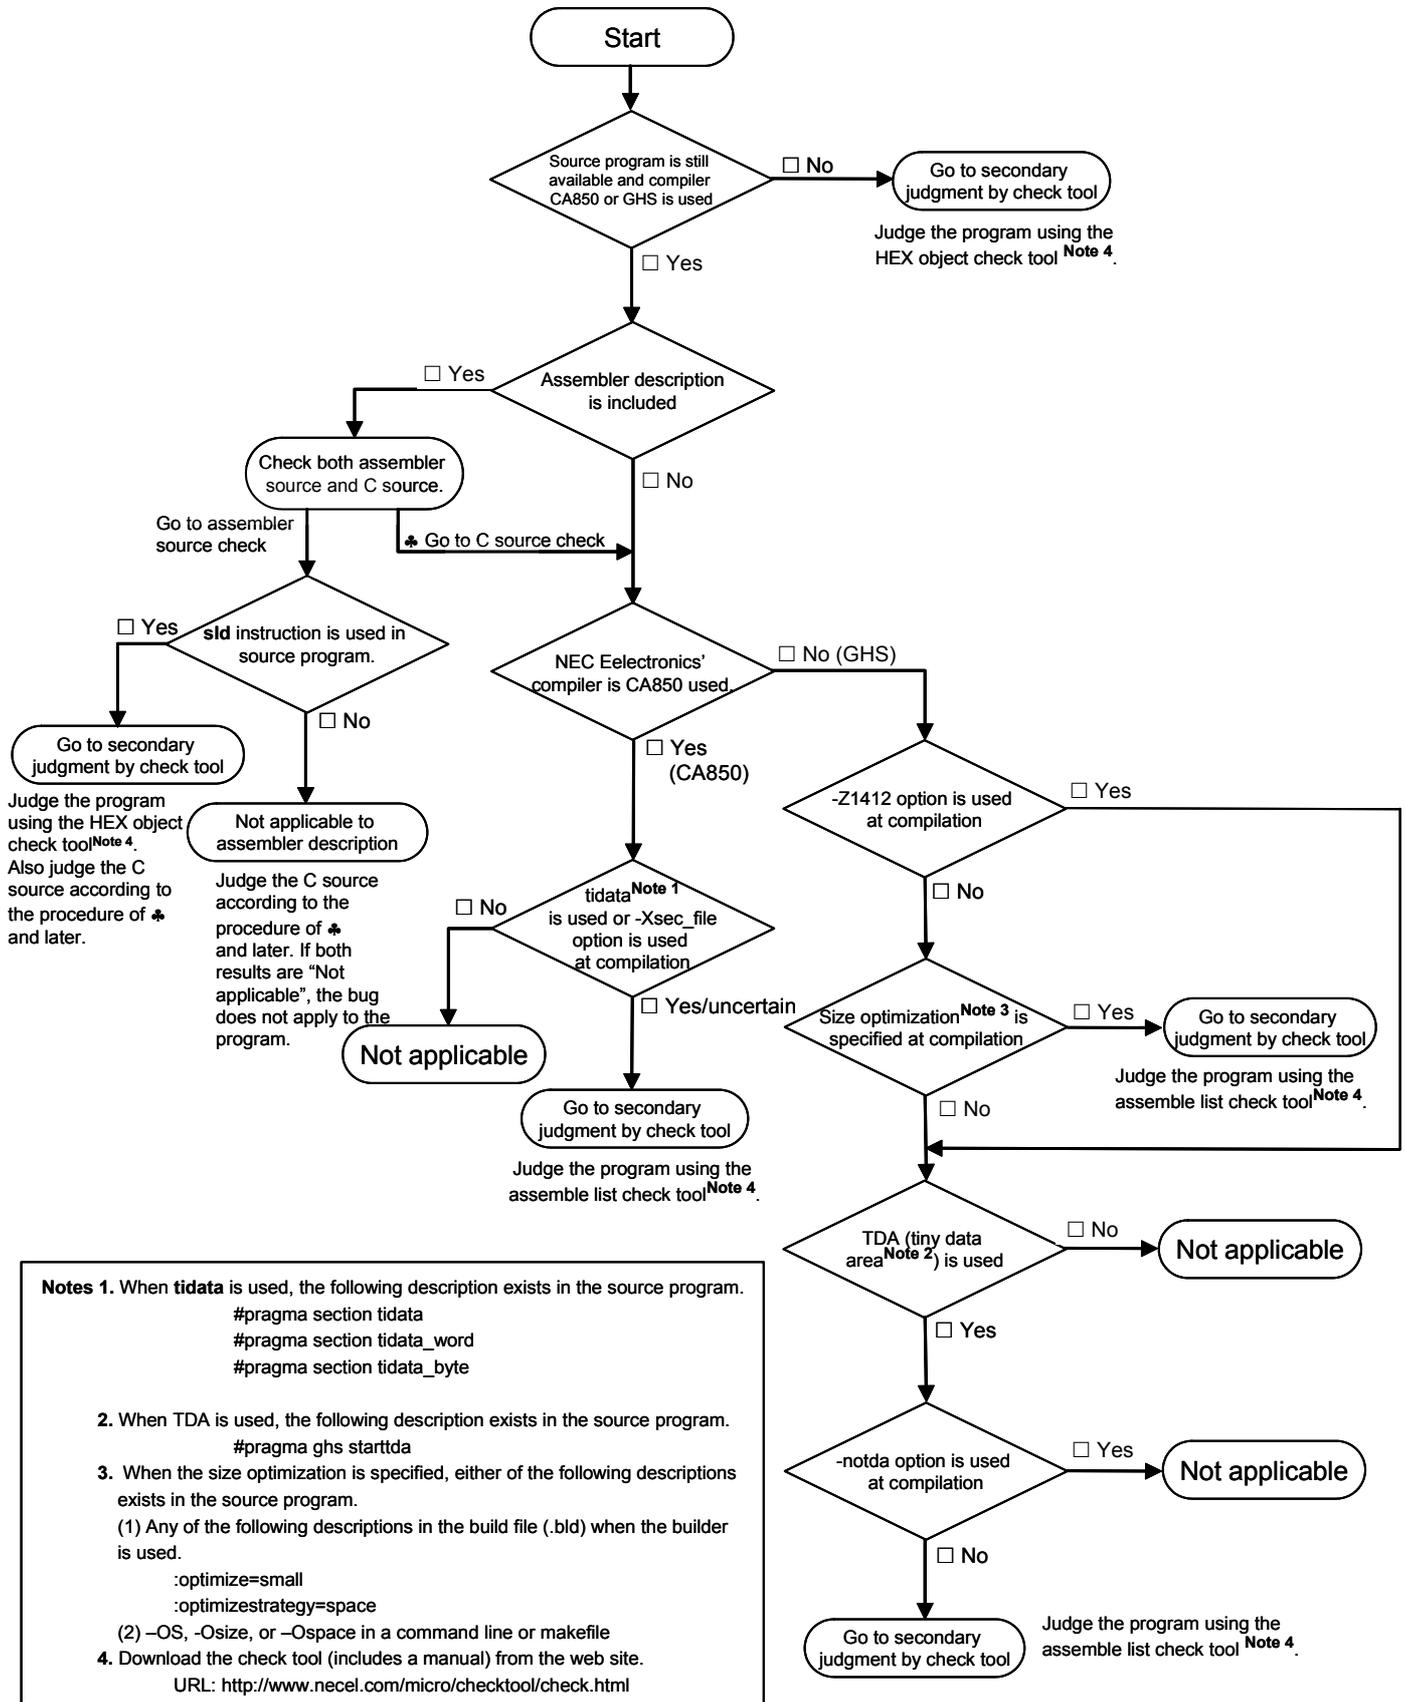
# Bug Check Sheet (for Primary Judgment)

Perform primary judgment for whether the bug applies or not according to the following flowchart. If the result is not "Not applicable", then proceed to secondary judgment using the check tool.
