Microcomputer Technical Information

32-Bit Microcontroller V850E/SV2 Usage Restrictions	Document No.	SBG-DT-04-0045	1/6
	Date issued	February 9, 2004	
	Issued by	Microcomputer Group 2nd Solutions Division Solutions Operations Unit NEC Electronics Corporation	
Related documents V850E/SV2 Hardware User's Manual: U16384E V850E1 Architecture User's Manual: U14559E	Notification classification	<input checked="" type="checkbox"/>	Usage restriction
		<input type="checkbox"/>	Upgrade
		<input type="checkbox"/>	Document modification
		<input type="checkbox"/>	Other notification

V850E/SV2 Usage Restrictions Revision History

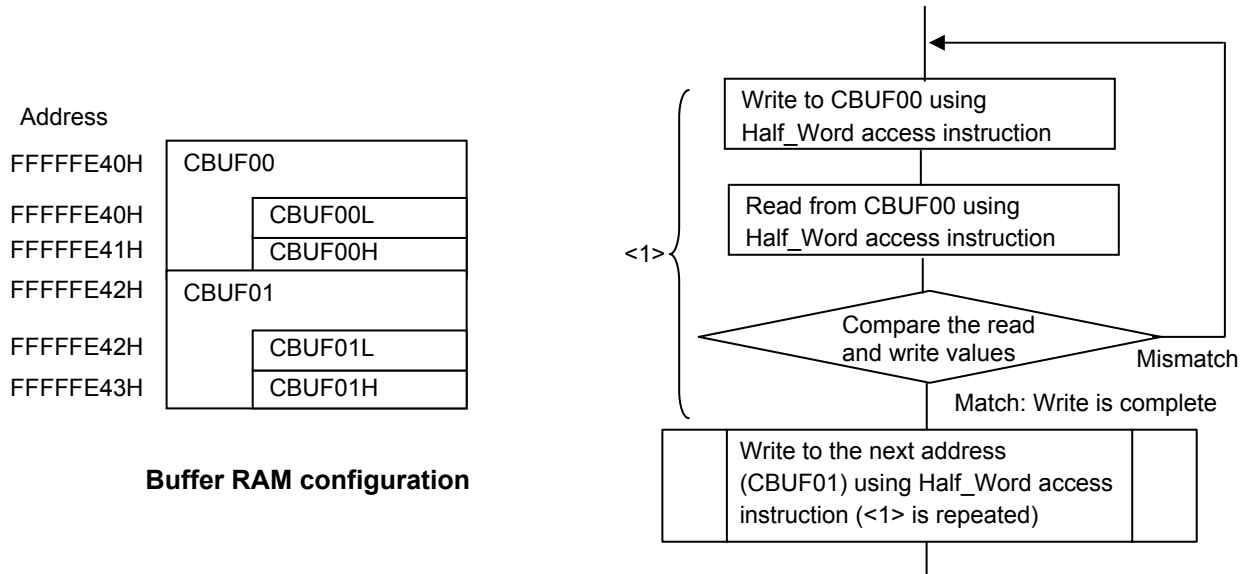
<Example of writing to buffer RAM (CBUF00 to CBUF01)>

When writing transmit data to the buffer RAM (CBUF n m), data may not be written correctly (e.g. Half_Word write is performed even though the Byte access instruction is used, or vice versa ($n = 0$ or 1 , $m = 0$ to 15)).

After data is written, read the data using the Half_Word access instruction (ST.H) and verify the values. If the data do not match, continue writing until the data match. At this time, it is not necessary to disable interrupts.

When writing an odd number of bytes, write dummy data to the buffer RAM (CBUF n mH) at the higher address. ($n = 0$ or 1 , $m = 0$ to 15)

The Half_Word access instruction must be used to access registers until the compare result matches and write is confirmed.

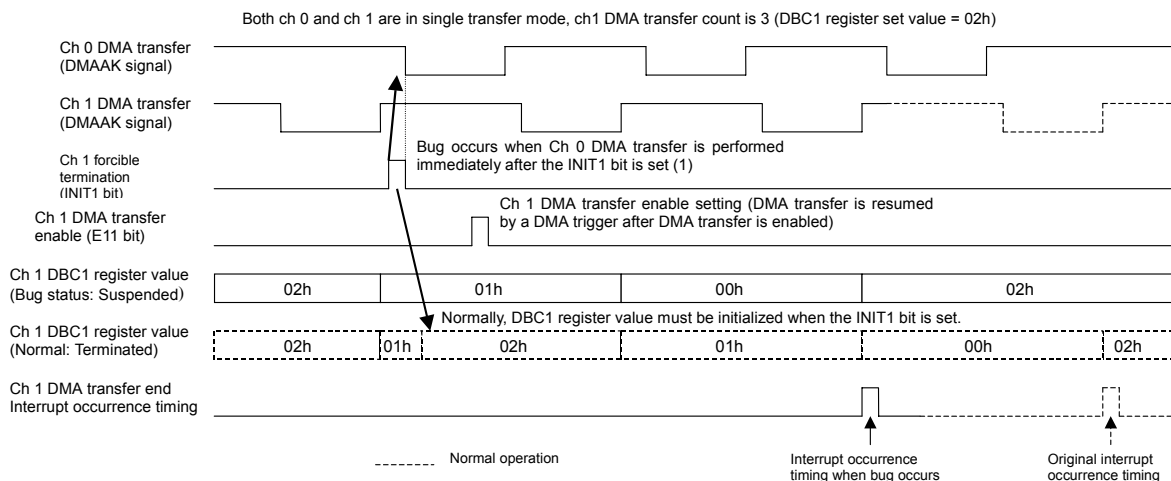
When terminating a DMA transfer by setting the INITn bit of the DCHCn register, the transfer may not be terminated, but just suspended, even though the INITn bit is set (1). As a result, when the DMA transfer of a channel that should have been terminated is resumed, the DMA transfer will terminate after an unexpected number of transfers are completed and a DMA transfer completion interrupt may occur (n = 0 to 3). This bug occurs if a DMA transfer is executed immediately after a forcible termination is set (by setting the INITn bit) (see the figure below).

The "initialization" in the above figure means that the contents of the master register are reflected in the slave register.

This bug can be avoided by implementing any of the following procedures using the software.

(1) Stop all the transfers from DMA channels temporarily

- <1> Disable interrupts (DI state).
- <2> Read the DMA restart register (DRST) and transfer the ENn bit of each channel to a general-purpose register (value A).
- <3> Write 00H to the DMA restart register (DRST) twice^{Note}.
By executing twice^{Note}, the DMA transfer is definitely stopped before proceeding to <4>.
- <4> Set (1) the INITn bit of the DCHCn register of the channel that should be terminated forcibly.
- <5> Perform the following operations for value A read in <2>. (Value B)
 - (a) Clear (0) the bit of the channel that should be terminated forcibly
 - (b) If the TCn and ENn bits of the channel that is not terminated forcibly are 1 (AND makes 1), clear (0) the bit of the channel.
- <6> Write value B in <5> to the DRST register.
- <7> Enable interrupts (EI state).

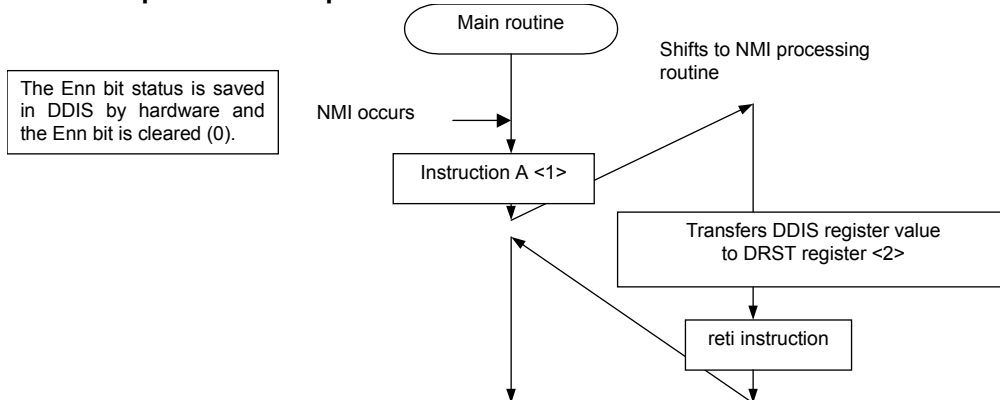
Operation Example

DMA transfer is forcibly suspended by an NMI input during a DMA transfer. At this time, the DMA controller saves the status of the Enn bit (bit 0 of the DCHCn register) of all the DMA channels to the DDIS register, clears (0) the Enn bit, and disables the DMA transfer. In addition, when an NMI interrupt is acknowledged in the CPU pipeline operation, an instruction that has already been fetched is executed (1 instruction max.).

As a result, the DMA transfer suspended by the NMI input cannot be restored as expected regardless of whether DMA transfer has been disabled or enabled.

When the Enn bit of the DCHCn register is set to disable or enable DMA using instruction A, the disable/enable status of each DMA channel is inconsistent in <1> and <2>. As a result, the normally suspended DMA transfer cannot be restored correctly.

Furthermore, when the Enn bit is set (1) using instruction A while the software trigger bit (STGn) of the DCHCn register is set (1), DMA transfer is performed even in the NMI processing routine.

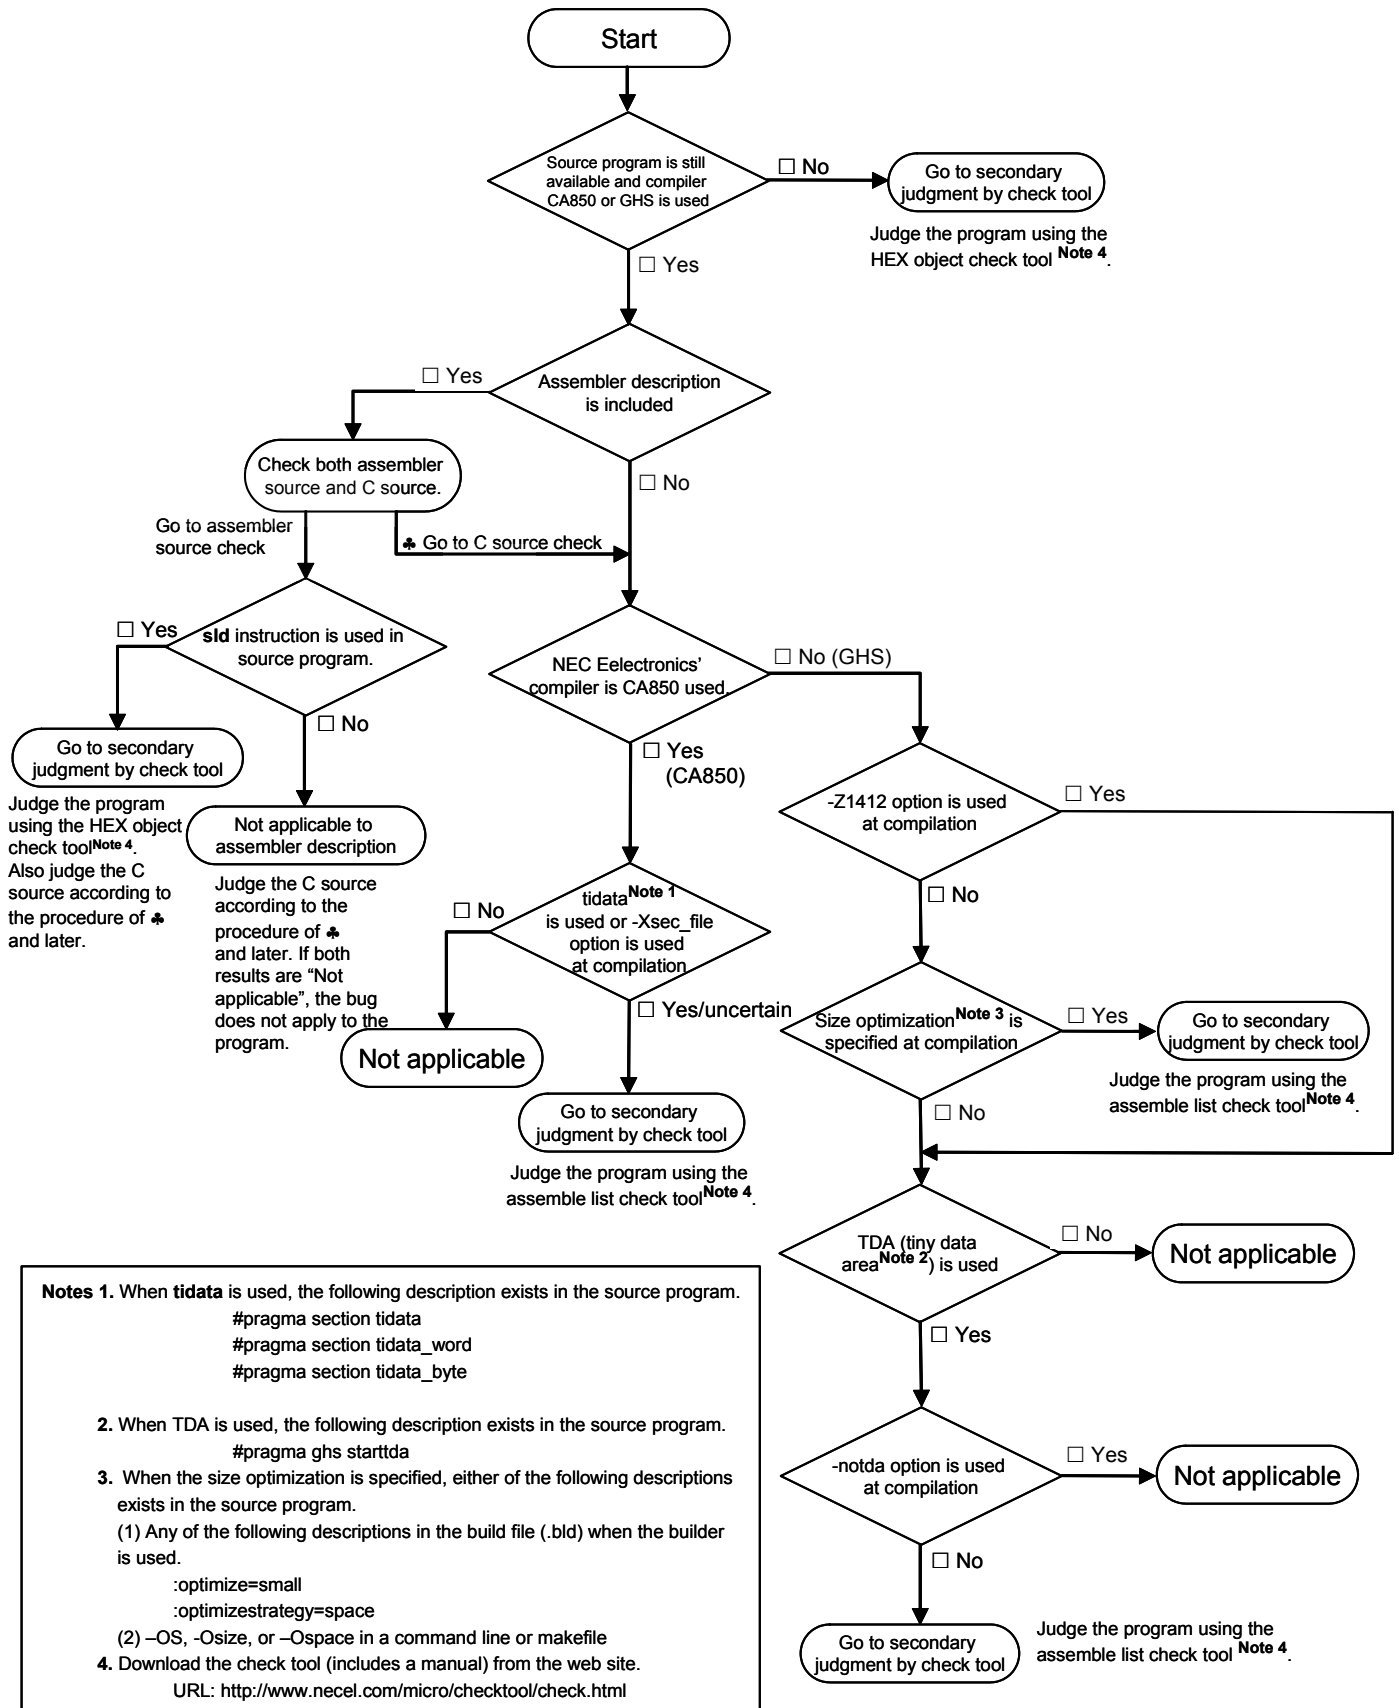
Bug Check Sheet (for Primary Judgment)

Perform primary judgment for whether the bug applies or not according to the following flowchart. If the result is not "Not applicable", then proceed to secondary judgment using the check tool.
