32-Bit Microcontroller V850/SA1  Usage Restrictions		Document No.	SBG-T-2476-E	1/2
		Date issued	September 12, 2001	
		Issued by	Microcomputer Engineering Dept. Solution Engineering Div. NEC Electron Devices NEC Corporation	
Related documents	User's manual -Hardware: U12768EJ	Notification classification	√	Usage restriction
	User's manual -Architecture: U10243EJ			Upgrade
	Data sheet (Flash memory): U14527EJ			Document modification
	Data sheet (Mask ROM): U14526EJ			Other notification
	Application note: U13851EJ

## Notes on Using V850/SA1

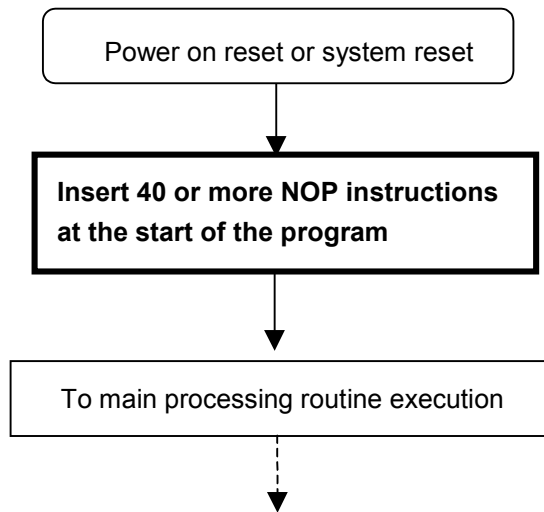
Figure) NOP Insertion Program Flowchart

The microcontroller may become inoperable after the power is turned on or the system is reset.

It is necessary to secure time for the voltage to rise sufficiently before the first fetch of the program. To do this, please insert **40 or more** NOP instructions at the start of the program.

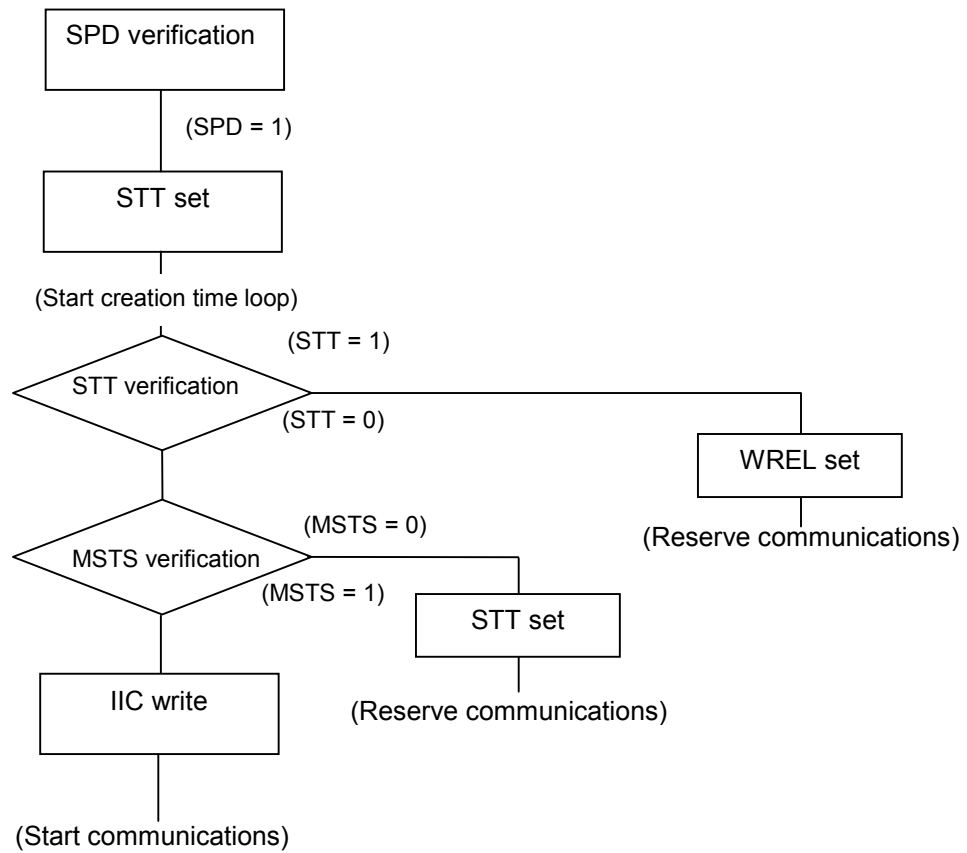
The following bugs may occur as a result of conflict between STT set timing and start condition detection.

- STT bit set operation may be rejected.
- The device may be incorrectly recognized as the master (MAST = 1) and the STT bit cleared.
- A WAIT condition may result from a fall in SCL if STT is set and SCL is in a high-level state (SPD = 1) when the target device has generated a start condition.

Provide software that performs the operations in the flow chart below.

Ensure that the time from SPD verification to WREL set in the above flow chart is as follows.

In high-speed mode: 17.5  $\mu$ s or less

In standard mode: 70.0  $\mu$ s or less

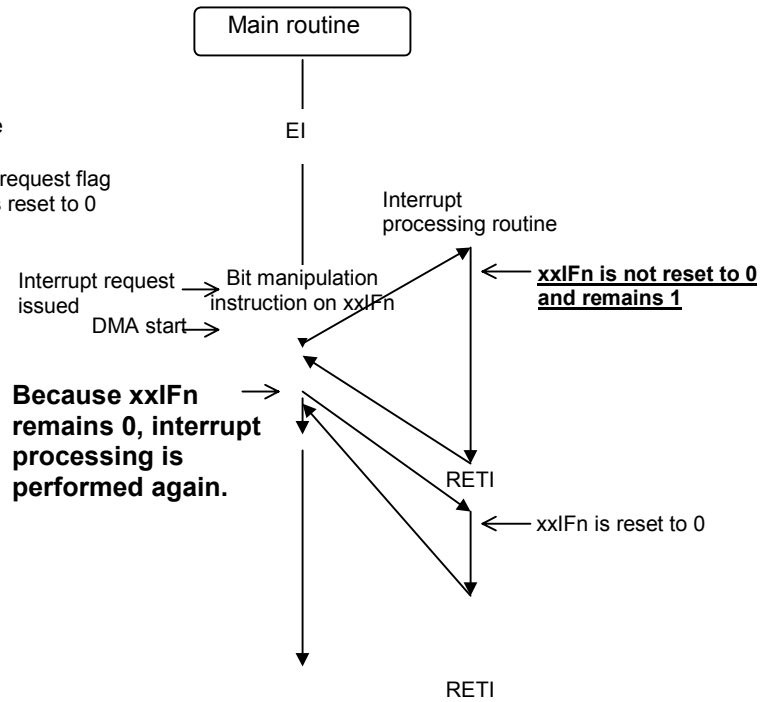
Figure 2. Interrupt Processing Causing This Bug

If the three conditions below occur at the same time while interrupts are enabled (EI), an interrupt that should only occur once occurs twice.

When the above conditions (1) to (3) coincide and interrupt processing begins, the interrupt request flag that should be reset by hardware is not reset, so that after returning from the interrupt processing routine (RETI instruction), the interrupt processing is executed again. (See figures 1 and 2.)
