## NEC Microcomputer Technical Information

<b>32-Bit Microcontroller V850/SB1, SB2 Usage Restrictions</b>		Document No.	SBG-DT-0007-E	1/1
		Date issued	October 4, 2001	
		Issued by	Microcomputer Group Sales Engineering Div. NEC Electron Devices NEC Corporation	
Related documents	User's manual -Hardware: U13850EJ4	Notification classification	<input checked="" type="checkbox"/>	Usage restriction
	User's manual -Architecture: U10243EJ7		<input type="checkbox"/>	Upgrade
	Data sheet (V850/SB1 ROM:128,256K): U14734EJ2		<input type="checkbox"/>	Document modification
	Data sheet (V850/SB1 ROM:384,512K): U14893EJ1		<input type="checkbox"/>	Other notification
	Data sheet (V850/SB2 ROM:128,256K): U14780EJ2			
	Data sheet (V850/SB2 ROM:384,512K): U14894EJ1

## List of Restrictions in V850/SB1, SB2

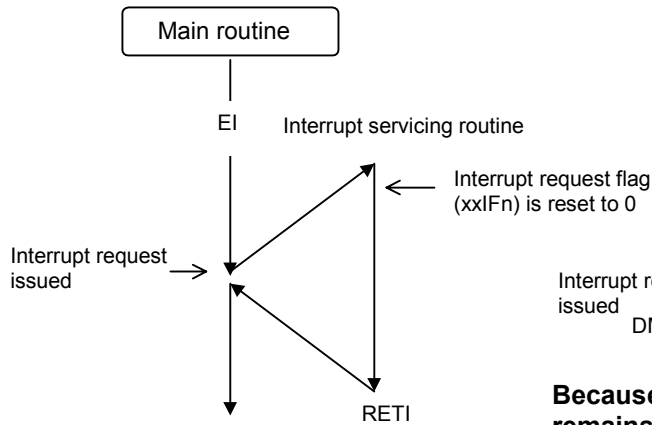
Figure 3-1. Normal Interrupt Servicing

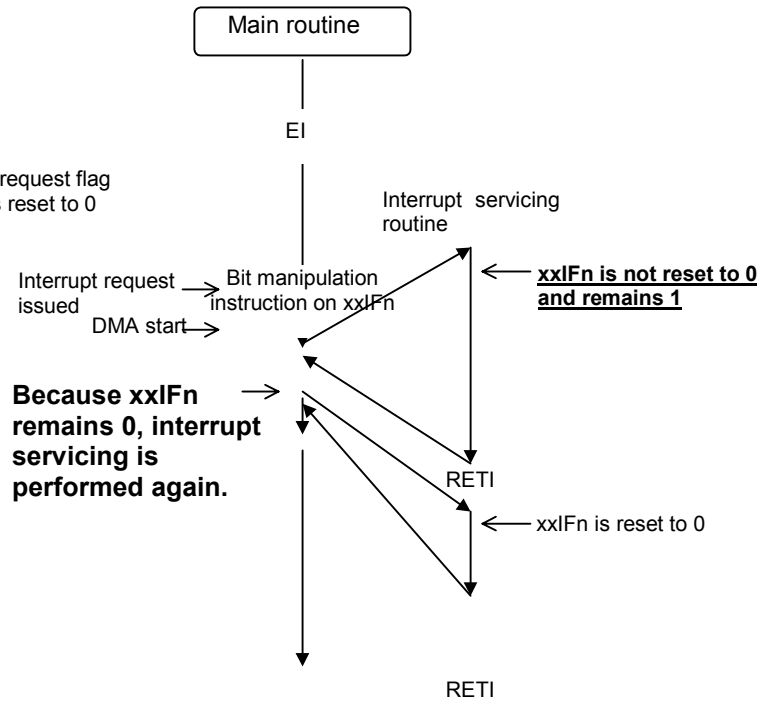
If the three conditions below occur at the same time while interrupts are enabled (EI), an interrupt that should only occur once occurs twice.

- (1) A bit manipulation instruction (set1, clr1, not1, tst1) is executed on an interrupt request flag (xxIFn) of an interrupt control register (xxICn).
- (2) Interrupt servicing occurs involving the hardware of the same register as in (1).
- (3) DMA is started while executing the above bit manipulation instruction.

When the above conditions (1) to (3) match and interrupt servicing begins, the interrupt request flag that should be reset by hardware is not reset, so that after returning from the interrupt servicing routine (RETI instruction), the interrupt servicing is executed again. (See Figures 3-1 and 3-2.)

Example) During a bit manipulation on the interrupt request flag (CSIF0) of the CSIC0 register using the clr1 instruction, the non-masked INTCSI0 interrupt occurs, which then conflicts with the start of DMA. In this case, the INTCSI0 interrupt servicing is executed twice.

Figure 3-2. Interrupt Servicing Causing This Bug

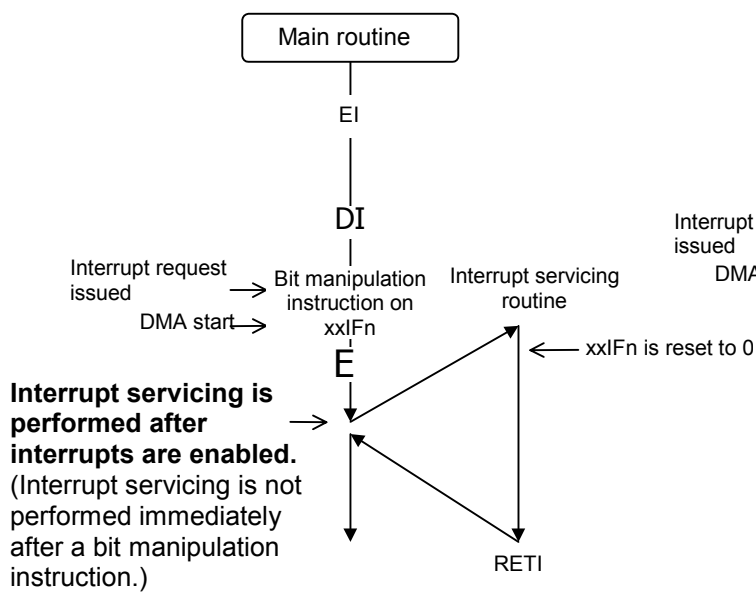
Figure 3-3. Workaround (1)

- (1) Issue the DI instruction before executing a bit manipulation instruction on the interrupt request flags (xxIFn) of an interrupt control register (xxICn) by software. Then issue an EI instruction afterwards, and do not execute interrupt servicing immediately after the bit manipulation instruction. (See Figure 3-3.)
- (2) When interrupt servicing begins, interrupts are disabled by hardware (the DI state), so clear the interrupt request flag in every interrupt processing routine before executing the EI instruction. (See Figure 3-4.)

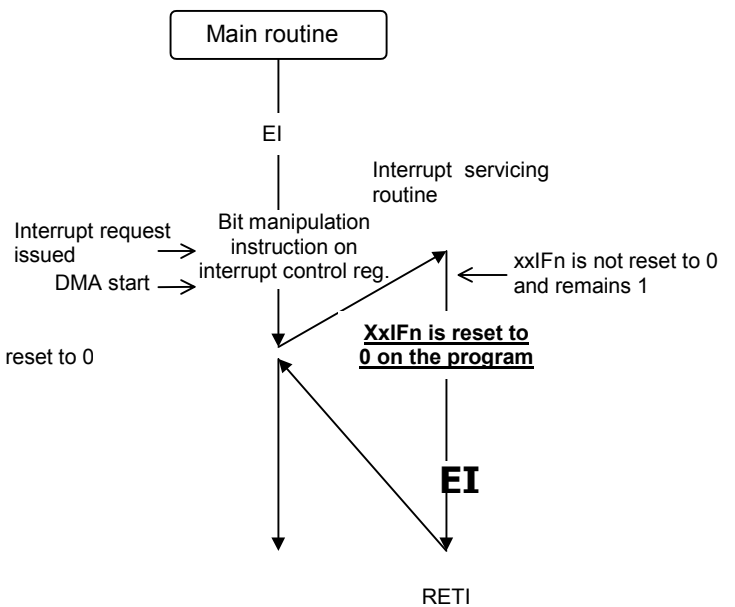
Figure 3-4. Workaround (2)
