CUSTOMER NOTIFICATION

SUD-FT-04-0105 (1/11)
April 19, 2004
Seiji Iigusa, Senior System Integrator Car Electronics Group 1st Solutions Division Solutions Operations Unit NEC Electronics Corporation

IE-703239-G1-EM1
(Control Code: A, B, C)

Notes on Using IE-703239-G1-EM1

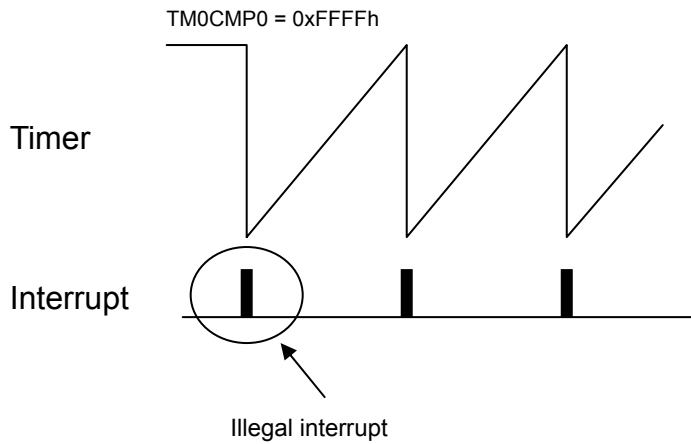
No.12 Bug in 16-bit timer M compare register

An illegal interrupt occurs after timer M activation when the compare register TM0CMP0 is set to FFFFH. See the figure below for details.

Do not set TM0CMP0 to FFFFH.
This bug has been corrected in control code C.
