CUSTOMER NOTIFICATION

SUD-T-4084-4-E
July 17, 2000
Yoichi Hirasawa, Expert Microcomputer Engineering Dept. Solution Engineering Div. NEC Electron Devices NEC Corporation

# IE-703100-MC (Control Code: A, B, C, D, E)

## RESTRICTIONS

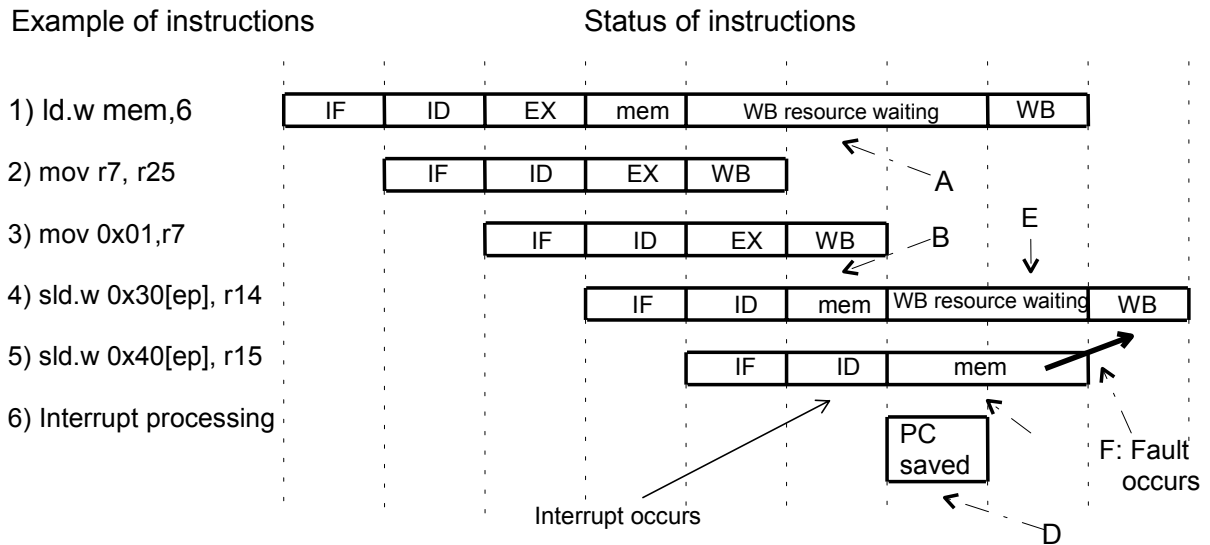
This error occurs when the following pipeline status occurs.

<Explanation of the above pipeline operation>

A. To improve performance with the V850E/MS1, the pipelining of other instructions goes ahead regardless of the dst waiting for resources in instruction 1, and consequently the WB of instructions 2 and 3 are executed before the WB of instruction 1.

B. The EX stage of instruction 4 is omitted and mem access is executed because address calculation resources are available in the ID stage.

C. Execution of mem access cannot be stopped even if an interrupt is received in the ID stage of instruction 5, so a dummy access is performed.

D. The PC is saved, and so on, due to the interrupt processing. Since this uses WB resources, the WB of instruction 1 is delayed even more.

E. The WB of instruction 4 is made to wait one clock cycle because otherwise it would conflict with the WB of instruction 1.

F. The data written in the WB stage of instruction 4 is the result of the dummy cycle of the mem stage of instruction 5, because reading cannot be masked due to the dummy cycle in instruction 5, and an incorrect write to r14 is performed, causing the malfunction.

This malfunction can be avoided by using one of the following countermeasures a through c below:

- Change the first sld instruction to an ld instruction where repeated sld instructions are used. This malfunction will not occur if all the sld instructions are changed to ld instructions.
- Set ep immediately before the first sld instruction when repeated sld instructions are used.
- Insert a nop instruction immediately before the first sld instruction when repeated sld instructions are used.

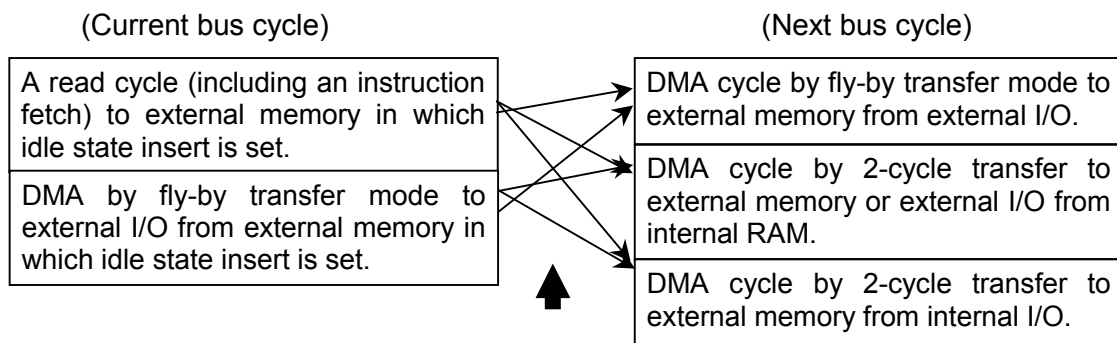
<Figure 1>

If an internal refresh request or external bus hold request occurs when a cycle operates under condition (B), as stated below, following a cycle operating under condition(A), the DMAAK signal responding to the DMA that is attempting to operate in an idle cycle (a one cycle period) which begins immediately before will be output abnormally (Figure 2). The cycle following the idle cycle that is input after a cycle in condition (A), however, becomes a refresh cycle or a external bus hold cycle because a refresh request or external bus hold request is given priority over a DMA cycle in condition (B). A DMA cycle is not generated while the abnormally output DMAAK cycle is active (DMA transfer is not performed).

The phenomenon shown in Figure 2 will result when a CPU internal refresh request or a bus hold request occur at this point.

It is possible to avoid this problem with any of the following methods.

- Do not insert an idle state with software.
- Do not use the internal refresh and external bus hold functions.
- Use the AND signal of the DMAAK output and IORD output that are generated by external circuitry instead of DMAAK output when abnormal DMAAK output due to this phenomenon becomes a problem with application systems or when the applicable DMA channel is used as a fixed channel from external I/O to external memory in fly-by transfer mode.
