CUSTOMER NOTIFICATION

SUD-T-4204-6-E
January 26, 2001
Yoichi Hirasawa, Expert Microcomputer Engineering Dept. Solution Engineering Div. NEC Electron Devices NEC Corporation

- IE-703102-MC (Control Code: A, B, C, D)
- IE-703102-MC-EM1 (Control Code: A, B)
- IE-703102-MC-EM1-A (Control Code: A, B)

### RESTRICTIONS

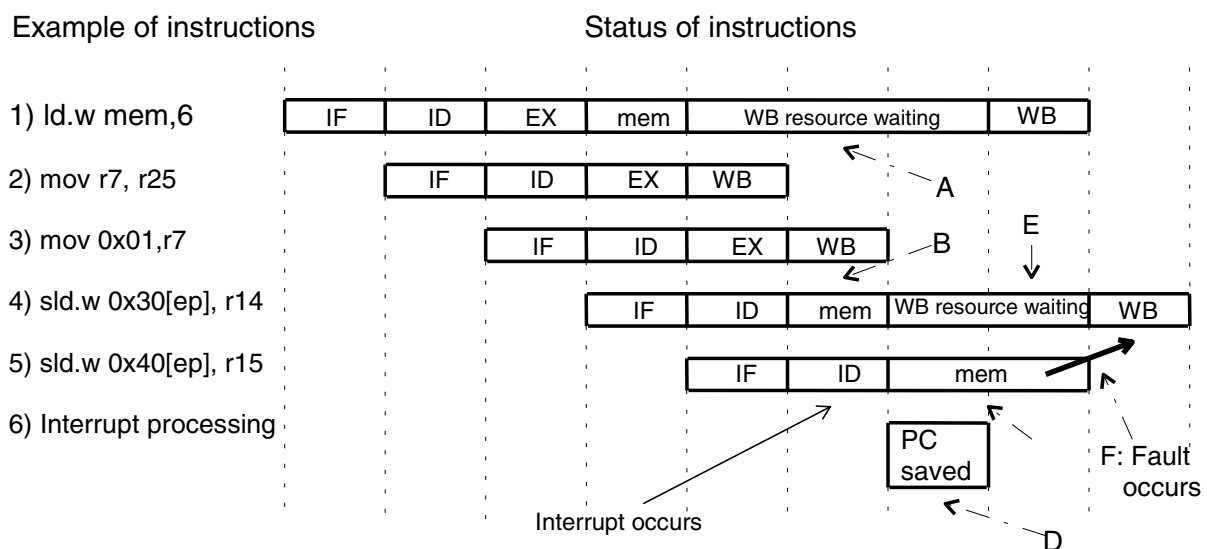
This error occurs when the following pipeline status occurs.

<Explanation of the above pipeline operation>

A. To improve performance with the V850E/MS1, the pipelining of other instructions goes ahead regardless of the dst waiting for resources in instruction 1, and consequently the WB of instructions 2 and 3 are executed before the WB of instruction 1.

B. The EX stage of instruction 4 is omitted and mem access is executed because address calculation resources are available in the ID stage.

C. Execution of mem access cannot be stopped even if an interrupt is received in the ID stage of instruction 5, so a dummy access is performed.

D. The PC is saved, and so on, due to the interrupt processing. Since this uses WB resources, the WB of instruction 1 is delayed even more.

E. The WB of instruction 4 is made to wait one clock cycle because otherwise it would conflict with the WB of instruction 1.

F. The data written in the WB stage of instruction 4 is the result of the dummy cycle of the mem stage of instruction 5, because reading cannot be masked due to the dummy cycle in instruction 5, and an incorrect write to r14 is performed, causing the malfunction.

[Countermeasures]

This malfunction can be avoided by using one of the following countermeasures **a** through **c** below:

- a. Change the first sld instruction to an ld instruction where repeated sld instructions are used. This malfunction will not occur if all the sld instructions are changed to ld instructions.
- b. Set ep immediately before the first sld instruction when repeated sld instructions are used.
- c. Insert a nop instruction immediately before the first sld instruction when repeated sld instructions are used.

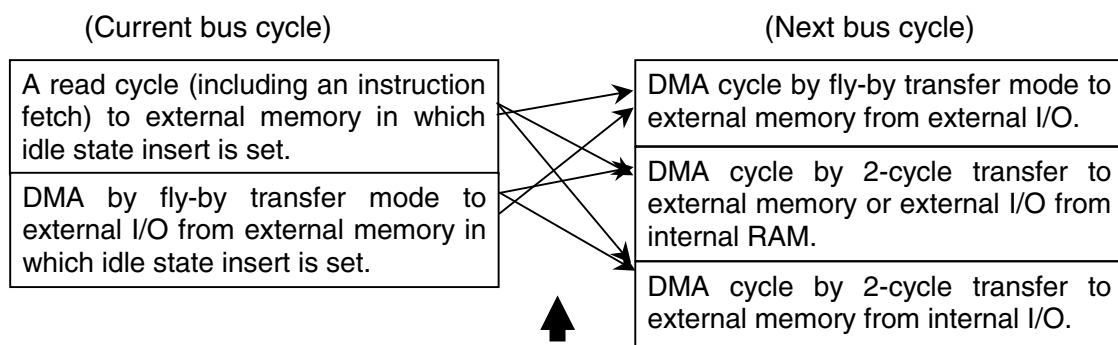
<Figure 1>

If an internal refresh request or external bus hold request occurs when a cycle operates under condition (B), as stated below, following a cycle operating under condition(A), the DMAAK signal responding to the DMA that is attempting to operate in an idle cycle (a one cycle period) which begins immediately before will be output abnormally (Figure 2). The cycle following the idle cycle that is input after a cycle in condition (A), however, becomes a refresh cycle or a external bus hold cycle because a refresh request or external bus hold request is given priority ever a DMA cycle in condition (B). A DMA cycle is not generated while the abnormally output DMAAK cycle is active (DMA transfer is not performed).

The phenomenon shown in Figure 2 will result when a CPU internal refresh request or a bus hold request occur at this point.

[Countermeasures]

It is possible to avoid this problem with any of the following methods.

- Do not insert an idle state with software.
- Do not use the internal refresh and external bus hold functions.
- Use the AND signal of the DMAAK output and IORD output that are generated by external circuitry instead of DMAAK output when abnormal DMAAK output due to this phenomenon becomes a problem with application systems or when the applicable DMA channel is used as a fixed channel from external I/O to external memory in fly-by transfer mode.  
(For applications for handshaking to an external DMA request.)
- Use DMA in combination with different modes those of the occurrence conditions.
