Microcomputer Technical Information

IE-703107-MC-EM1 In-Circuit Emulator Option Board for V850E/MA1, V850E/MA2 Usage Restrictions		Document No.	ZBG-CD-04-0005	1/2
		Date issued	May 17, 2004	
		Issued by	Development Tool Group Multipurpose Microcomputer Systems Division 3rd Systems Operations Unit NEC Electronics Corporation	
Related documents	IE-703107-MC-EM1 User's Manual: U14481EJ2V0UM00	Notification classification	√	Usage restriction
				Upgrade
				Document modification
				Other notification

- No.14 Bug in _HLDK signal output

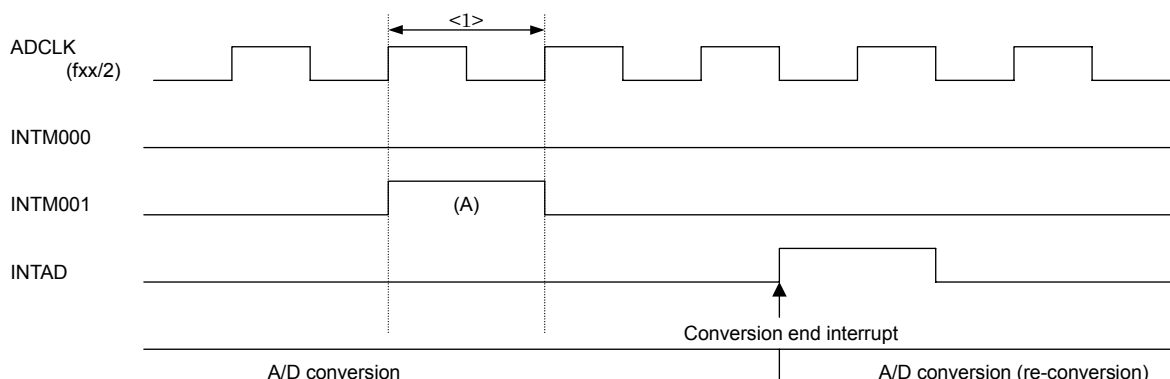
[Example of timing at which this bug occurs]

No.13 Restriction on A/D converter

This restriction occurs when the timer 1 trigger mode or external trigger mode of the A/D converter is used (this bug does not occur when the A/D trigger mode or timer 4 trigger mode is used).

Originally, only INTM000 can be the trigger to start the A/D converter in the timer 1 trigger mode, and ADTRG pin input in the external trigger mode, therefore the interrupt sources listed below should be ignored. However, if one of the interrupt sources listed below occurs immediately before the end of A/D conversion (<1> in the figure below; 2 internal system clocks), it is mistakenly judged as the A/D conversion start trigger. As a result, A/D conversion is started again after the A/D conversion end interrupt (INTAD) is issued. The first A/D conversion ends correctly and the result is stored in the ADCRn register (this value can be read during the second conversion).

The restarted A/D converter performs the conversion operation correctly, issues the A/D conversion end interrupt (INTAD) and stops. The result is overwritten to the ADCRn register.

Note The external interrupt signal that functions alternately as the external capture trigger input of timer C (channels 0 and 1) can also be a trigger for re-conversion. In the case of an external interrupt input, this bug occurs when a valid edge is input before the timing of (A) in the figure below by the noise eliminator (analog delay (60 to 220 ns)).

Since the conversion result is correct even when this bug occurs, the affect of this bug is small when obtaining the latest conversion value. If the re-conversion causes any problems, start A/D conversion in the A/D trigger mode by setting the ADCE bit of the ADM0 register to 1 in the interrupt service routine of the timer match interrupt.

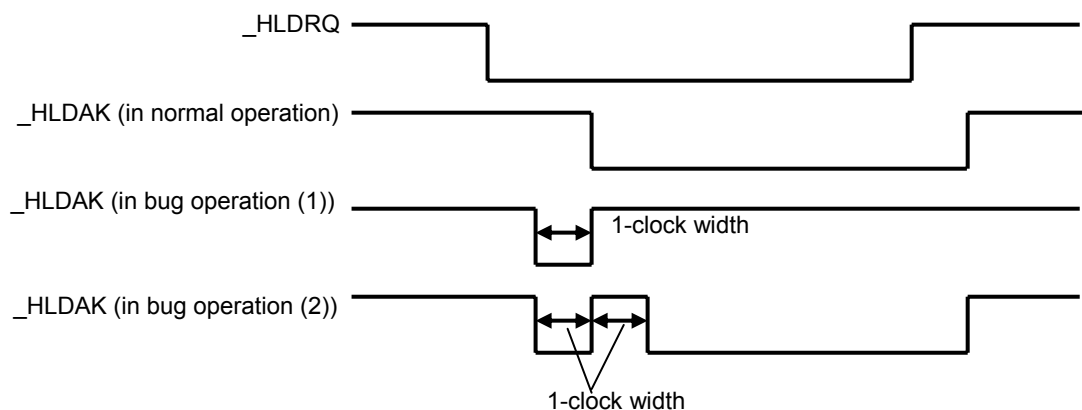
No.14 Bug in _HLDAK signal output

The _HLDAK signal output from the emulator in response to the _HLDRQ signal from the target system may be illegal (there are two cases).

This bug occurs only when output of the _HLDAK signal and refresh conflict.

There is no workaround.

This restriction has been corrected in the IE-703107-MC-EM1 with control code E or later.
