CUSTOMER NOTIFICATION

SUD-DT-04-0010 (1/5)
January 26, 2004
Koji Nishibayashi, Senior System Integrator Microcomputer Group 2nd Solutions Division Solutions Operations Unit NEC Electronics Corporation

IE-703166-MC-EM1
(Control Code: A, B, C)

Operating Precautions

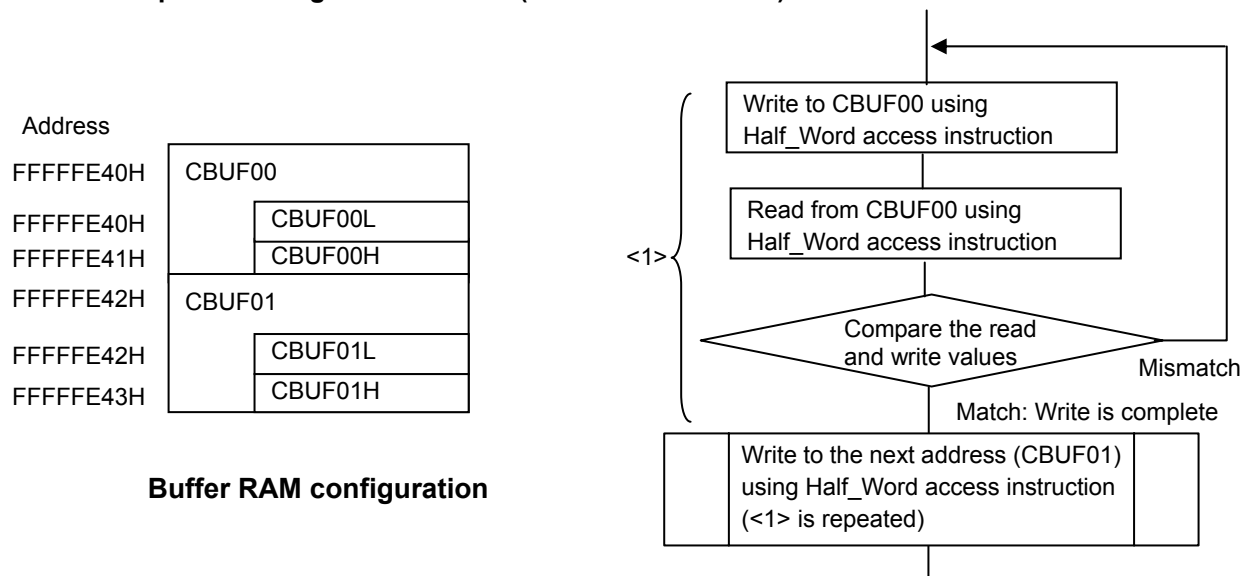
<Example of writing to buffer RAM (CBUF00 to CBUF01)>

When writing transmit data to the buffer RAM (CBUFnm), data may not be written correctly depending on the instruction executed next to the write instruction (n = 0 or 1, m = 0 to 15).

After data is written, read the data using the Half_Word access instruction (ST.H) and verify the values. If the data do not match, continue writing until the data match. At this time, it is not necessary to disable interrupts.

When writing an odd number of bytes, write dummy data to the buffer RAM (CBUFnmH) at the higher address. (n = 0 or 1, m = 0 to 15)

The Half_Word access instruction must be used to access registers until the compare result matches and write is confirmed.
