CUSTOMER NOTIFICATION

SUD-DT-03-0136-1-E (1/6) (SUD-TT-0117-5-E)
March 20, 2003
Koji Nishibayashi, Senior System Integrator Microcomputer Group 2nd Solutions Division Solutions Operations Unit NEC Electronics Corporation

IE-703217-G1-EM1
(Control Code: A, B, C)

Operating Precautions

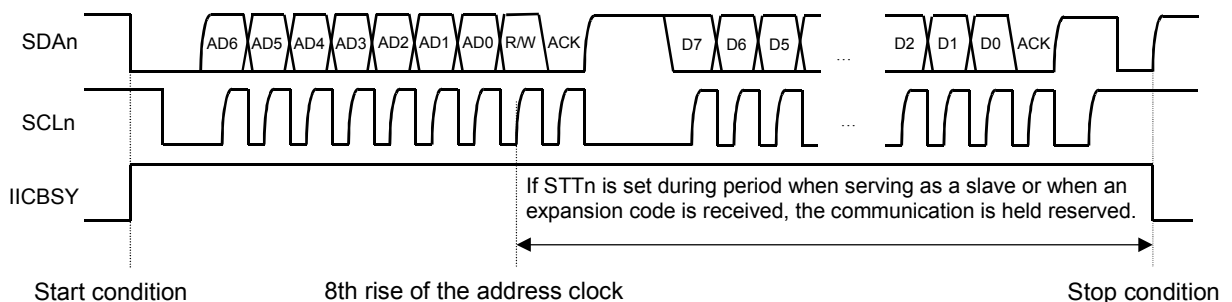
No.6 Restriction on IIC bus communication reservation

If conditions (1) and (2) are satisfied when using the IIC bus interface (IICn), the communication is held reserved even if communication reservation is disabled (IICRSVn = 1). At this time, the start condition clear flag (STCFn) is not set (n = 0 or 1). (See the figure below.)

- (1) When the address value and the slave address register (SVAn) value match or when an expansion code is received
- (2) When the start condition trigger (STTn) is set in the period from the 8th rise of the address clock to stop condition detection.

This bug occurs when the bus flag (IICBSY) is being set. Before generating the start condition (STT_n ← 1) while communication reservation is disabled (IICRSVn = 1), confirm that the IIC bus status flag has been cleared (IICBSYn = 0).

STT_n can be set immediately after IICBSYn = 0 is confirmed, but it is recommended to disable interrupts because if it takes a long time to set STT_n due to an interrupt, the start condition may be detected during the period, and a slave match may occur or expansion code may be received at the 8th address clock.

This restriction has been corrected in control code C.

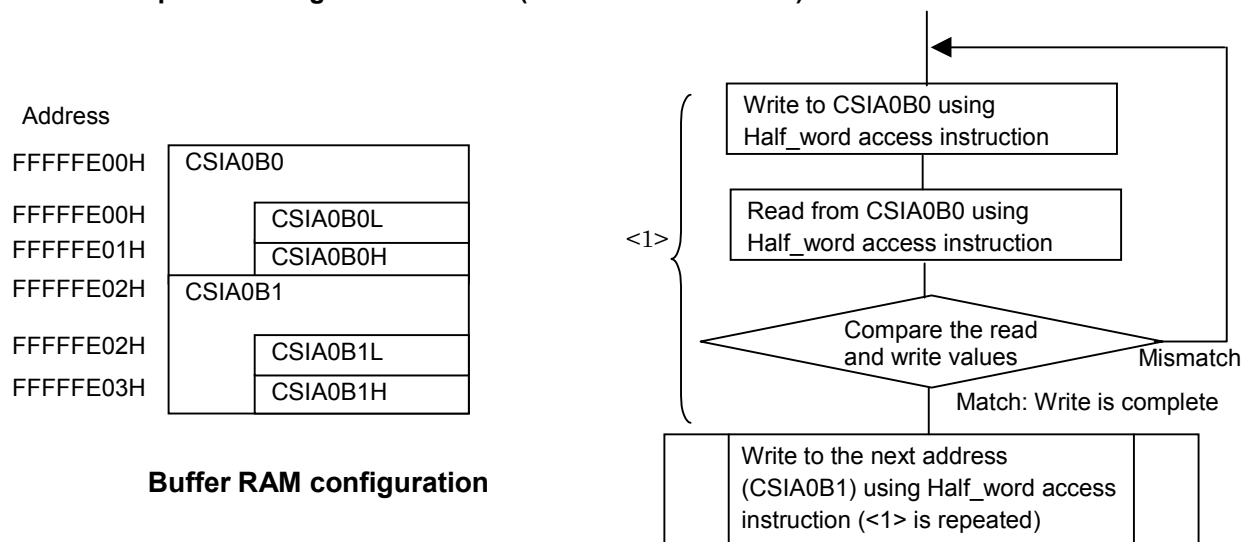
<Example of writing to buffer RAM (CSIA0B0 to CSIA0B1)>

When writing transmit data to the buffer RAM (CSIA_nB_m) using the 3-wire serial interface with automatic transfer function (CSIA_n), data may not be written correctly depending on the instruction executed next to the write instruction (n = 0 or 1, m = 0 to F).

After data is written, read the data using the Half_Word access instruction (ST.H) and compare the values. If the data do not match, perform the write again. At this time, it is not necessary to disable interrupts.

When writing an odd number of bytes, write dummy data to the buffer RAM (CSIA_nB_mH) at the higher address. The Half_Word access instruction must be used to access registers until the compare result matches and write is confirmed.
