CUSTOMER NOTIFICATION

SUD-DT-03-0566
December 19, 2003
Koji Nishibayashi, Senior System Integrator Microcomputer Group 2nd Solutions Division Solutions Operations Unit NEC Electronics Corporation

IE-703220-G1-EM1
(Control Code: A)

Operating Precautions

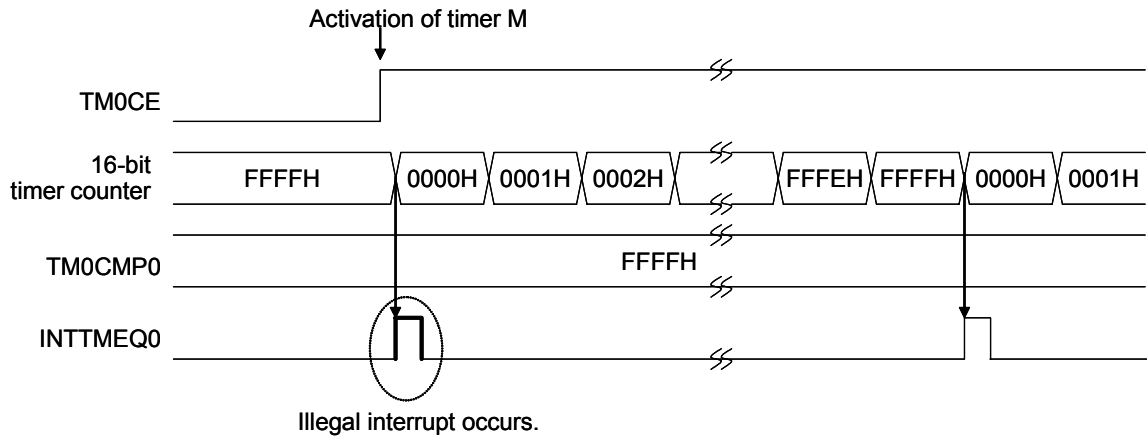
No.8 Bug in 16-bit timer M compare register

An illegal interrupt occurs after timer M activation when the compare register TM0CMP0 is set to FFFFH. See the figure below for details.

Do not set TM0CMP0 to FFFFH.

Please regard this item as a permanent restriction.
