# Microcontroller Technical Information

IE-703288-G1-EM1 In-Circuit Emulator Emulation Board for V850ES/SG1, V850ES/SG2, V850ES/SJ2, V850ES/SG3, and V850ES/SJ3 Usage Restrictions		Document No.	ZBG-CD-07-0019	1/2
		Date issued	March 30, 2007	
		Issued by	Development Tool Group Multipurpose Microcomputer Systems Division 4th Systems Operations Unit NEC Electronics Corporation	
Related documents	IE-703288-G1-EM1 User's Manual: U16697EJ1V0UM	Notification classification	√	Usage restriction
				Upgrade
				Document modification
				Other notification

## 1. Affected product

## Notes on Using IE-703288-G1-EM1

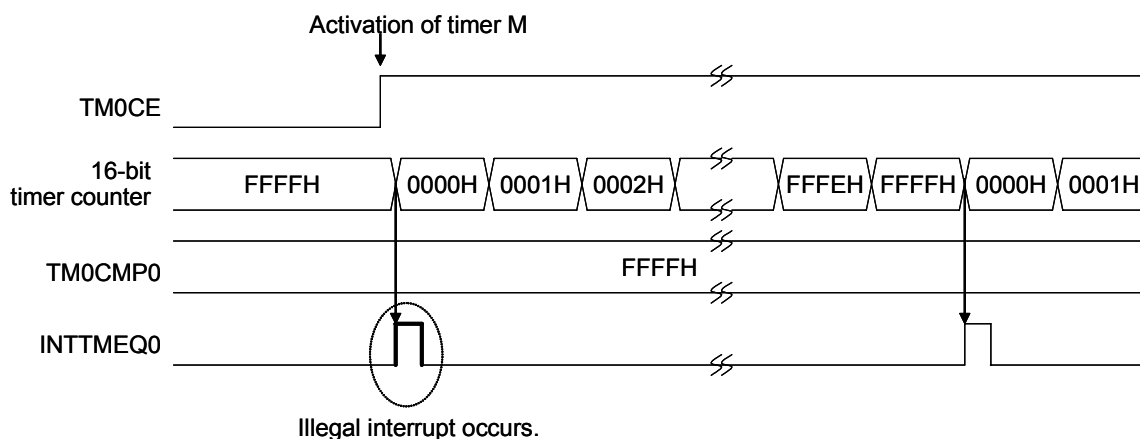
No. 11 Bug in 16-bit timer M compare register

An illegal interrupt occurs after timer M activation when TMM0 compare register 0 (TM0CMP0) is set to FFFFH. See the figure below for details.

Do not set the TM0CMP0 register to FFFFH.  
Please regard this issue as a permanent restriction.
