Microcomputer Technical Information

<p style="text-align: center;">IE-78K0K1-ET In-Circuit Emulator for 78K0/KB1, KC1, KD1, KE1, KF1, KB1+, KC1+, KD1+, KE1+, KF1+</p> <p style="text-align: center;">Usage Restrictions</p>		Document No.	ZBG-CD-04-0035	1/2
		Date issued	July 8, 2004	
		Issued by	Development Tool Group Multipurpose Microcomputer Systems Division 3rd Systems Operations Unit NEC Electronics Corporation	
Related documents	IE-78K0K1-ET Preliminary User's Manual: U16604EJ1V0UM00	Notification classification	√	Usage restriction
				Upgrade
				Document modification
				Other notification

Usage Restrictions

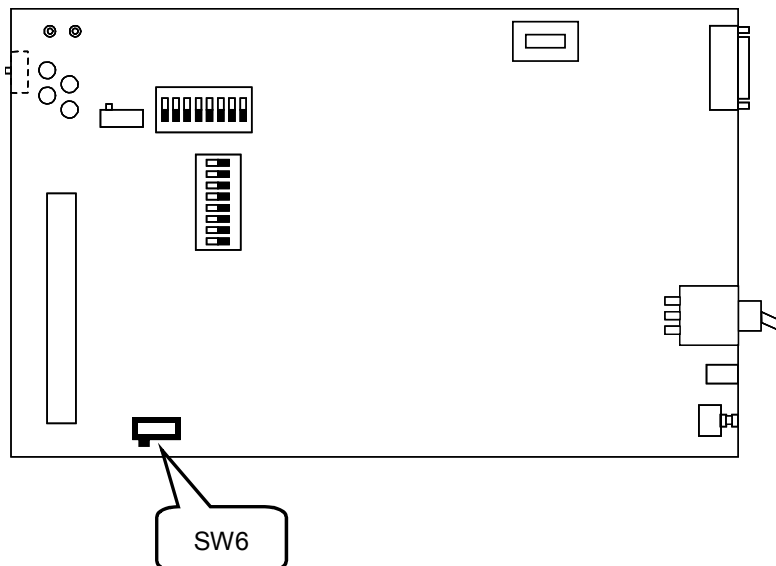
Package Drawing of Emulation board (S-780148 Board)

No.2 SW6

[Description]

Use SW6 in the default setting (3-side). (SW6 is a switch used for maintenance.)

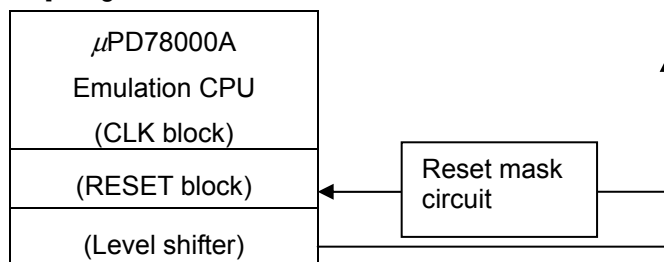
(14) Addition of reset mask circuit

[Location] Pages 37, 41, 45, 49, and 53
