CUSTOMER NOTIFICATION

SUD-DT-03-0314-1-E (SUD-DT-02-0087-1-E revision)
July 31, 2003
Koji Nishibayashi, Senior System Integrator Microcomputer Group 2nd Solutions Division Solutions Operations Unit NEC Electronics Corporation

IE-V850E-MC (Control Code: A, B, C, D)
IE-V850E-MC-A (Control Code: B, C, D, E, F, G)

Operating Precautions

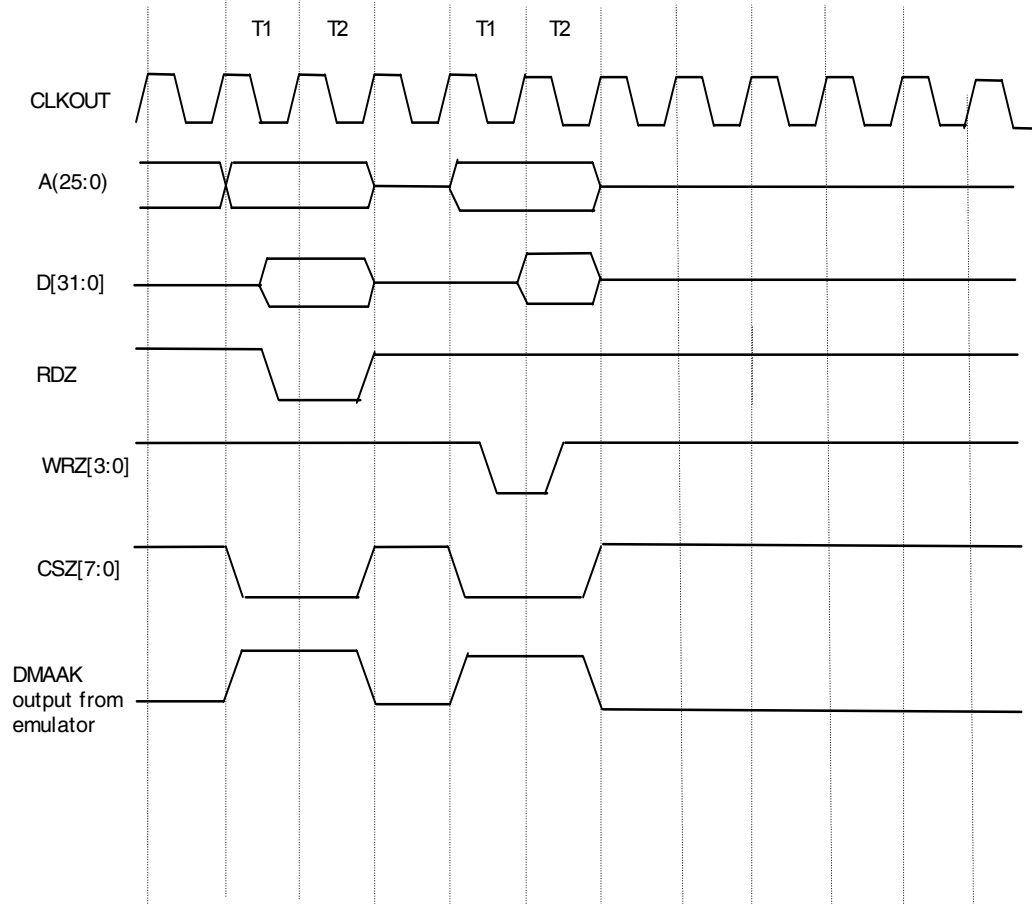
2-cycle line transfer timing from in-circuit emulator (external SRAM → external SRAM)

- When developing V850E/MA1, MA2:
This restriction does not apply because these products do not support line transfer.
- When developing V850E/IA1, IA2:
This restriction does not apply because these products do not support line transfer.
- When developing a system LSI:
This restriction does not apply and the DMAAK signal is output correctly as a DMACTV signal.

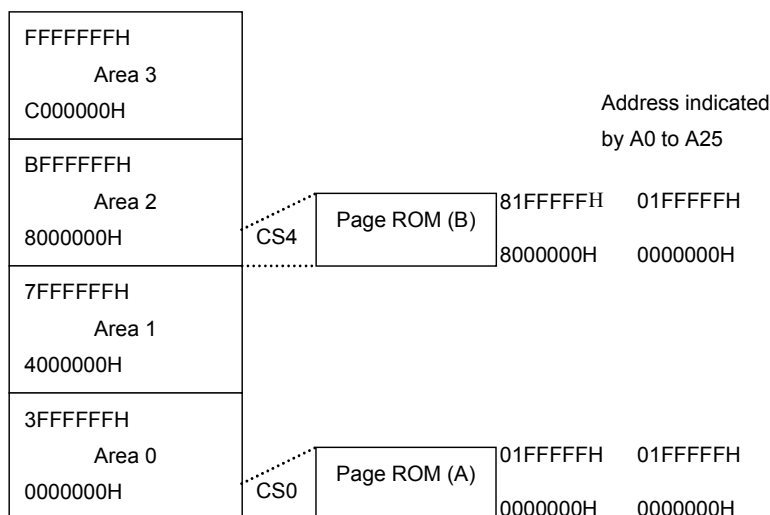
Example of configuration in which this bug can occur

When accessing address 0xxxxx0H in the CS0 area is followed by accessing address 8xxxxx2H in the CS4 area, an on-page cycle will be issued for address 8xxxxx2H.

When multiple page ROMs are used, allocate addresses 25 to 0 so that they do not overlap in each page ROM.

For example, when allocating two 2 MB page ROMs to different CS areas, allocate one page ROM within addresses 0000000H to 01FFFFFFH, and the other within addresses F800000H to F9FFFFFFH.

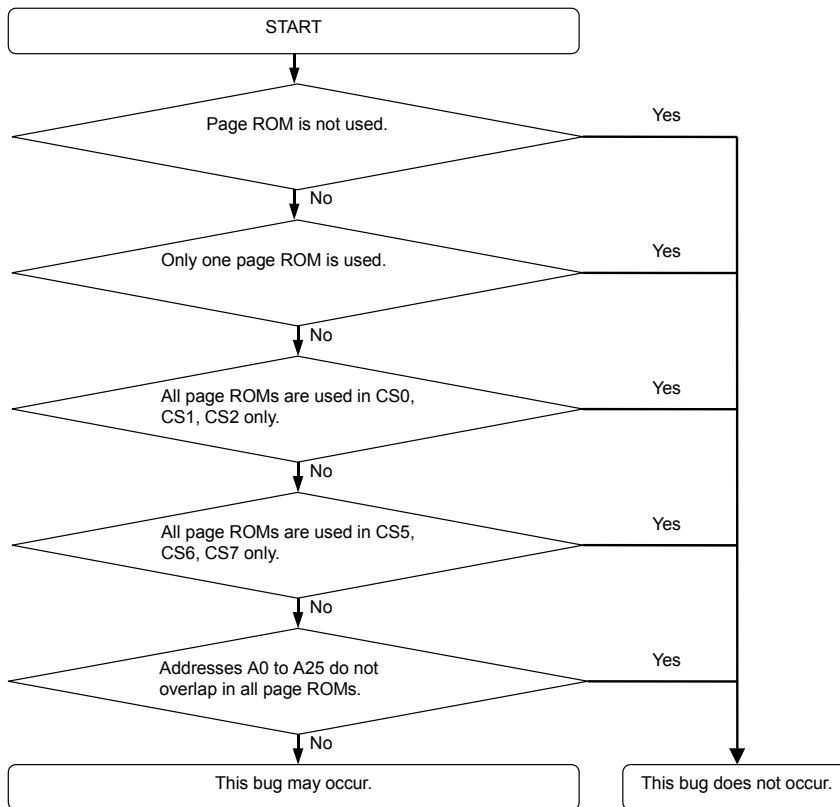
Bug check procedure

The following flowchart can be used to check whether this bug occurs or not. Confirm if this bug applies your company's product using this flowchart.

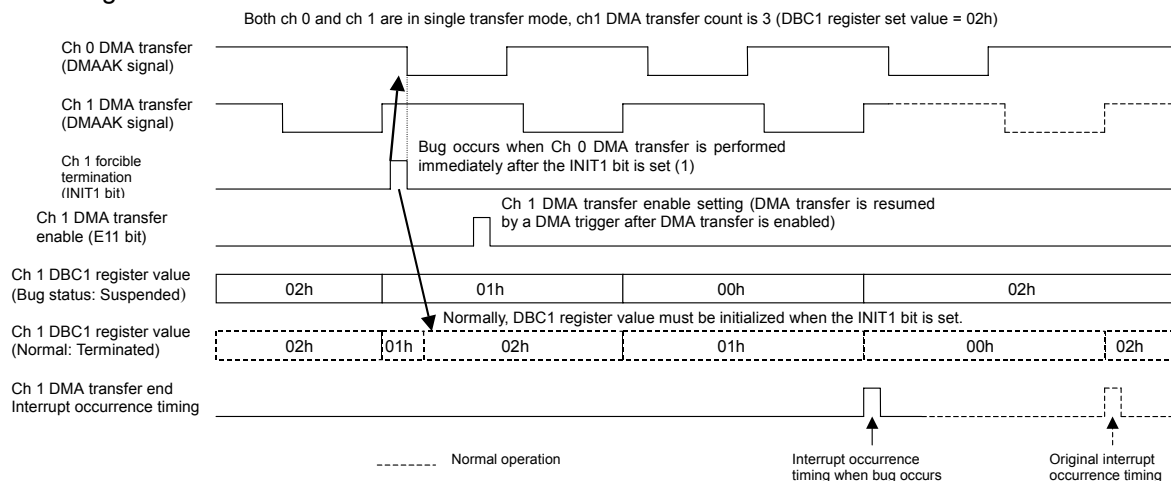
When terminating a DMA transfer by setting the INITn bit of the DCHCn register, the transfer may not be terminated, but just suspended, even though the INITn bit is set (1). As a result, when the DMA transfer of a channel that should have been terminated is resumed, the DMA transfer will terminate after an unexpected number of transfers are completed and a DMA transfer completion interrupt may occur (n = 0 to 3). This bug occurs if a DMA transfer is executed immediately after a forcible termination is set (by setting the INITn bit) (see the figure below).

This bug does not depend on the number of transfer channels, transfer type (2-cycle or flyby), transfer target (between memory and memory, memory and I/O; including internal resources), transfer mode (single, single-step, or block), or trigger (external request, interrupt from internal peripheral I/O, or software), and can occur with any combination of the above elements that can be set under the specifications. In addition, another channel may affect the occurrence of this bug.

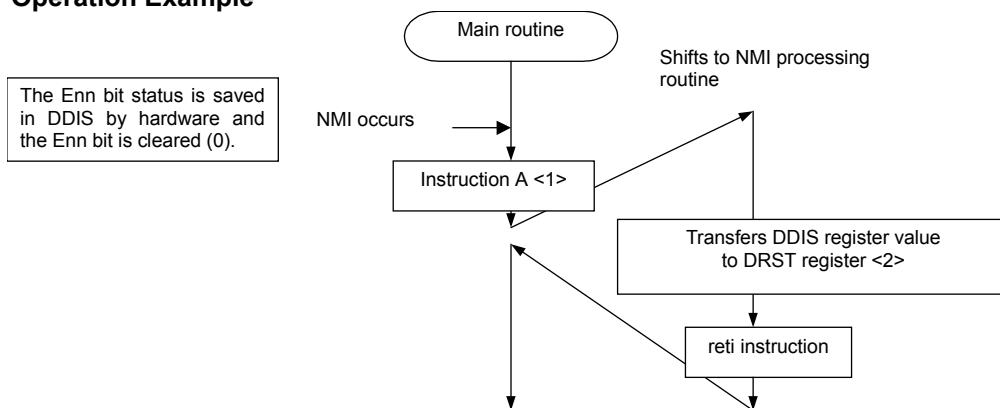
Operation Example

As a result, the DMA transfer suspended by the NMI input cannot be restored as expected regardless of whether DMA transfer has been disabled or enabled.

When the Enn bit of the DCHCn register is set to disable or enable DMA using instruction A, the disable/enable status of each DMA channel is inconsistent in <1> and <2>. As a result, the normally suspended DMA transfer cannot be restored correctly.

Furthermore, when the Enn bit is set (1) using instruction A while the software trigger bit (STGn) of the DCHCn register is set (1), DMA transfer is performed even in the NMI processing routine.

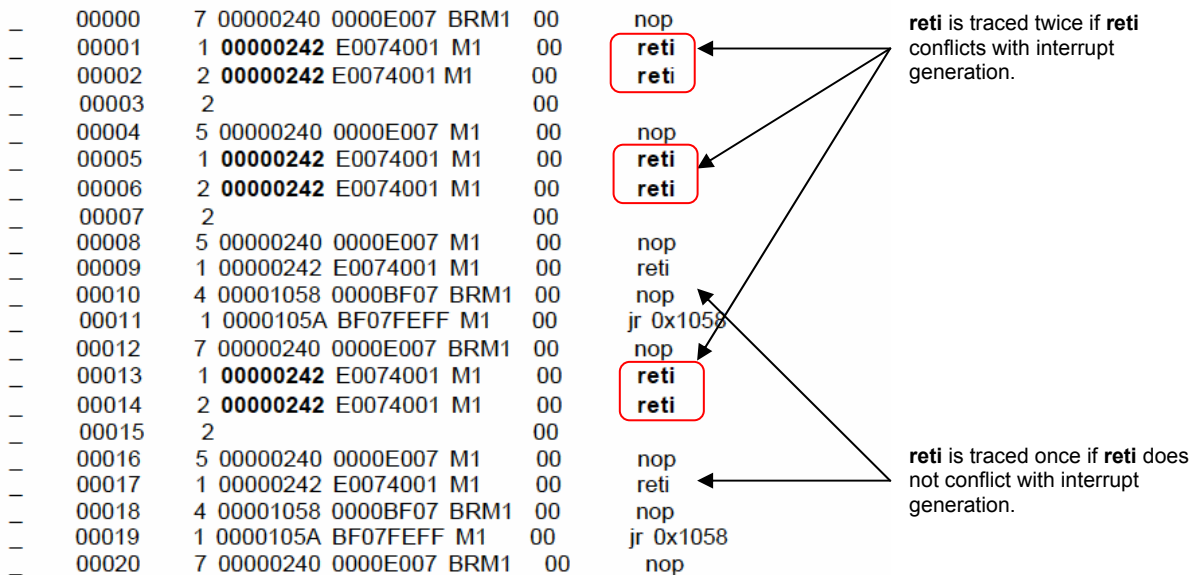
[Bug example]

This restriction affects the trace display only; the actual instruction is executed only once.

There is no workaround. Please regard this as a permanent restriction.

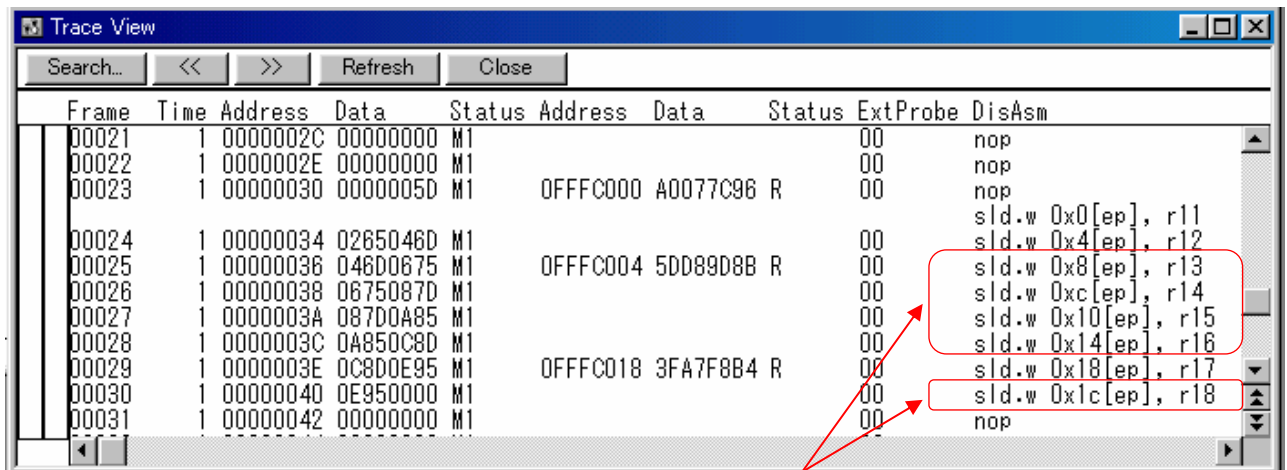
Instruction for which access address/access data is not displayed

When the sld instruction is executed successively, the access data or access address in the trace data may not be displayed. The disassemble data is displayed normally.

This restriction affects the trace display only; the actual instruction is executed normally.

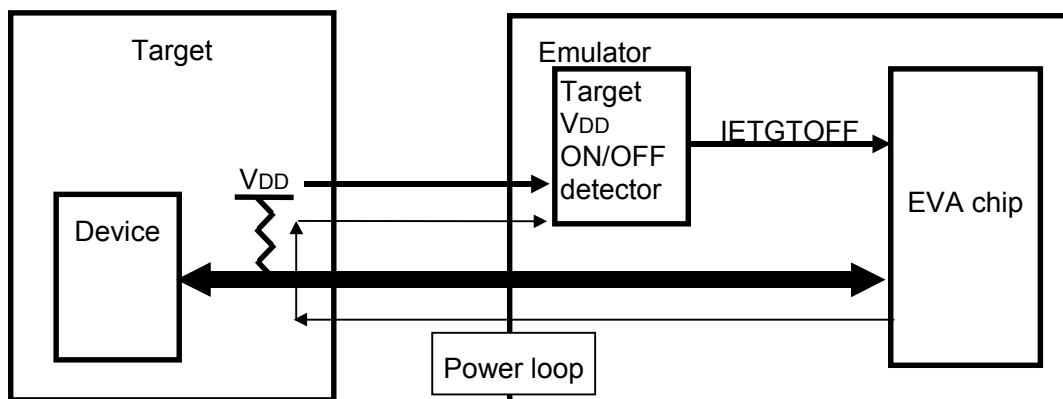
When power to the emulator is on and that to the target is off, leakage current may flow from the emulator to the target.

Some external bus signals, however, drive a high level, and a current may leak into VDD of the target via the pull-up resistor of the target.

The target supply voltage detector circuit of the emulator detects this VDD, and the emulator assumes that power is applied to the target. Consequently, reset is cleared and the external bus signals are driven. As a result, a leakage current flows.

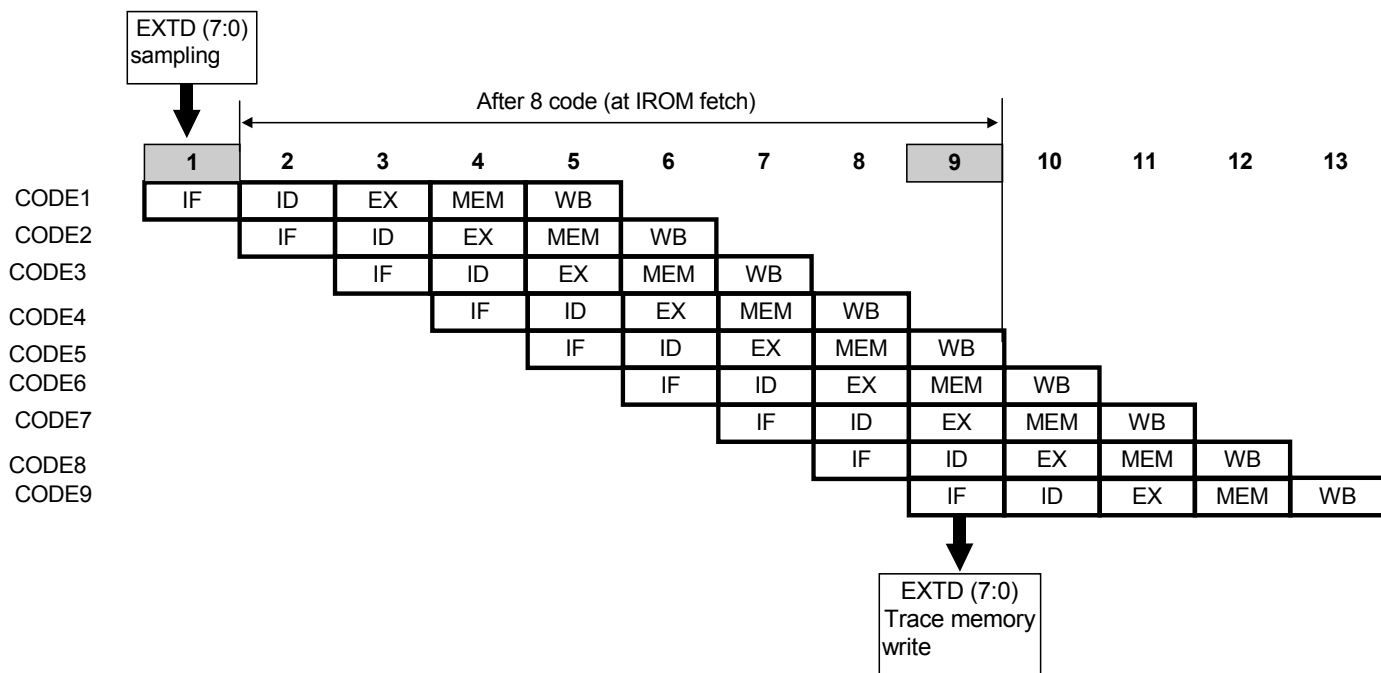
The point to be noted is that the external logic data is not sampled every clock. Because it is not sampled unless instruction execution is performed, a signal that changes after execution of one instruction and before execution of another cannot be detected.

If there is a possibility that an instruction is executed every clock as is the case with IROM, therefore, the chance of missing the external logic data decreases. Conversely, if many wait cycles are inserted in the external memory, the chance of missing the external logic data increases.
