RENESAS TECHNICAL UPDATE

Product Category	Application specific IC		Document No.	TN-ASP-022A/E	Rev.	1.00
Title	M66291 Usage Precautions of the Buffer memory initialization by the Control Read Buffer		Information Category	Technical Notification		
Applicable Product	USB ASSP M66291	Lot No.	Reference Document	M66291 Data Sheet (REJ03F0125)

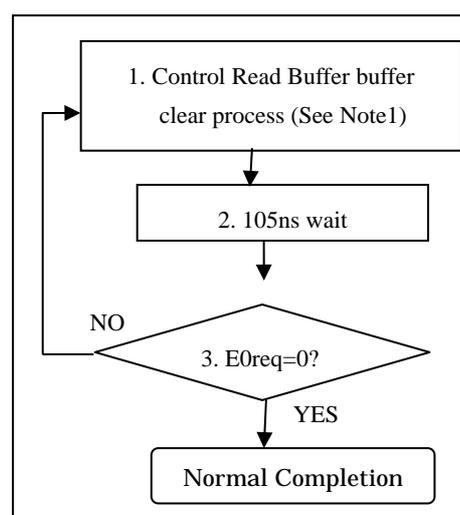
Figure 1. Buffer clear for Control Read Buffer

When sending/receiving packets other than EP0 (EP1, EP2, etc.), the buffer clear process (see Note 1) is disabled when executed in the Control Read Buffer (the buffer used for control read transfers).

This phenomenon occurs when the buffer clear process (see Note 1) is executed in the Control Read Buffer during any of the following three packet transfers (during the periods described).

Repeat the Control Read Buffer buffer clear process until normal completion.

Specifically, use the clear process as described below (also see Fig. 1).

1. Execute Control Read Buffer buffer clear process (see Note 1).

2. Wait 105ns or more after Step 1.

3. Confirm E0req. Repeat Steps 1 and 2 until

E0req is "0" (normal completion)

Note 1: When ISEL = 1, set EP0_BCLR = 1.
