RENESAS TECHNICAL UPDATE

Product Category	Application specific IC		Document No.	TN-ASP-A020A/E	Rev.	1.00
Title	M66591 Usage Precautions of the Buffer memory initialization by the ACLRM bit		Information Category	Technical Notification		
Applicable Product	USB ASSP M66591	Lot No.	Reference Document	M66591 data sheet (REJ03F0101)

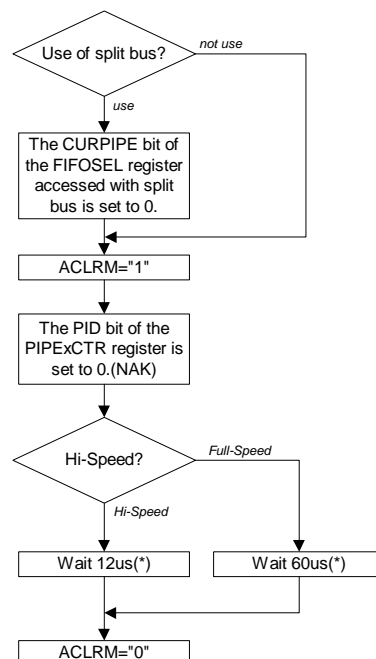
This precaution concerns the Buffer memory initialization by the ACLRM bit.

When the conditions described in [2. Occurring Conditions] below are met, the Interrupt status of the pertinent pipe cannot operate properly.

[1. Phenomena] described above may occur when condition 1 is present at the same time as condition 2 or 3.

Condition 1: The ACLRM bit is set to "1" and then to "0".

Condition 2: During a USB communication.

Condition 3: During an access by using Split bus.

This phenomenon can be avoided by using the following software flowchart.

* When used on Bulk IN transfer (theoretical figure)
