# RENESAS TECHNICAL UPDATE

Product Category	MPU&MCU		Document No.	TN-H8*-A292A/E	Rev.	1.0
Title	Notes on Arbitration Lost in I <sup>2</sup> C Bus Interface of the H8S/2633 Series, H8S/2643 Series and H8S/2638,2639,2630 Group		Information Category	Technical Notification		
Applicable Product	H8S/2633W Series	Lot No.	Reference Document	H8S/2633 Series Hardware Manual (ADE-602-165C Rev.4.0) H8S/2639, H8S/2638, H8S/2636, H8S/2630 Group Hardware Manual (REJ09B0103-0500O Rev.5.00) H8S/2643 Series Hardware Manual (ADE-602-214A Rev.2.0)		
	H8S/2638W, 2639W, 2630W Group	All				
H8S/2643W Series

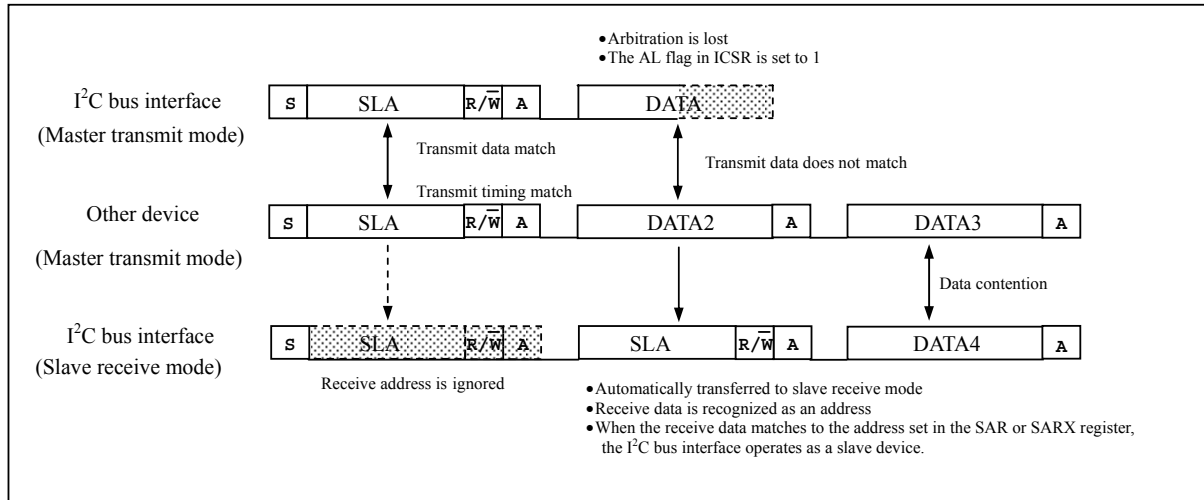
Figure 1 Diagram of Erroneous Operation when Arbitration is Lost

The I<sup>2</sup>C bus interface recognizes the data in transmit/receive frame as an address when arbitration is lost in master mode and a transition to slave receive mode is automatically carried out.

When arbitration is lost not in the first frame but in the second frame or subsequent frame, transmit/receive data that is not an address is compared with the value set in the SAR or SARX register as an address. If the receive data matches with the address in the SAR or SARX register, the I<sup>2</sup>C bus interface erroneously recognizes that the address call has occurred. (See figure 1.)

In multi-master mode, a bus conflict could happen. When the I<sup>2</sup>C bus interface is operated in master mode, check the state of the AL bit in the ICSR register every time after one frame of data has been transmitted or received.

When arbitration is lost during transmitting the second frame or subsequent frame, take avoidance measures.
