Concerned Products:	Customer Notification	Date: Sep. 21, 2000
<p><i>μPD703031A</i> <i>μPD703031AY</i> <i>μPD703032A</i> <i>μPD703032AY</i> <i>μPD703033A</i> <i>μPD703033AY</i> <i>μPD70F3032A</i> <i>μPD70F3032AY</i> <i>μPD70F3033A</i> <i>μPD70F3033AY</i> <i>μPD70F3033</i> <i>μPD70F3033Y</i></p>	Bug Report	<p>NEC-Electronics (Europe) GmbH EAD –Technical Product Support</p> <p>Source Doc: HW 260199 HW 080299 SBG-T-1719 SBG-T-1777 SBG-T-2107</p> <p>Author: H.-W. Hoefl, Udo Wenzel</p>
Date of initial issue: Feb 19 th 99		Doc. No.: TPS-HE-B-2122

(A) BUG LIST

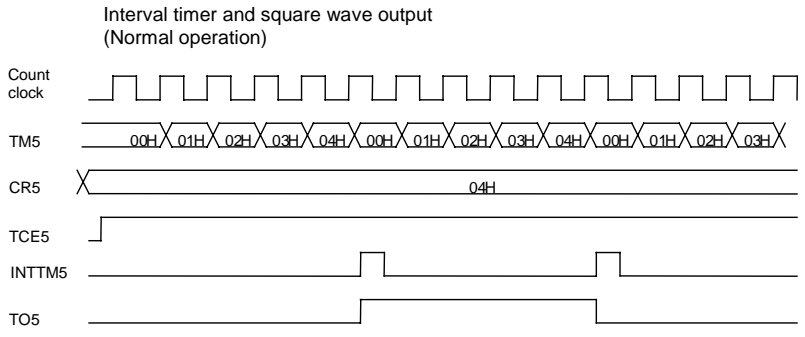
<p>3</p>	<p>TM 2-5 operational defect</p>	<p><u>Details:</u></p> <p>When used in interval timer mode If the compare register (CR20-50) is written when the timer register (TM2-5) and compare register (CR20-50) coincide, a coincidence signal is not generated. For this reason, the software must be designed to prevent timer coincidence and writing the compare register occurring at the same time. (Example: use a Vector interrupt)</p> <p>When used in square wave output mode If the compare register (CR20-50) is written when the timer register (TM2-5) and compare register (CR20-50) coincide, a coincidence signal is not generated and the output waveform does not invert. For this reason, the software must be designed to prevent timer coincidence and writing the compare register occurring at the same time. (Example: use a Vector interrupt)</p> <div style="text-align: center;"> <p>Interval timer and square wave output (Normal operation)</p>

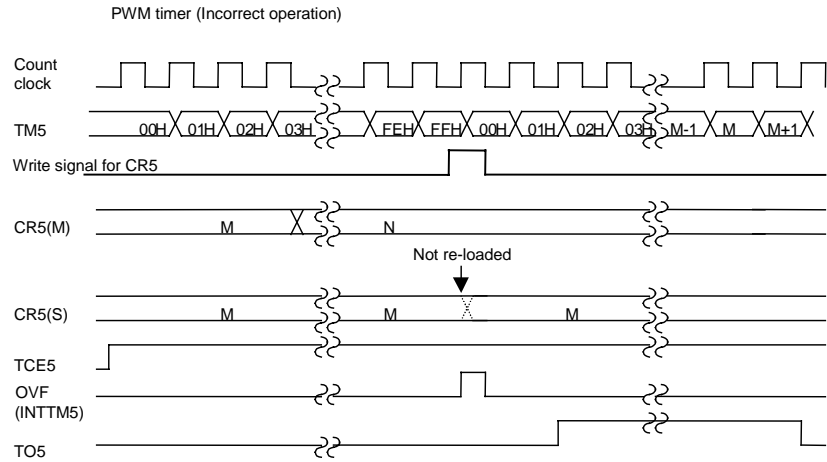
- If the CR20-50 register is read when an overflow occurs, the CR20-50 master register will not transfer data to the CR20-50 slave register. The data is transferred when the next overflow occurs.

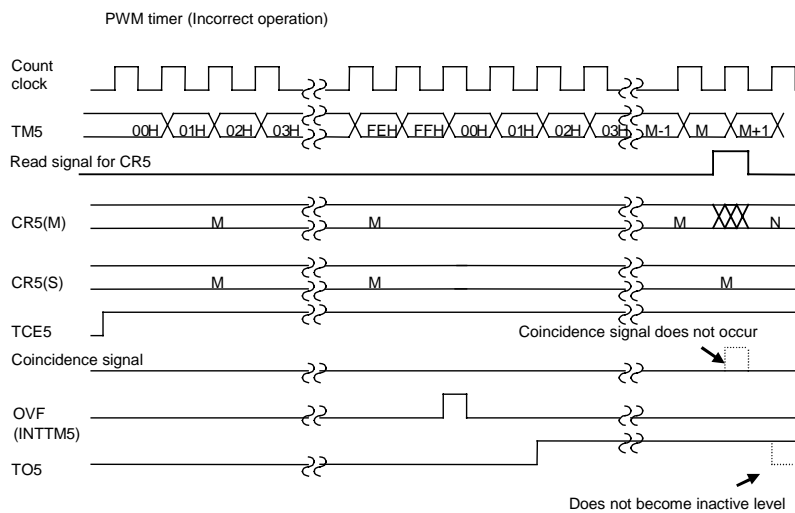
- If the compare register (CR20-50) is written when the timer register (TM2-5) and compare register (CR20-50 [slave register]) coincide, a coincidence signal is not generated and the inactive level is not attained.

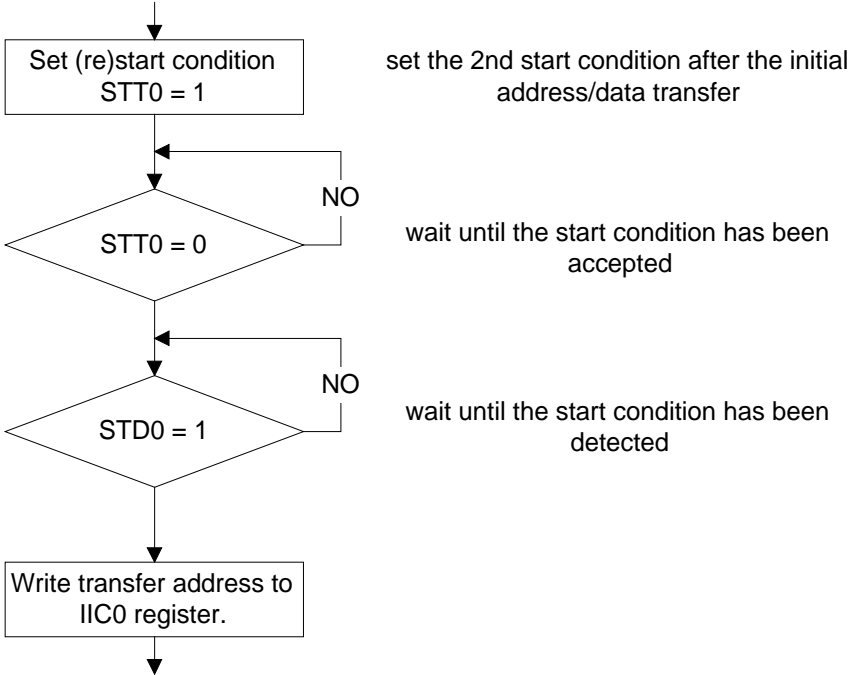
Bug No.	Outline	Description
4	Using the IIC restart condition causes a faulty address transfer.	<p><u>Details</u> If the transfer address is set to the shift register (IIC0) immediately after the (re)start is set (STT = 1), the transfer address will be sent simultaneously by rising edge of the serial clock (SCL). The serial clock is at low level normally before a restart condition will be set, due to the preceded address/data transfer. To generate a (re)start condition the serial clock (SCL) has to be first on high level (recessive state). By falling edge of the SDA line, when SCL has high level, the (re)start condition can be detected. Afterwards the SCL line will fall to low level and the slave address can be transferred by normal operation. Now, if the slave address is written into the shift register (IIC0) immediately after the start condition trigger (STT0) is set, the rising edge on the SCL line resulting in data output before the start condition is set. This causes the bug.</p> <p><u>Workaround</u> The transfer address must be set after the confirmation of start condition detection (STT=0, STD = 1).</p>

<pre> graph TD Start([Start]) --> Set[Set (re)start condition STT0 = 1] Set --> STT0{STT0 = 0} STT0 -- NO --> Wait1[wait until the start condition has been accepted] Wait1 --> STT0 STT0 -- YES --> STD0{STD0 = 1} STD0 -- NO --> Wait2[wait until the start condition has been detected] Wait2 --> STD0 STD0 -- YES --> Write[Write transfer address to IIC0 register.] Write --> End([End]) </pre>

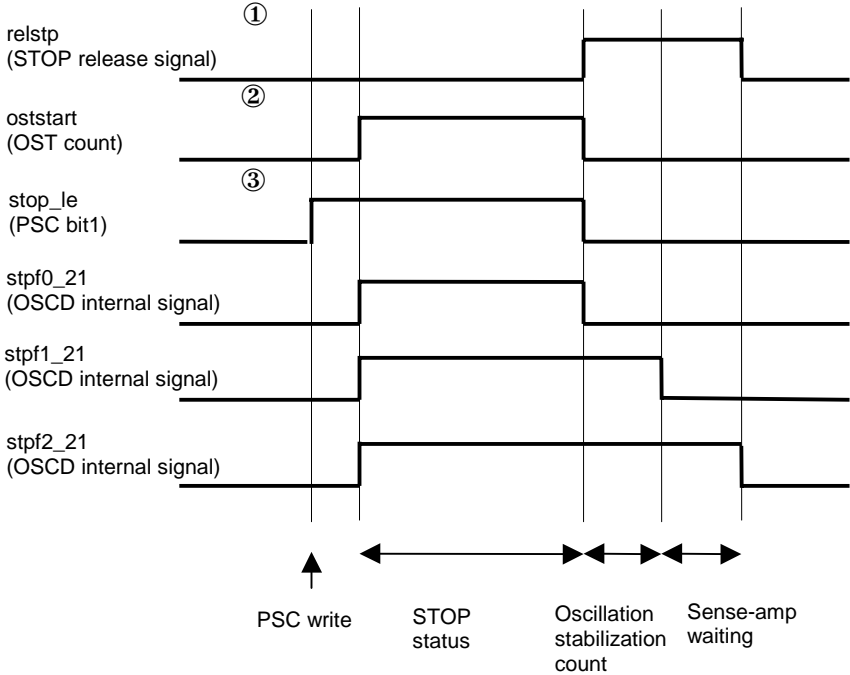
<p>Diagramm1: STOP release operation timing (Normal)</p>

Bug No.	Outline	Description
5	STOP Mode	<p>The CPU becomes deadlocked, if the timing of a STOP mode enable and a Stop mode release are in conflict</p> <p><u>Details</u></p> <p>With the V850/SA1, the STOP mode is enable by writing (stop_le^③) to the PSC register (Power Save Control register). To release the Stop mode, the count initialization signal (oststart:^②) is generated to start the WDT (watchdog timer) that counts out the oscillation stabilization time (refer to diagram 1). However, if the stop mode release signal (relstp:^①) because of an interrupt, etc. conflicts with writing to the PSC register (the timing for the bug to occur is within 2 clocks), then the oststart signal is not generated and WDT does not start counting. This means that the microcomputer remains waiting for the oscillation stabilization time to elapse, and even if the stop mode release signal is generated, STOP mode cannot be released (refer to diagram 2).</p> <p><u>Workaround</u></p> <p>As a temporary measure it is suggest that you use the IDLE mode or sub-IDLE mode instead of the STOP mode.</p>
