<b>Concerned Products:</b>	<b>Customer Notification</b>	Date: Nov. 8, 1999
<i>μPD703033</i> <i>μPD703033Y</i> <i>μPD70F3033</i> <i>μPD70F3033Y</i>		NEC-Electronics (Europe) GmbH EAD –Technical Product Support
<b>Bug Report</b>		Source Doc: HW 260199 HW 080299 SBG-T-1719 SBG-T-1777
		Author: H.-W. Hoefft, Udo Wenzel
Date of initial issue: Feb 19 <sup>th</sup> 99		Doc. No.: TPS-HE-B-2120

**(A) BUG LIST**

**(B) BUG DESCRIPTION**

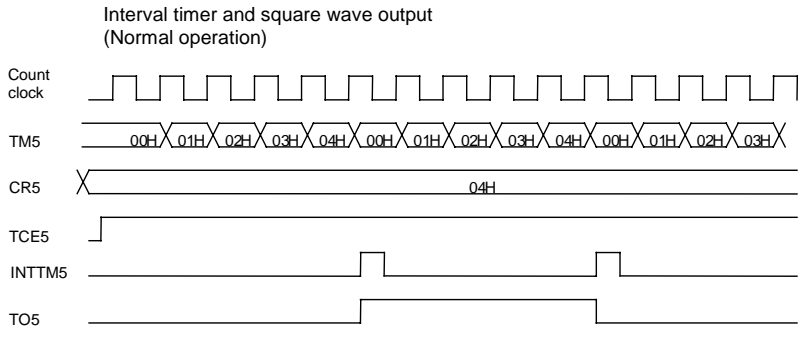
<p>3</p>	<p>TM 2-5 operational defect</p>	<p><u>Details:</u></p> <p>When used in interval timer mode          If the compare register (CR20-50) is written when the timer register (TM2-5) and compare register (CR20-50) coincide, a coincidence signal is not generated. For this reason, the software must be designed to prevent timer coincidence and writing the compare register occurring at the same time. (Example: use a Vector interrupt)</p> <p>When used in square wave output mode          If the compare register (CR20-50) is written when the timer register (TM2-5) and compare register (CR20-50) coincide, a coincidence signal is not generated and the output waveform does not invert. For this reason, the software must be designed to prevent timer coincidence and writing the compare register occurring at the same time. (Example: use a Vector interrupt)</p> <div style="text-align: center;"> <p>Interval timer and square wave output (Normal operation)</p>

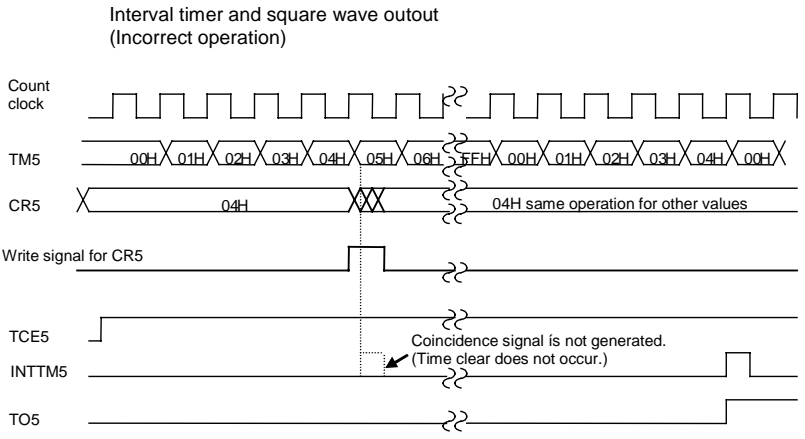
</div> <div style="text-align: center;"> <p>Interval timer and square wave output (Incorrect operation)</p>

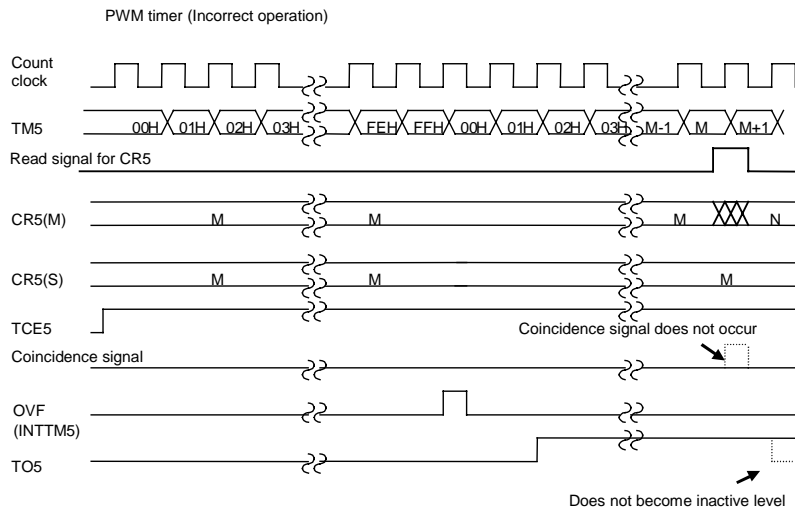
- If the compare register (CR20-50) is written when the timer register (TM2-5) and compare register (CR20-50 [slave register]) coincide, a coincidence signal is not generated and the inactive level is not attained.

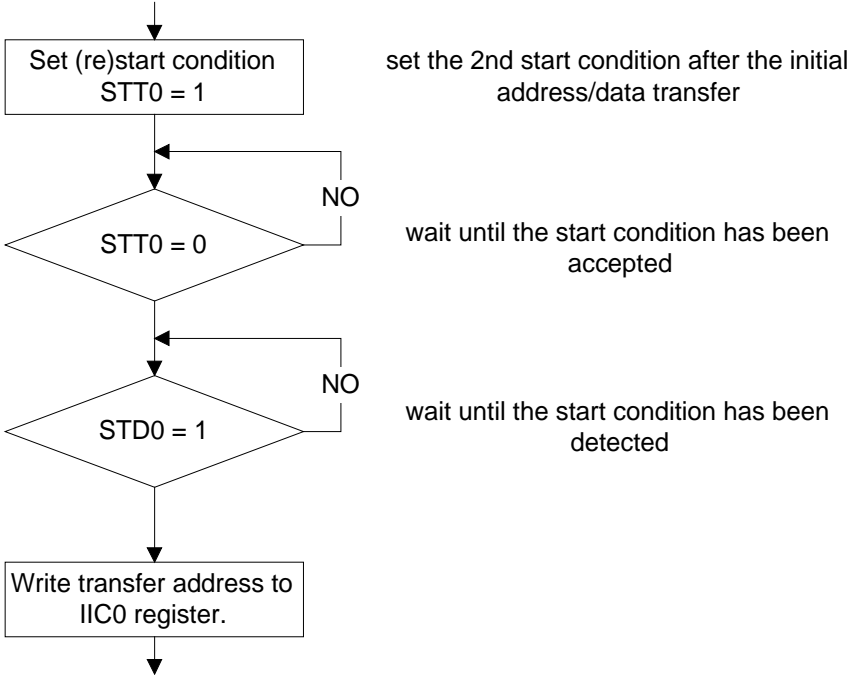
Bug No.	Outline	Description
4	Using the IIC restart condition causes a faulty address transfer.	<p><u>Details</u>                      If the transfer address is set to the shift register (IIC0) immediately after the (re)start is set (STT = 1), the transfer address will be sent simultaneously by rising edge of the serial clock (SCL).                      The serial clock is at low level normally before a restart condition will be set, due to the preceded address/data transfer. To generate a (re)start condition the serial clock (SCL) has to be first on high level (recessive state). By falling edge of the SDA line, when SCL has high level, the (re)start condition can be detected. Afterwards the SCL line will fall to low level and the slave address can be transferred by normal operation.                      Now, if the slave address is written into the shift register (IIC0) immediately after the start condition trigger (STT0) is set, the rising edge on the SCL line resulting in data output before the start condition is set. This causes the bug.</p> <p><u>Workaround</u>                      The transfer address must be set after the confirmation of start condition detection (STT=0, STD = 1).</p>

<pre>                     graph TD                         Start([Start]) --&gt; Set[Set (re)start condition STT0 = 1]                         Set --&gt; STT0{STT0 = 0}                         STT0 -- NO --&gt; Wait1[wait until the start condition has been accepted]                         Wait1 --&gt; STT0                         STT0 -- YES --&gt; STD0{STD0 = 1}                         STD0 -- NO --&gt; Wait2[wait until the start condition has been detected]                         Wait2 --&gt; STD0                         STD0 -- YES --&gt; Write[Write transfer address to IIC0 register.]                         Write --&gt; End([End])                     </pre>

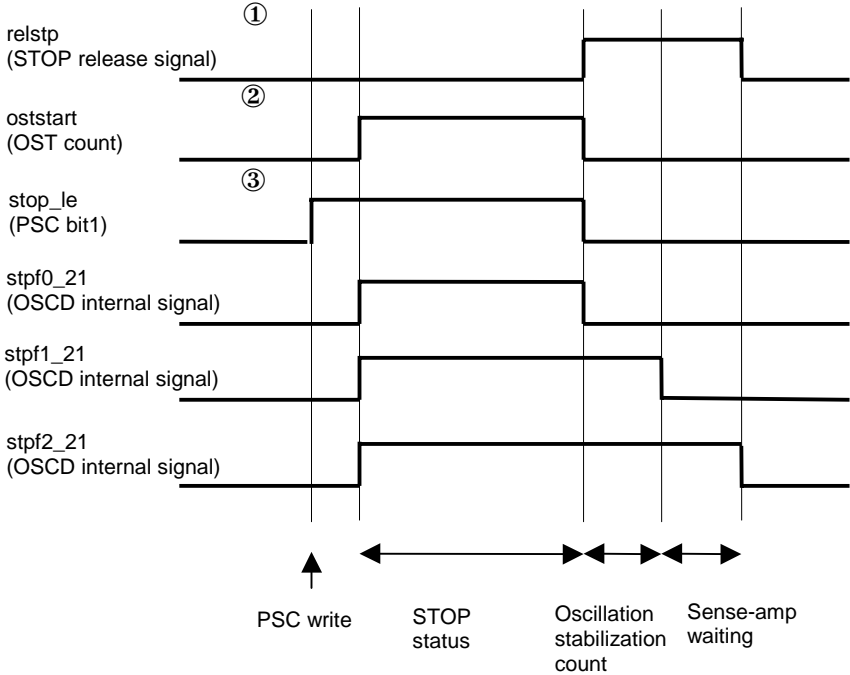
<p style="text-align: center;">Diagramm1: STOP release operation timing (Normal)</p>

Bug No.	Outline	Description
5	STOP Mode	<p>The CPU becomes deadlocked, if the timing of a STOP mode enable and a Stop mode release are in conflict</p> <p><u>Details</u></p> <p>With the V850/SA1, the STOP mode is enable by writing (stop_le<sup>③</sup>) to the PSC register (Power Save Control register). To release the Stop mode, the count initialization signal (oststart:<sup>②</sup>) is generated to start the WDT (watchdog timer) that counts out the oscillation stabilization time (refer to diagram 1). However, if the stop mode release signal (relstp:<sup>①</sup>) because of an interrupt, etc. conflicts with writing to the PSC register (the timing for the bug to occur is within 2 clocks), then the oststart signal is not generated and WDT does not start counting. This means that the microcomputer remains waiting for the oscillation stabilization time to elapse, and even if the stop mode release signal is generated, STOP mode cannot be released (refer to diagram 2).</p> <p><u>Workaround</u></p> <p>As a temporary measure it is suggest that you use the IDLE mode or sub-IDLE mode instead of the STOP mode.</p>
