Concerned Products:	Customer Notification	Date: 16 March 2000
<p><i>μPD784224</i> <i>μPD784224Y</i> <i>μPD784225</i> <i>μPD784225Y</i></p> <p><i>μPD78F4225</i> <i>μPD78F4225Y</i></p>		NEC-Electronics (Europe) GmbH EAD -Technical Product Support
Bug Report		Source Doc: SBG-T-0483 SBG-T-0504 SIF-T-?? (TQ-TH970820/1) SIF-T-10395 (TQ-TH971215/2) SBG-T-0619 NN
		Author: A. Twardy
Date of initial issue: 07 August 1998		Doc. No.: TPS-LE-B-4223

(A) BUG LIST

(B) BUG DESCRIPTION

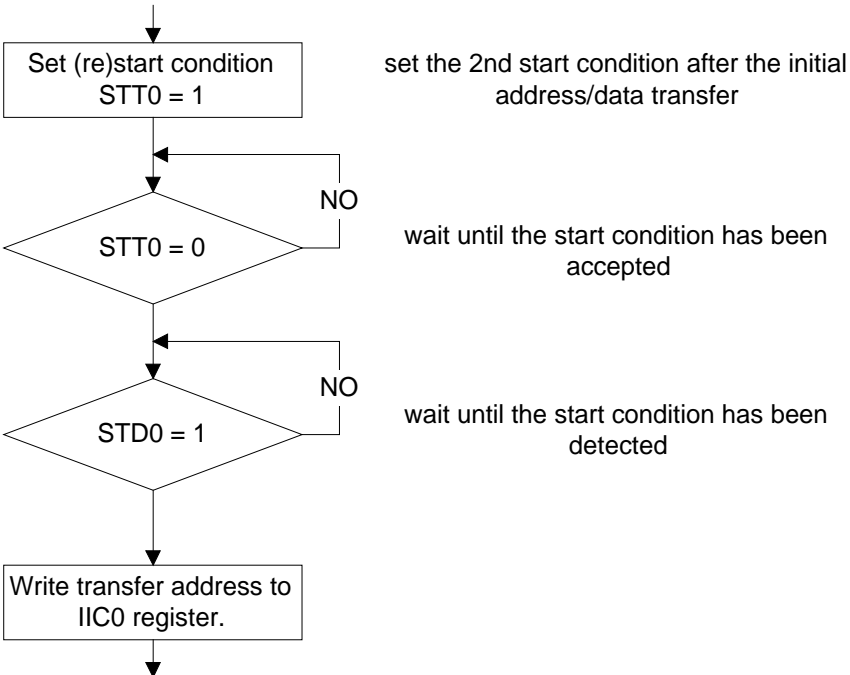
Bug No.	Outline	Description
4	Using the I ² C restart condition causes a faulty address transfer.	<p><u>Details</u></p> <p>If the transfer address is set to the shift register (IIC0) immediately after the (re)start is set (STT = 1), the transfer address will be sent simultaneously by rising edge of the serial clock (SCL).</p> <p>The serial clock is at low level normally before a restart condition will be set, due to the preceded address/data transfer. To generate a (re)start condition the serial clock (SCL) has to be first on high level (recessive state). By falling edge of the SDA line, when SCL has high level, the (re)start condition can be detected. Afterwards the SCL line will fall to low level and the slave address can be transferred by normal operation. Now, if the slave address is written into the shift register (IIC0) immediately after the start condition trigger (STT0) is set, the rising edge on the SCL line resulting in data output before the start condition is set. This causes the bug.</p> <p><u>Workaround</u></p> <p>The transfer address must be set after the confirmation of start condition detection (STT=0, STD = 1).</p>

<pre> graph TD Start(()) --> Set[Set (re)start condition STT0 = 1] Set --> STT0{STT0 = 0} STT0 -- NO --> STT0 STT0 -- YES --> STD0{STD0 = 1} STD0 -- NO --> STD0 STD0 -- YES --> Write[Write transfer address to IIC0 register.] Write --> End(()) </pre> <p>set the 2nd start condition after the initial address/data transfer</p> <p>wait until the start condition has been accepted</p> <p>wait until the start condition has been detected</p>

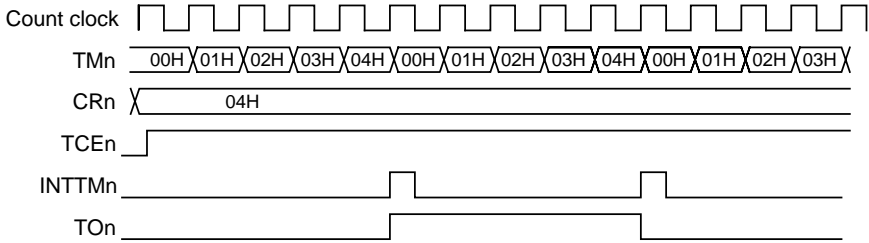
Bug No.	Outline	Description
6	Timer compare register access while corresponding timer register matches	<p><u>Details</u></p> <p>The Bugs described below concern all 8-Bit Timers of the μPD784216/4216Y subseries. In detail the timers concerned are Timer 1, 2, 5, 6, 7 and Timer 8.</p> <p>6.1 Interval timer mode Writing to a compare register while the corresponding timer register matches does not generate an interrupt request. Under conditions like above the timerregister is not cleared in the "Timer Clear & Start" mode.</p> <p>6.2 Square wave output mode Writing to a compare register while the corresponding timer register matches does not invert the output signal of the timer output.</p> <p>Please refer to the timing diagrams shown below.</p> <div style="border: 1px solid black; padding: 5px; margin: 10px 0;"> <p>Please note, however, that the timing charts below are schematic representations of operations and therefore do not indicate a precise operation timing.</p> </div> <p><u>Normal operation</u></p>

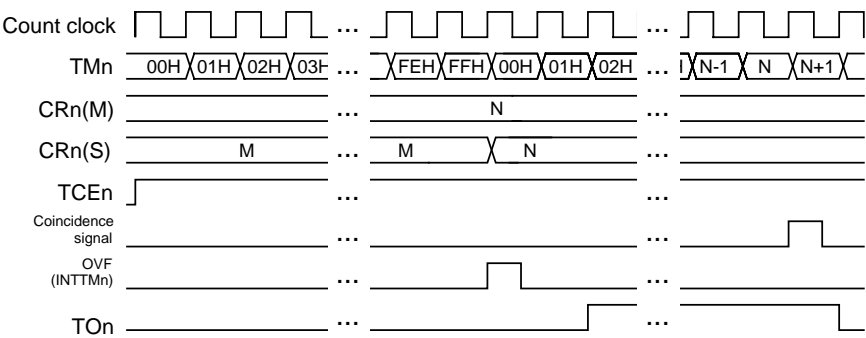
<p>In PWM mode the data transfer from the master to the slave register is performed when an overflow occurs. This bug occurs when performing a data transfer from the concerned master register to the slave register when an overflow occurs in an attempt to rewrite the value of the master register, thus damaging the data to be transferred.</p> <p>The description of the bugs are in detail as following:</p> <p>6.3.1 Writing to a compare register while the corresponding timer register matches does not change the output signal of the timer to the inactive level.</p> <p>6.3.2 Writing to CRn0 (master register) once and then writing again when the corresponding timer register (TMn) overflows causes an undefined value to be transferred to CRn0 (slave register).</p> <p>6.3.3 Reading the compare register when an overflow of the corresponding timer occurs stops the transfer of data form CRn0 (master register) to CRn0 (slave register). The transfer is performed when overflow of the timer occurs.</p> <p>Please refer to the timing diagrams shown below.</p> <div style="border: 1px solid black; padding: 5px; margin: 10px 0;"> <p>Please note, however, that the timing charts below are schematic representations of operations and therefore do not indicate a precise operation timing.</p> </div> <p><u>Normal operation as PWM timer</u></p>

Bug No.	Outline	Description
6	Timer compare register access while corresponding timer register matches (continuation)	<p><u>Workaround</u></p> <p>In general the countermeasure is to avoid writing to the compare register by coincidence between timer register and compare register. This can be realised by using the interrupt processing (INTTMn) of each timer.</p> <p><u>In the cases mentioned under 6.1 and 6.2</u></p> <p>Use the interrupt which is generated by coincidence between the timer register and the compare register. This interrupt should be used to write to the compare register before the next coincidence occurs.</p> <p><u>In the cases mentioned under 6.3.1, 6.3.2 and 6.3.3</u></p> <p>Use the interrupt which is generated when the overflow of the timer occurs. In this interrupt process avoid the correspondences between the timer register, the compare register and the next timeroverflow.</p> <p>Another countermeasure for all bugs mentioned under 6, is to stop the timer operation once before resuming it.</p>
