Concerned Products:	Customer Notification		Date: May 3, 1999
μPD789011 μPD789012 μPD78P9014			Bug Report
Jan. 28th, 98		Doc. No.: TPS-LE-B-S001	
1 st revision	: May 3, 99	Doc. No.: TPS-LE-B-S001-1

(A) BUG LIST

(B) BUG DESCRIPTION

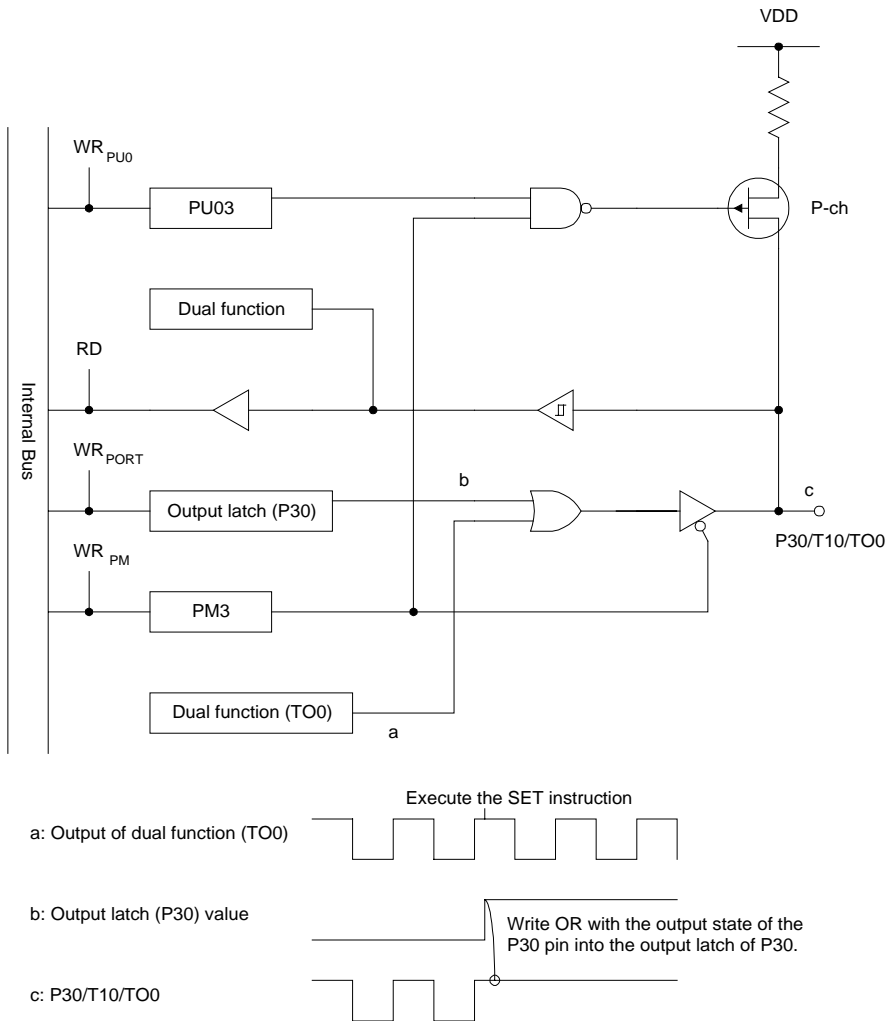
Figure P30 Block Diagram

Bug No.	Outline	Description
1	Bit and logical operation at ports 2 and 3	<p>Details</p> <p>Avoid to use bit operation instructions and logical operation instructions on Ports 2 and 3(dual function pins). Instead of this, be sure to use 8 or 16-bit data transfer instructions to control output ports 2 and 3.</p> <p>Reason for operating precautions Executing bit operation instructions (SET1, CLR1) and logical operation instructions (OR, XOR, etc.) on the ports (2 and 3) which have the dual functions of timer output and serial interface may cause the contents of the dual function pins to be different from the expected values. This is because the bit operation instructions and logical operation instructions of the μPD789011, 789012 and 78P9014 are not for performing operations on the contents of the output latch but for performing operations on the status of the relevant pins.</p> <p>We have no plans to change the device circuits.</p> <p>For your reference, Attachment 1 shows an example of executing the SET1 instruction on P32 causing P30 to be fixed to "H" and Attachment 2 is listing the ports and instructions relevant to this precaution.</p>

- ① Uses P30 as the TO0 output to execute “SET1 PORT 3.2” while TO0 is outputting a high level.
- ② The CPU reads all the pin statuses of Port 3 in response to the SET1 operating instruction, sets the relevant bit (P32 in this example) and writes the result to the latch of the Port 3.
- ③ When this SET1 instruction was executed, pin P30 was high level. This results in a high level being written to the output latch of P30, thus causing the pin’s output to be fixed to high level. (When outputting TO0, it is necessary to set the output latch to low level first.)

The example below shows an example where only the relevant bits are affected, taking the restrictions into consideration.

C Language	Assembler
P3 = (P3 0 x 04) & 0 x 04;	MOV A, P3 OR A, #4 AND A, #4 MOV P3, A
