Concerned Products:	Customer Notification		Date: Aug. 30, 1999
μPD789405/6/7 μPD789415/6/7 μPD78F9418			Bug Report
Jan. 28th, 98		Doc. No.: TPS-LE-B-S401	
1 st revision	: June 4th, 98	Doc. No.: TPS-LE-B-S401	
2 nd revision	: Nov. 18th, 98	Doc. No.: TPS-LE-B-S401-1	
3 rd revision	: Aug. 30th, 99	Doc. No.: TPS-LE-B-S401-2

(A) BUG LIST

(B) BUG DESCRIPTION

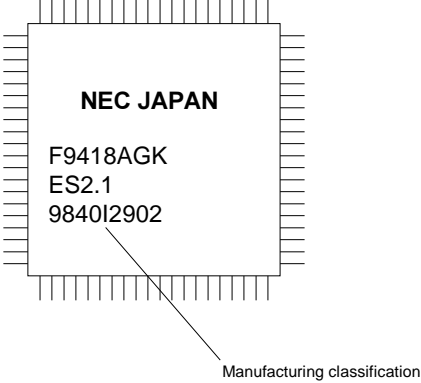
Bug No.	Outline	Description
7	uPD78F9418A ES2.1 restrictions	<p>Detail:</p> <p>1: Restrictions</p> <p>The samples we are sending to your company are ES level. Therefore, NEC does not guarantee their reliability. Please use these samples for function verification only.</p> <p>2: Writing to flash memory</p> <p>Set the flash memory write/erease VPP voltage of this product to 10.3V with the flash programmer.</p> <p>→ As a result of this restriction, samples marked with the manufacturing classification "K" onwards should be set to VPP=10.0V.</p> <p>Manufacturing classification is shown on the device lot number markings as indicated below.</p>

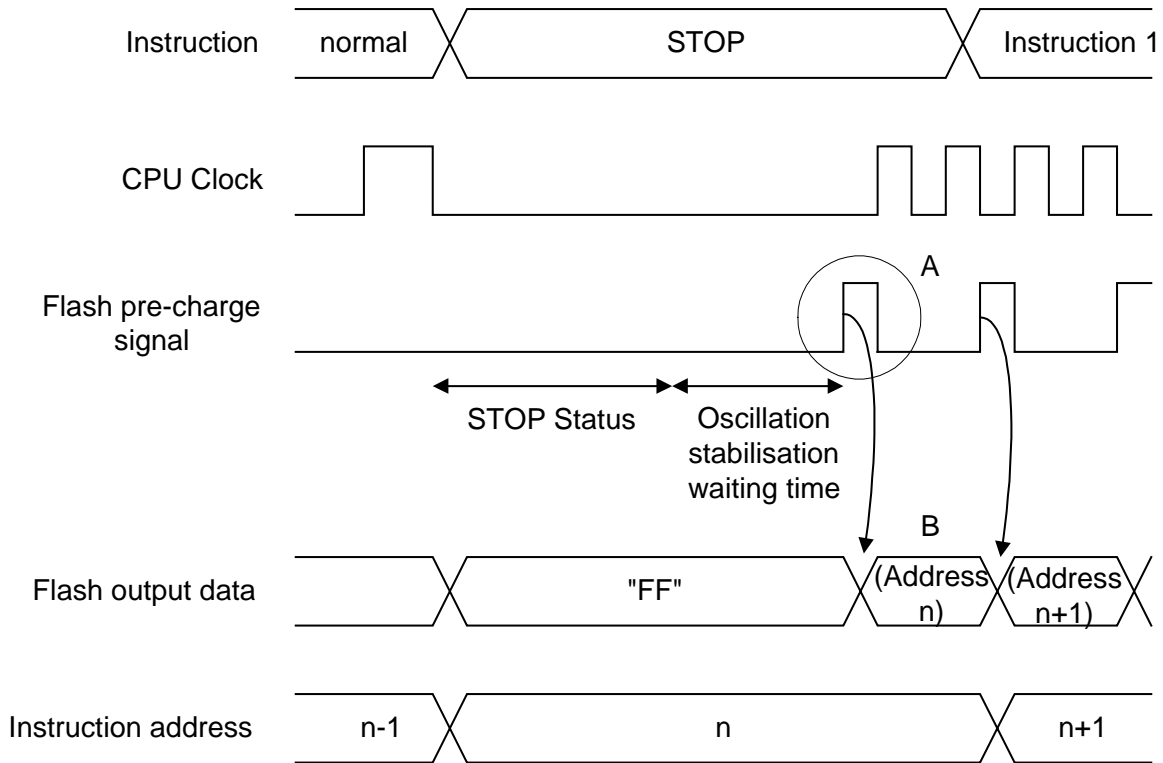
Attachment 1

Bug No.	Outline	Description
6	Stop mode release restrictions for flash device	<p>Detail:</p> <p>To use the flash device in stop mode, be sure to release the stop mode with a vector interrupt, not only with the request flag. For a detailed restriction description see the Attachment 1.</p> <p>An interrupt, which does not jump to a vector after stop mode is released results in runover after STOP is released.</p>

Example of operation where jump to vector does not occur after STOP releasing.

(When STOP instruction exists at address (n-1))

The diagram shows that the pre-charge signal does not occur and "FF" remains output since flash does not output data B.

After releasing STOP, the next instruction "Instruction 1" becomes "FF" since vector is not jumped to, and unstable operation occurs since "FF" has not been mapped.

→ When vector is jumped to after releasing STOP, data B is not used as an instruction and Instruction 1 is processed as vector operation, therefore, the problem does not occur.
