Concerned Products:	Customer Notification	Date: June 4, 1998
		NEC-Electronics (Europe) GmbH EAD –Technical Product Support
IE-789136-NS-EM1	Bug Report	Source Doc: SBG-T-0603
		Author: W. Noll M. Kratz
June 4th, 98		Doc. No.: TPS-LE-B-ST10
1 st revision :		Doc. No.:

(A) BUG LIST

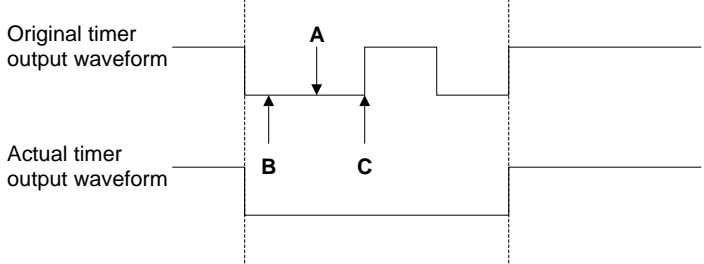
Bug No.	Outline	Description
2	8-bit PWM timer (TM80/TM81/TM82) restrictions	<p><u>Detail restriction 1:</u> To use these timers in interval timer mode, rewrite the value of the compare registers (CR89/CR81/CR82) in a state where the timer operation is inhibited. Rewriting the value of a compare register (CRxx) in a state where the timer operation is permitted may generate coincidence signals immediately. (In the case that interrupts are permitted, interrupt requests will occur.)</p> <p><u>Detail restriction 2:</u> These timers do not have a compare register reload function. To use them in PWM mode, therefore, rewriting the value of the compare register (CR80/CR81/CR82) during timer operation may cause the following phenomenon to occur:</p>

<p>Assuming that "B" refers to the value of the compare register (CR80/CR81/CR82) after rewriting and "C" to the value of the original compare register (CR80/CR81/CR82), an attempt to set the compare register value to "B" at the point when the counter value is "A" ($A < C$, $A > B$) will cause this cycle to fail to output the waveform.</p>
